**REQUEST FOR ADDITIONAL SAMPLING/ANALYSIS
SANTA SUSANA FIELD LABORATORY – RFI GROUP 8
AREA OF CONCERN: BLDG 56 LANDFILL/EXCAVATION AREA
OUTFALL 7**

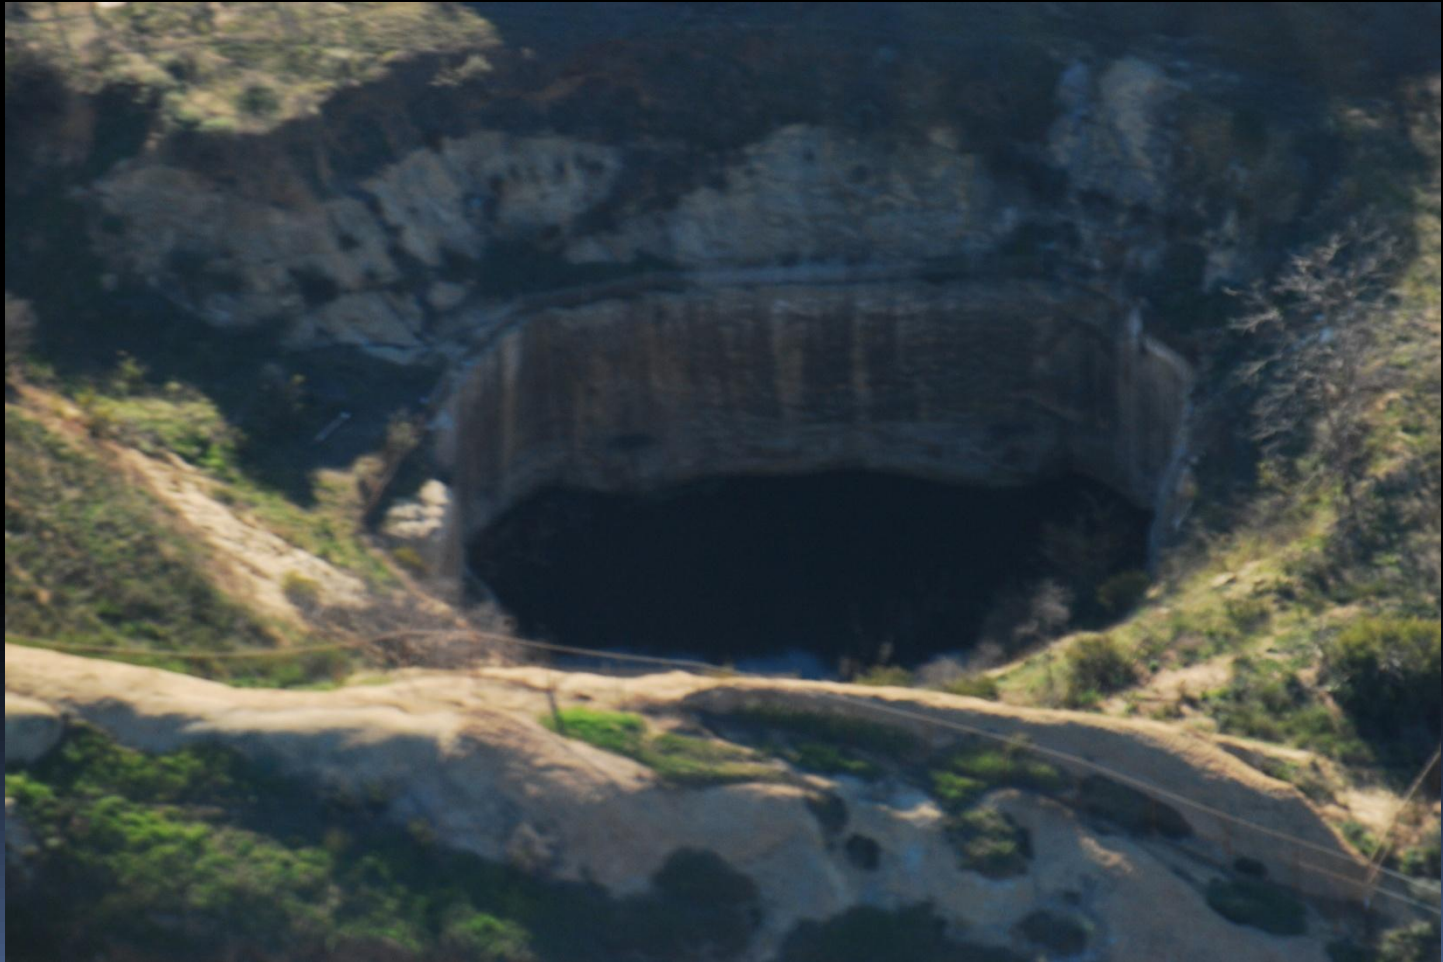
89 Drums of hazardous waste was stored “on top” of the landfill, DOE report states this area qualifies as a potential CERCLA site under DOE order 5400.4

This hole is 50 feet deep and the fill sediment thickness is “unknown”

Location of Outfall 7 is intended, based on bmp structural solution, to deal with water draining from the Building 100 lower slope, but misses all effluent water draining from the Building 100 landfill and excavation areas.

The drums stored on top of the Bldg 56 Landfill area are described as having contained hazardous wastes including reaction products and TCE and other VOCs.

Oil and Grease up to 1100 mg/kg and groundwater impacts in RD7 at 130ppb TCE

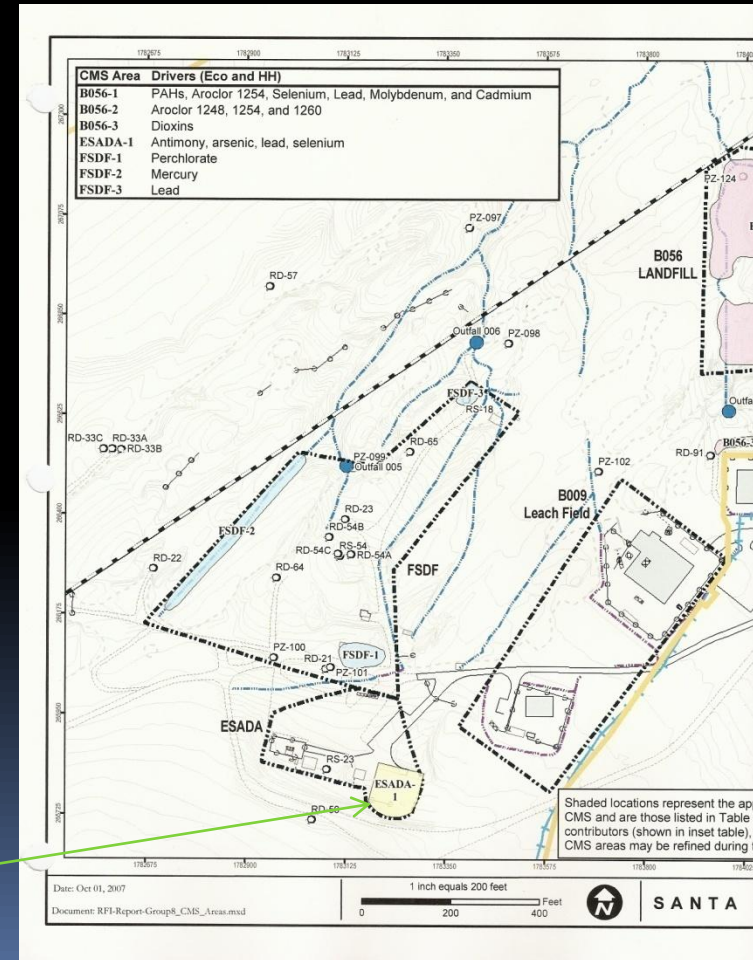
Outfall 6 also misses contaminants from ESADA:

Through the use of drainage culverts, we believe that drainage from the ESADA by-passes the outfall 6 location, going under the road and following the water-divide toward Building 9 leachfield area.

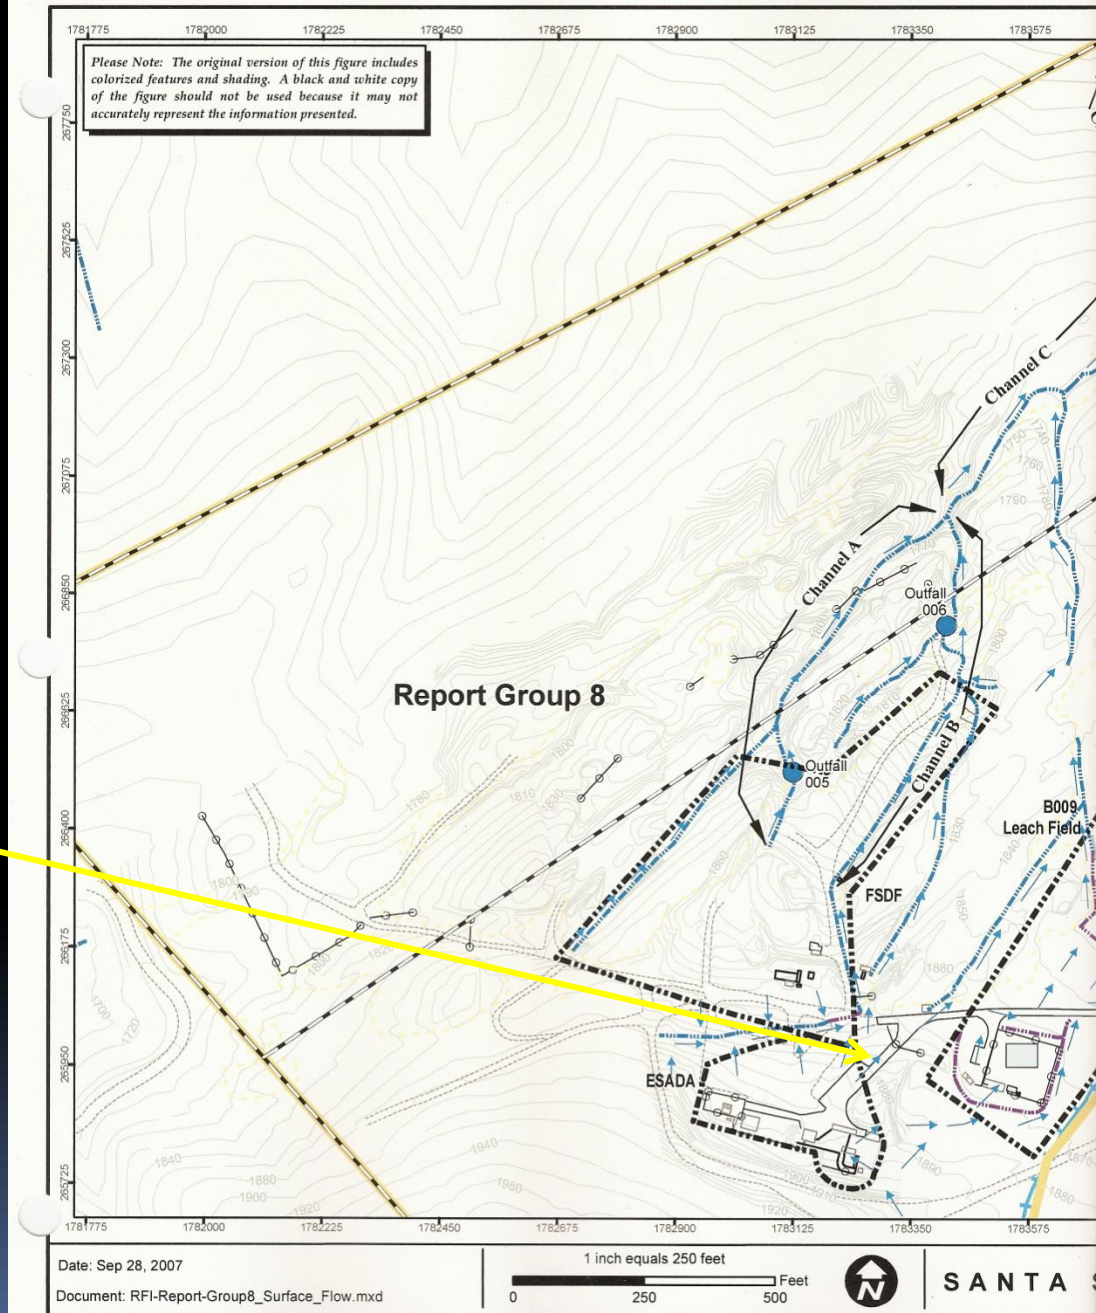
Water Divides:

This area shows under-road culvers that direct storm-water runoff:

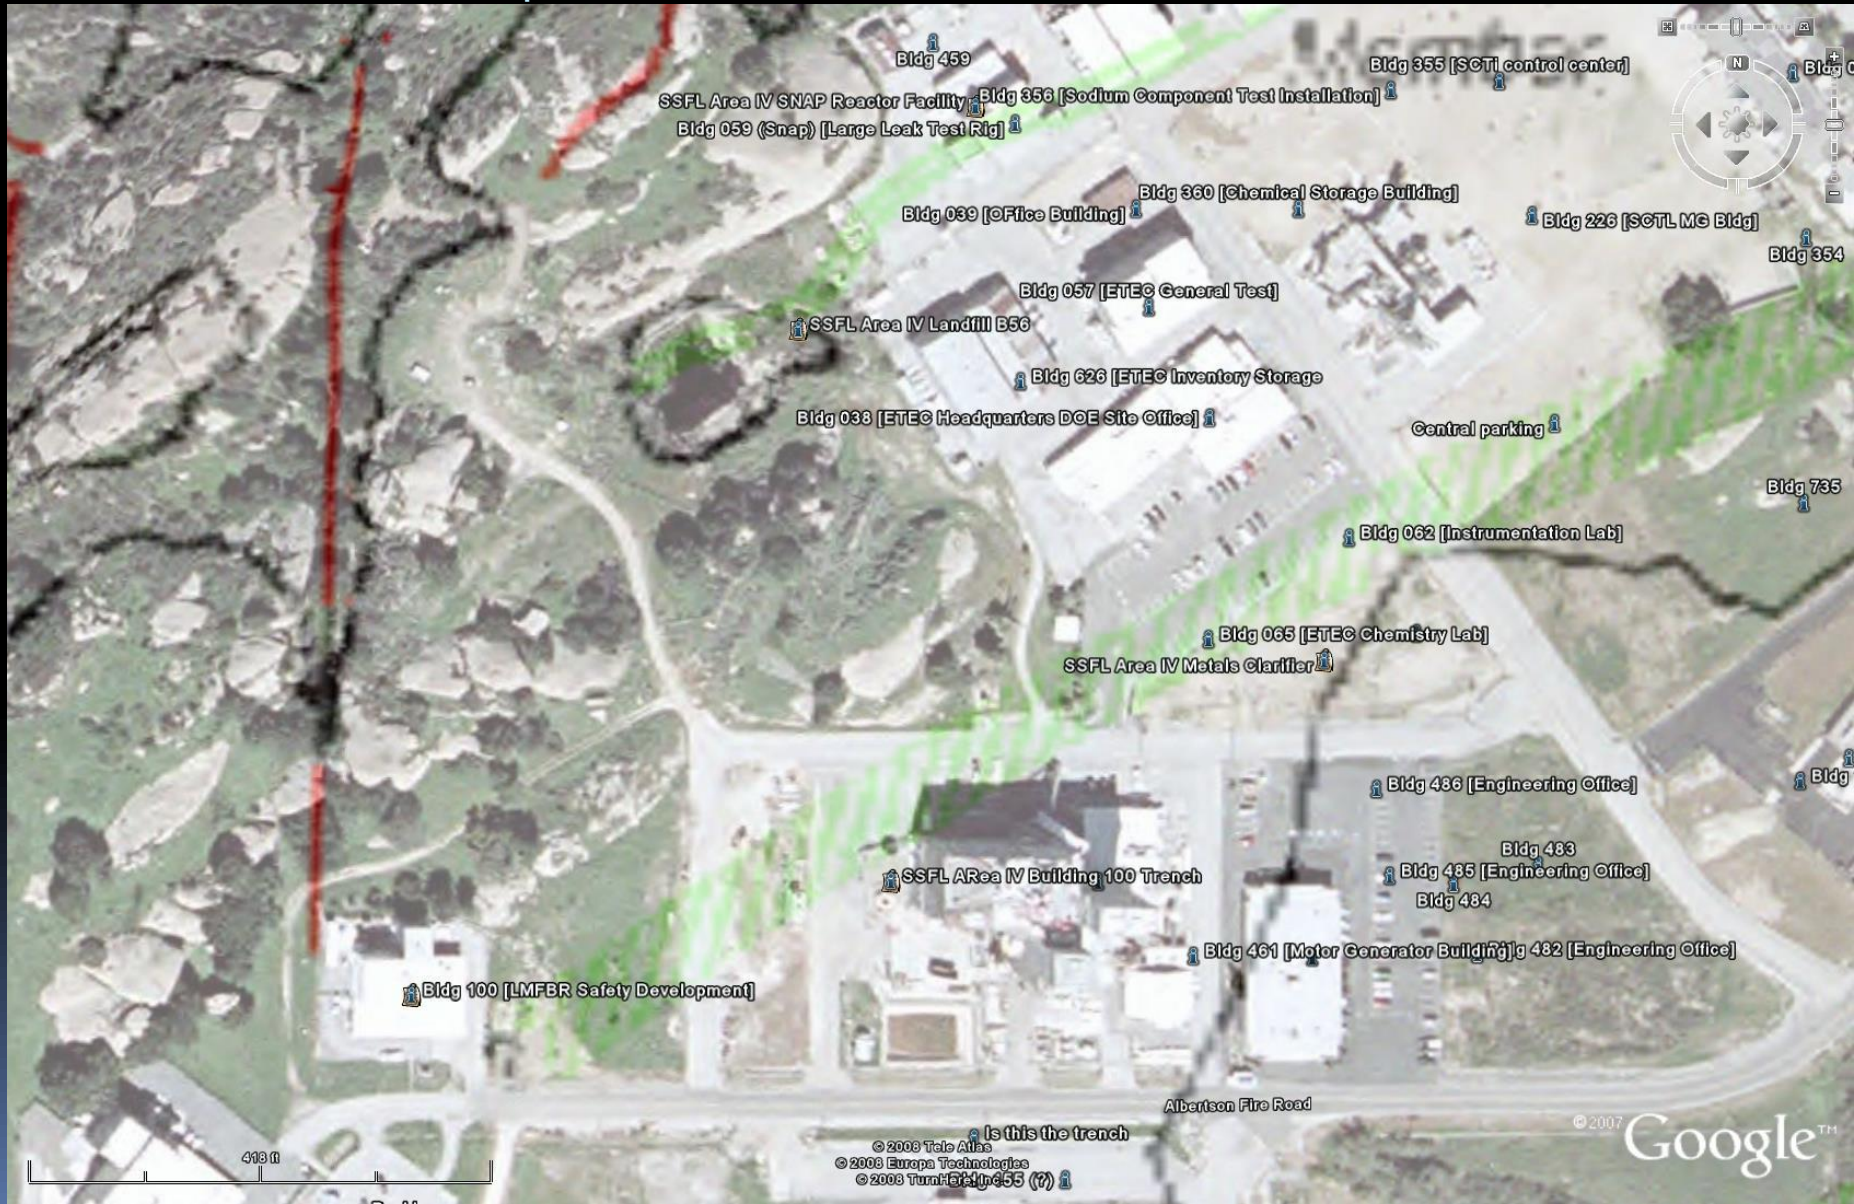
Fault runs from south to north (overlay of Fig 2-5 of known faults shown in red), beginning from Building 100 down the drainage. This area of the B56 Landfill is not showing sampling even though sediment fill was deposited here as well as in the excavation hole.

- We believe that a sampling program is appropriate for this area based on the historical uses of the landfill itself, as well as long-term storage of 89 drums of hazardous wastes on top of the landfill (removed in 1980/1981). SAIC 91
- Pursuant to Section 13267 of the California Water Code it is appropriate to employ a monitoring program for these locations to determine if further action is needed.
- Thank you in advance for your consideration.

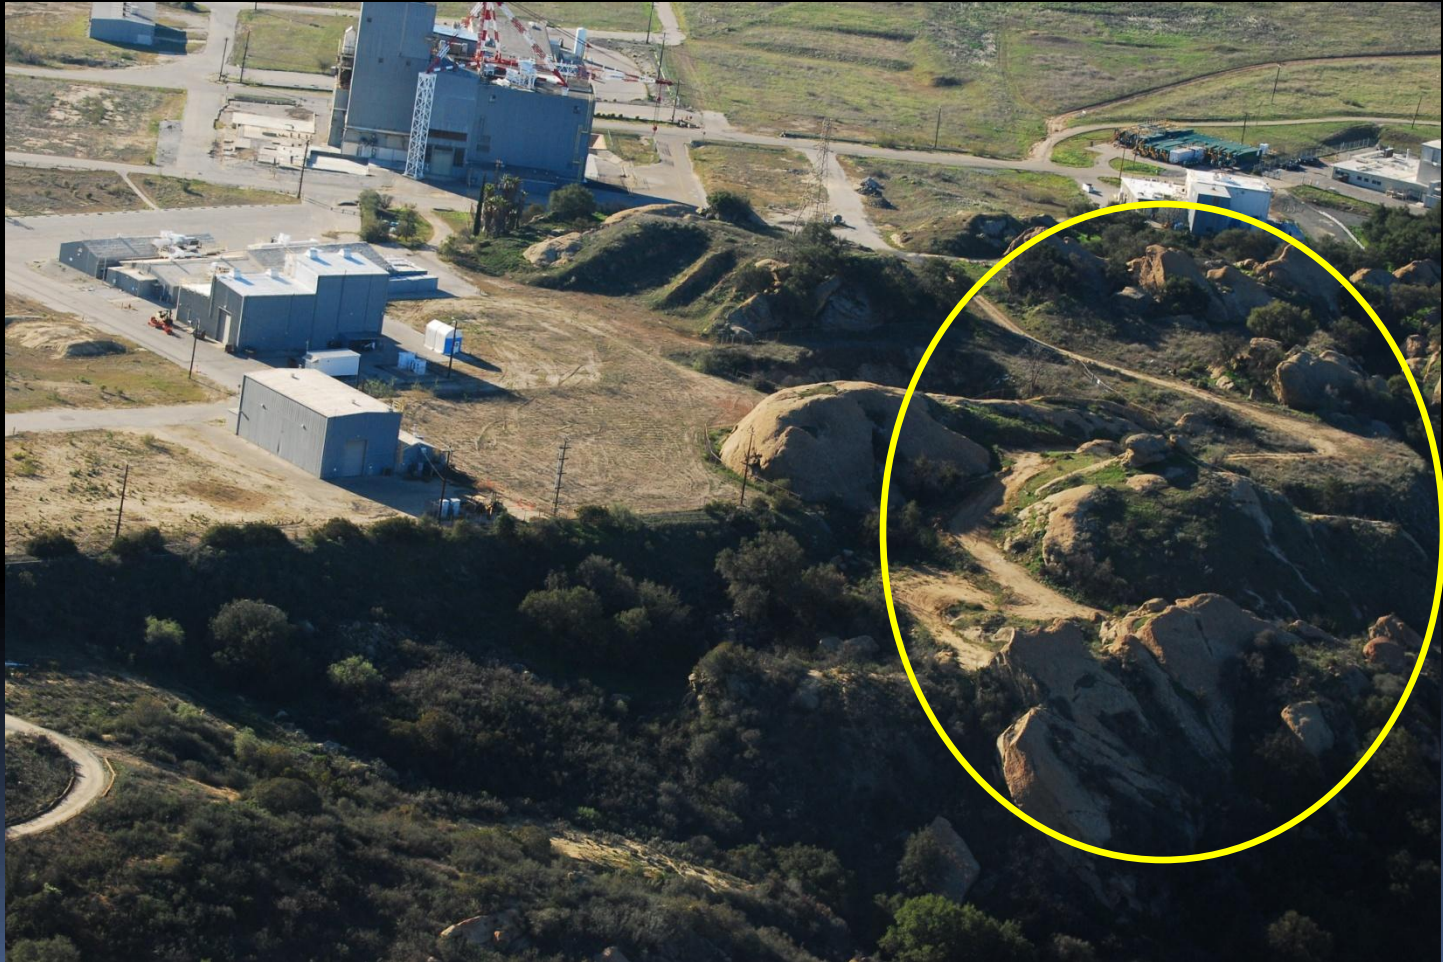
Building 56 Landfill:

Connection to groundwater is also important and presents a migration pathway continuous release, generation of subsurface gas, making it a continuous threat to groundwater and also a potential source for release to air.
