May 14<sup>th</sup>, 2009

RE: RCRA Group 5 SSFL  
Comments for Santa Susana  
Field Laboratory Areas III and  
IV as defined within the RCRA  
group guidelines

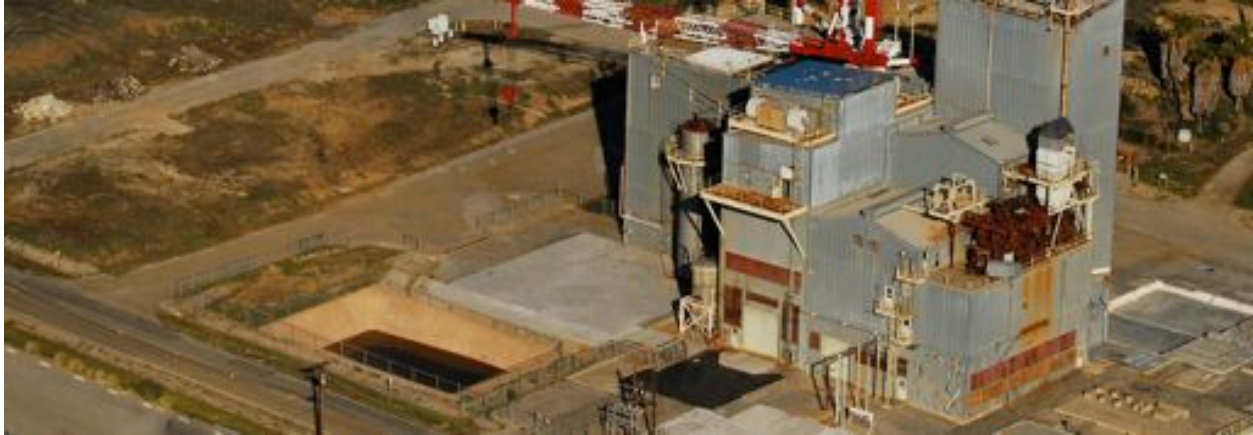
recycling program among other things, went on, are not even located within the boundary of the DOE LF3 designation as noted on Figure 4-2<sup>1</sup>. Not only are they not included in the CMS areas, they are barely acknowledged in the form of sampling, and the related pond is not even indicated on the map despite its obvious existence.

We would like to emphasize that we feel that all significant operational areas should be clearly described and investigated, as well as clearly shown on all reference materials as belonging to the designated areas they belong to.

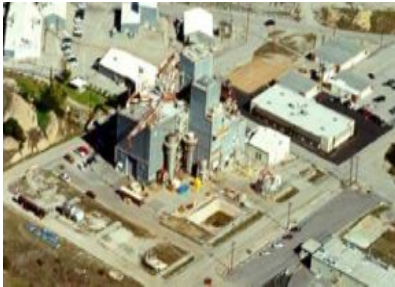
Photograph - Building 4463

- **B4463:** Component Handling and Cleaning Facility (CHCF): used to assemble, disassemble, and clean pumps and other parts of the Sodium Pump Test Facility (SPTF).

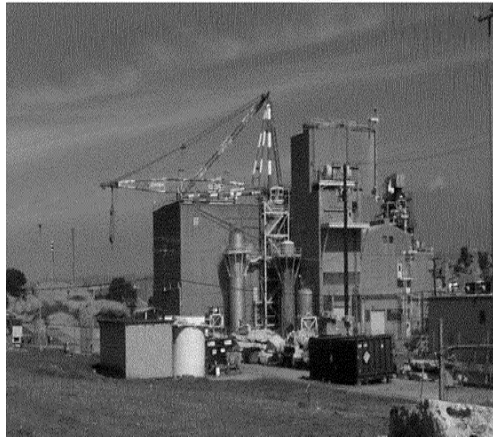
The pond shown here, is not indicated in the SAP maps included in the Group 5 Report.

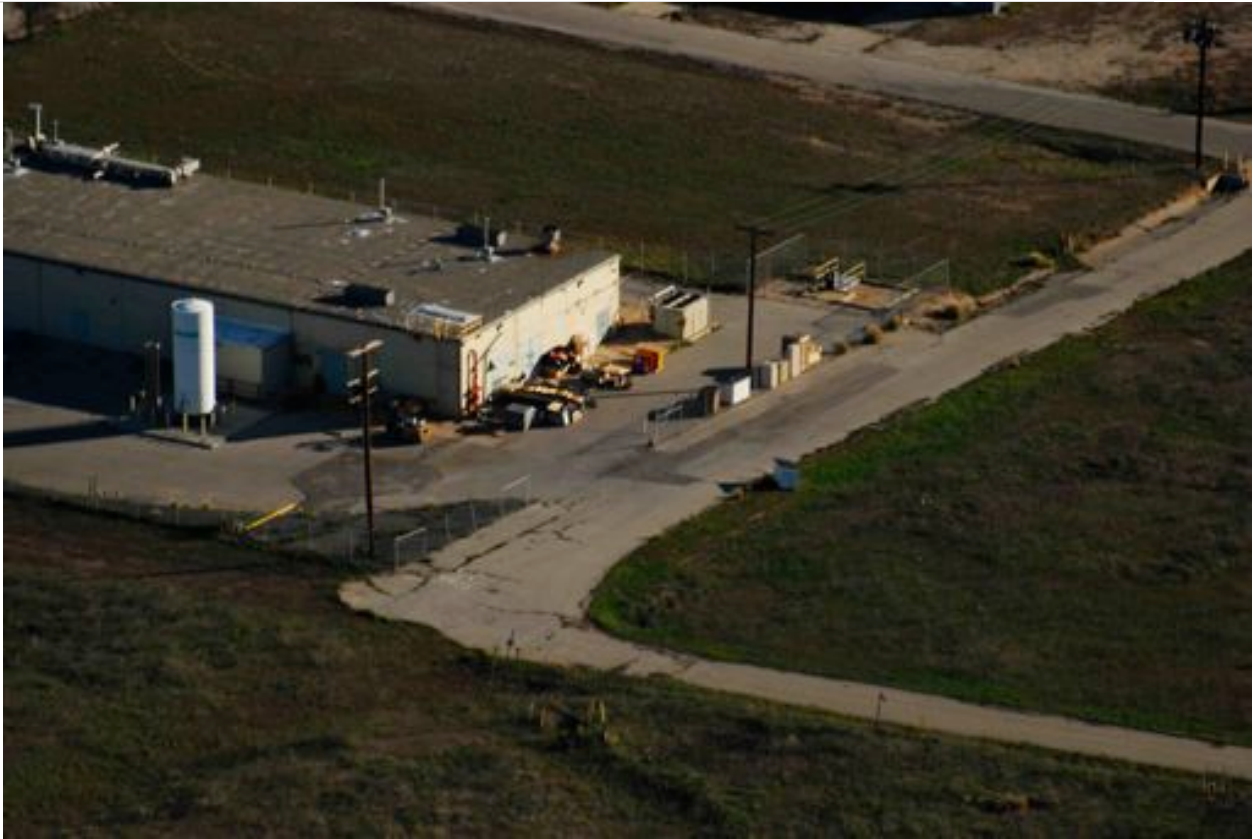
- The drainage and loading areas seem to be overlooked and should be examined with higher scrutiny for potential as migration pathways for contaminants. Please note the drainage culvert in the upper right corner of the photograph below, that leads stormwater toward STL IV.

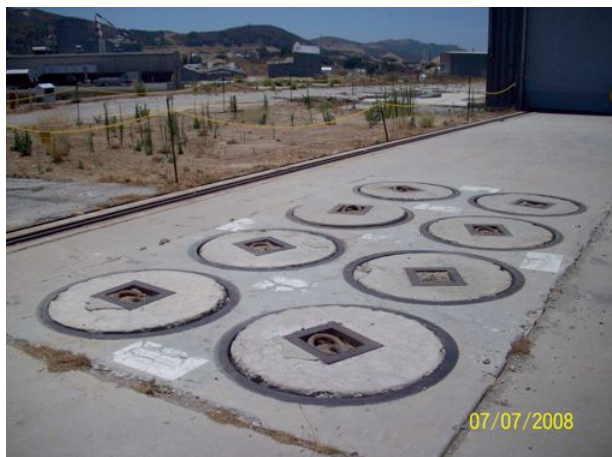
The most disturbing of the “sampling warranted NO” features that we have reviewed, is 4024-005 which is described as “radioactive waste storage vaults” and because they are “intact” meaning still existing, they are recommended for no further sampling when there is no possible way to understand these to be intact without thorough investigation which has not yet taken place. To recommend these areas for NFA at this point is inappropriate.

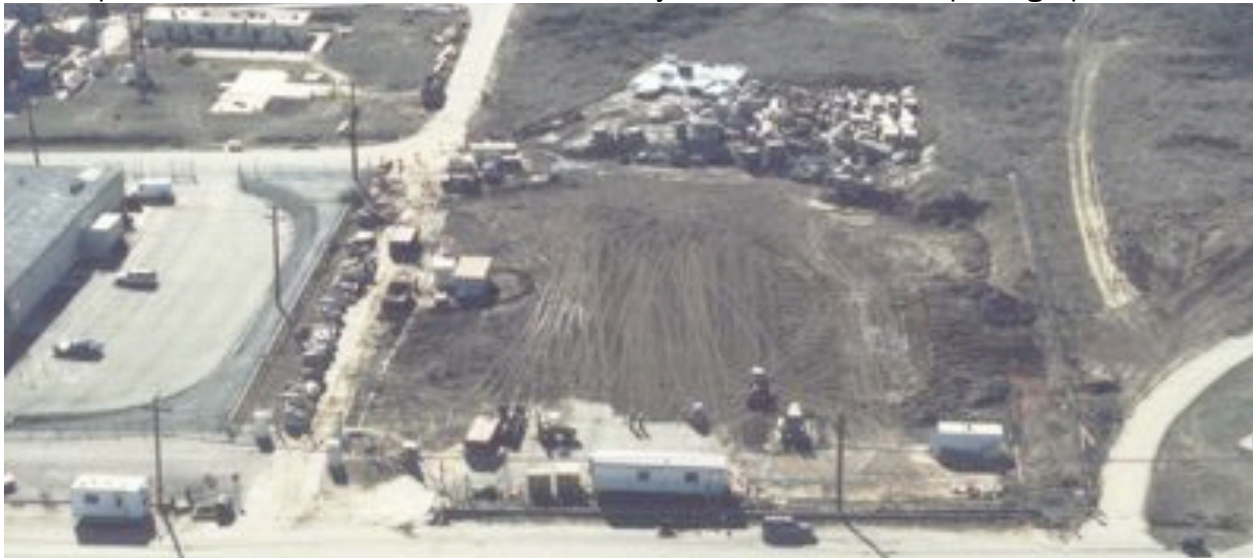
Our concerns about the parking lot area not being adequately sampled, or even designated as an operational area is further demonstrated by this 1997 historical photograph:

In addition to the parking lot area being used for loading and unloading of hazardous radioactive waste, it was also used to store all the existing radioactive and other waste during the demolition process in 1997. This makes it even more important to sample for all COPCs as this area clearly requires more investigation.

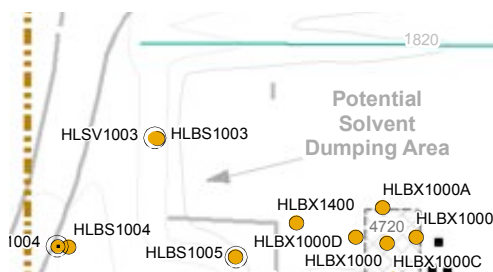
Based on the potential solvent dumping area, it should be sampled, and yet the depiction does not indicate samples taken at the location believe to contain the highest levels of solvent impacts<sup>10</sup>.

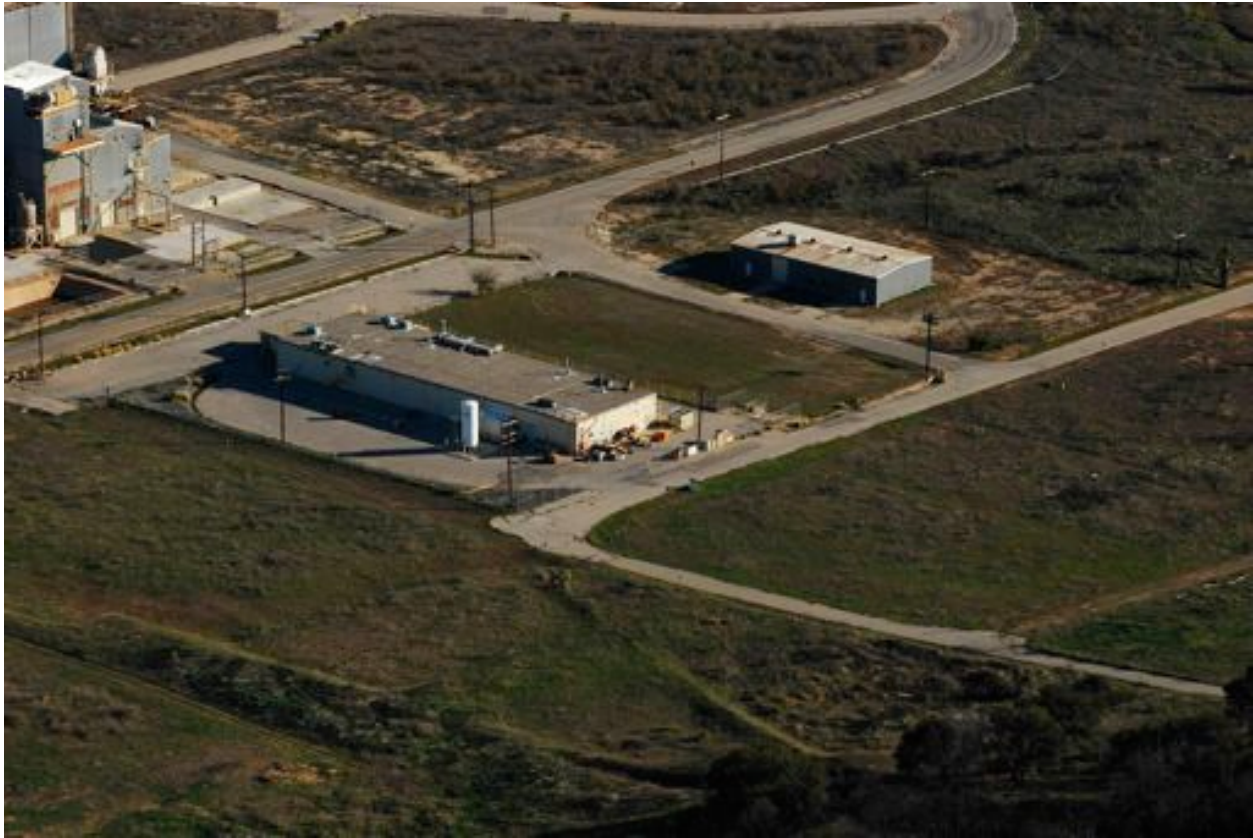
In this aerial photograph taken in January of 2008 you can still see the outline of the parking lot and the pipes that led from the tanks above, down to the lab. Sampling needs to include the area, including the parking and loading areas of both the Hot Lab and the neighboring Building 55.

Please note that the only remaining buildings and structures as shown in the aforementioned photograph are considered “footnotes” to DOE LF 3, and are not even considered RFI sites in their own right, yet, NFA is the recommendation we see, despite the fact that they are still there, not sampled, not really addressed for what they are: Existing nuclear buildings where hazardous materials were used, disposed of, buried, leaked, washed down, loaded, unloaded, etc. These are all operational processes that must be considered in the characterization process. We ask that they be properly considered here.

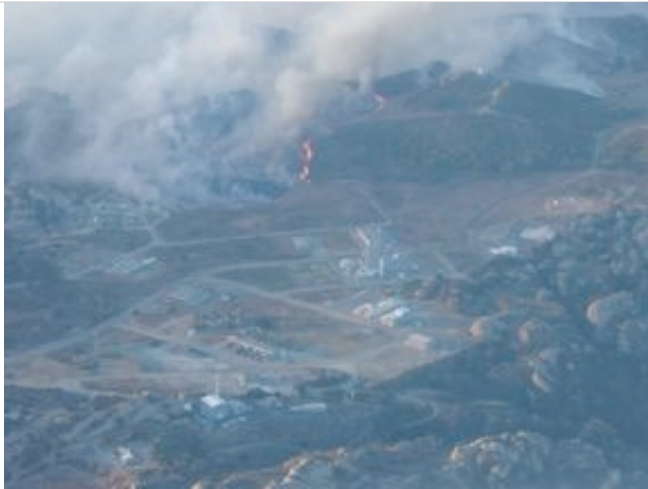
The footprint of the Hotlab burned during this fire. Fire fighters were exposed to potentially contaminated vegetation materials combusted in that smoke that fell out upon the surrounding areas, crossing borders as well as going off-site.

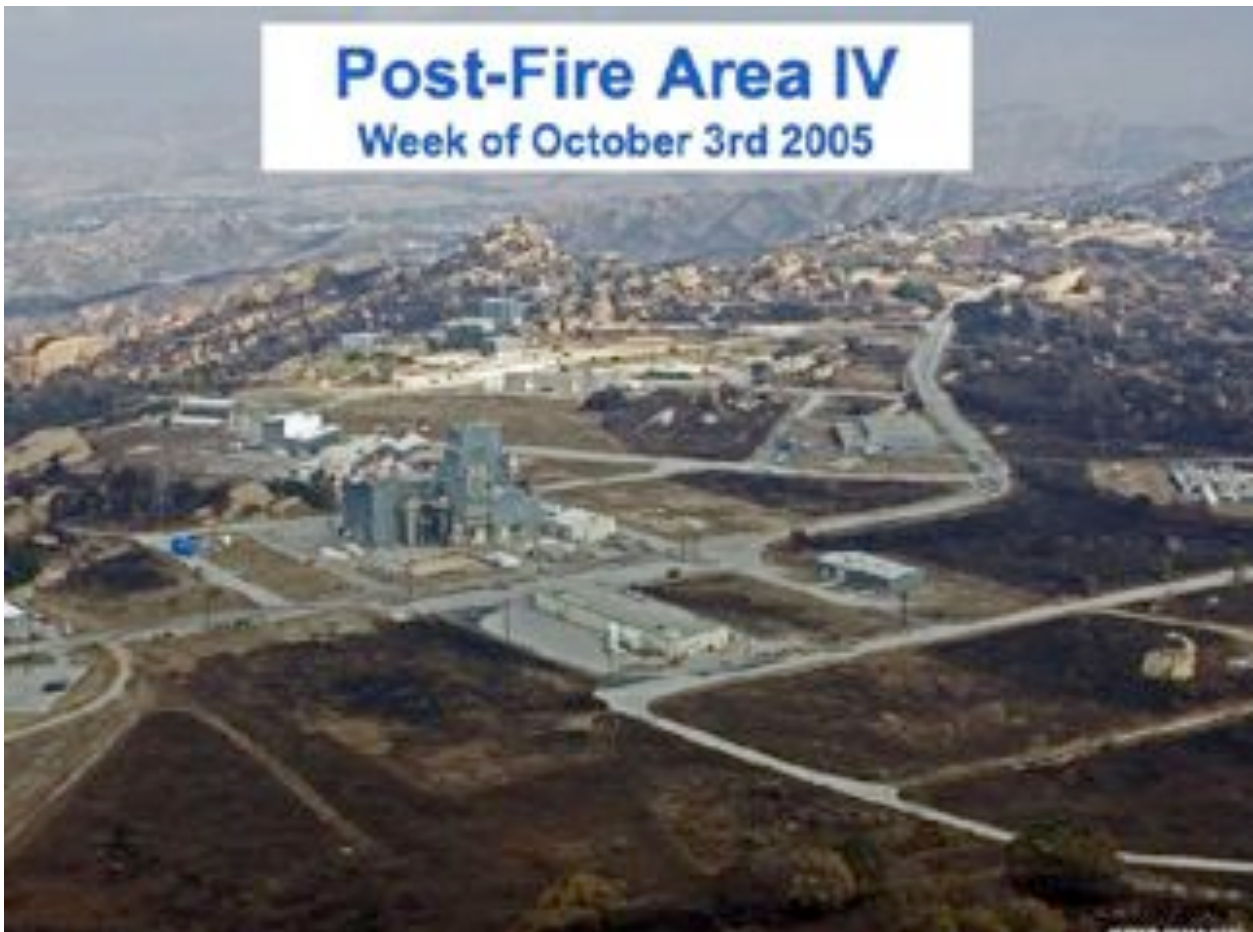
In this photo, in addition to the Hot Lab footprint having burned, the entire pond-dredge area also burned during the 2005 fire. This area also shows disturbed soil and dumped debris that needs further investigation to the south of the former Hot Lab location.

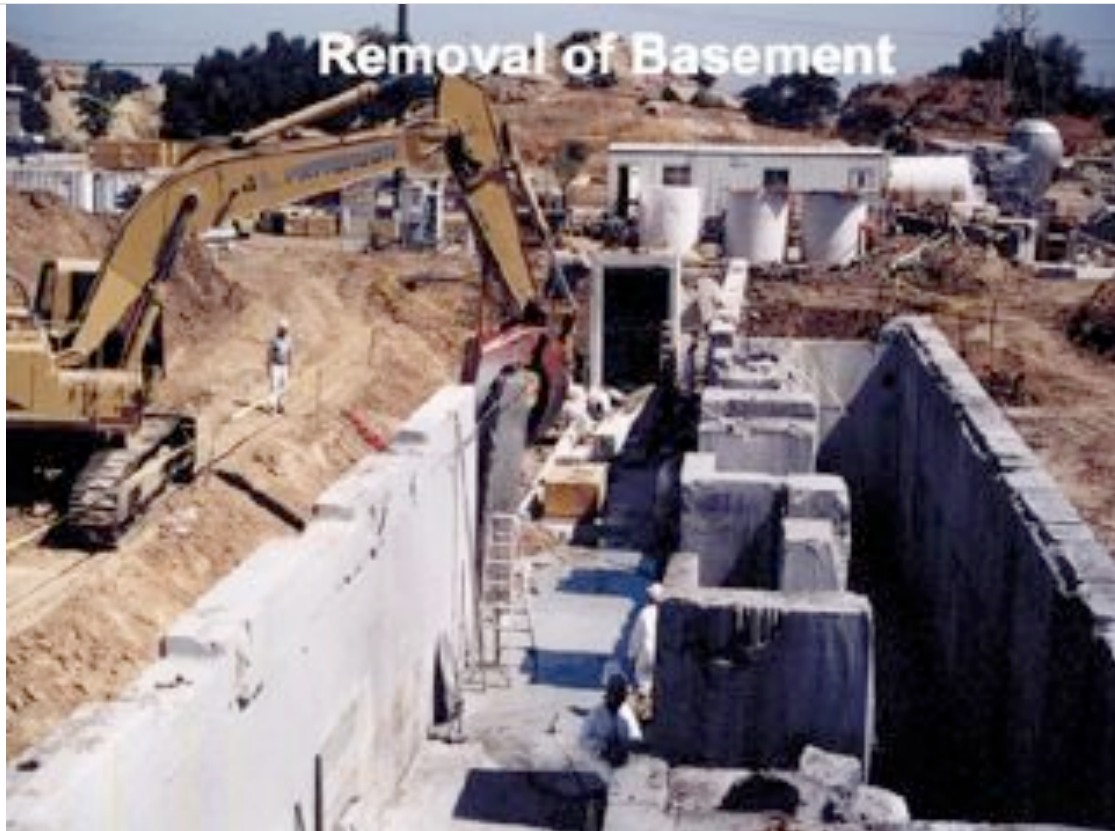
Here the vaults are shown along the right, and they actually are not very thick.

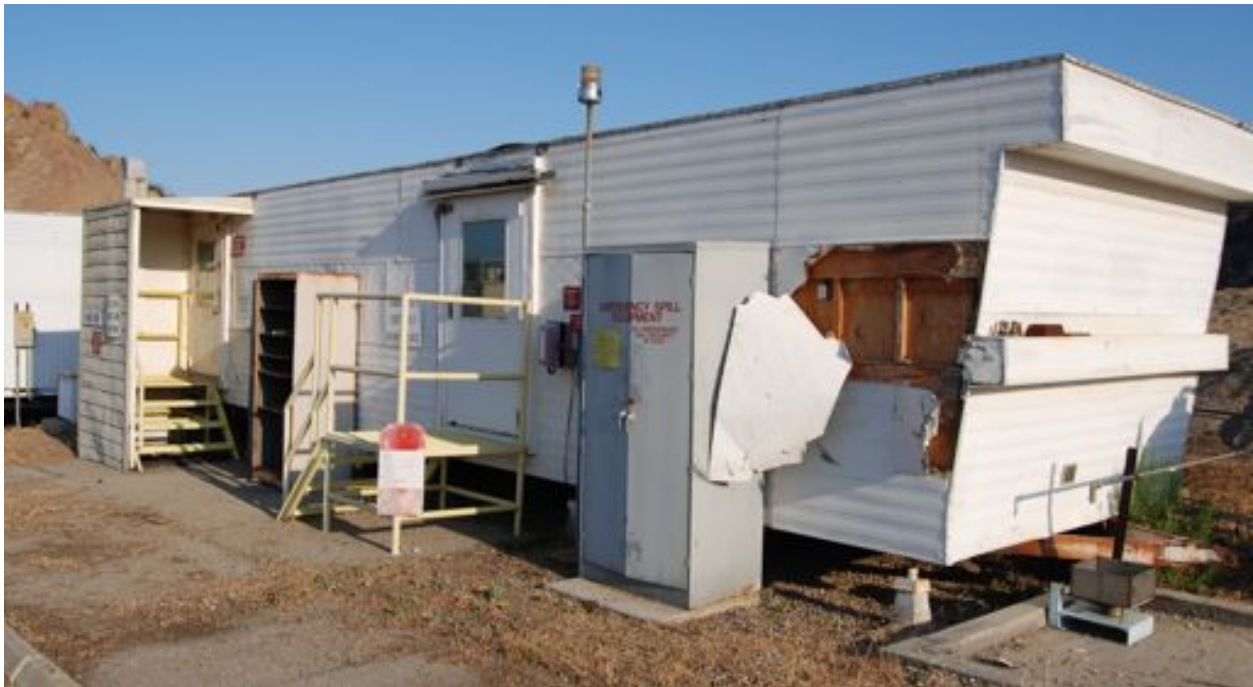
Please note the effluent drainage into the containment area described as feature number

3274-001 which indicates that no sampling is warranted and that is due to the condition of the item being “intact.” We appreciate the opportunity to discuss the use of various descriptive words to mean, either “still existing” or “removed” since it is not possible to evaluate the condition of the containment structure sub-surface. Insufficient sampling has taken place to-date in this area and all COPCs should be looked for as this was the terminus of a laboratory sink in a decontamination environment as seen below by the signage inside the trailer.

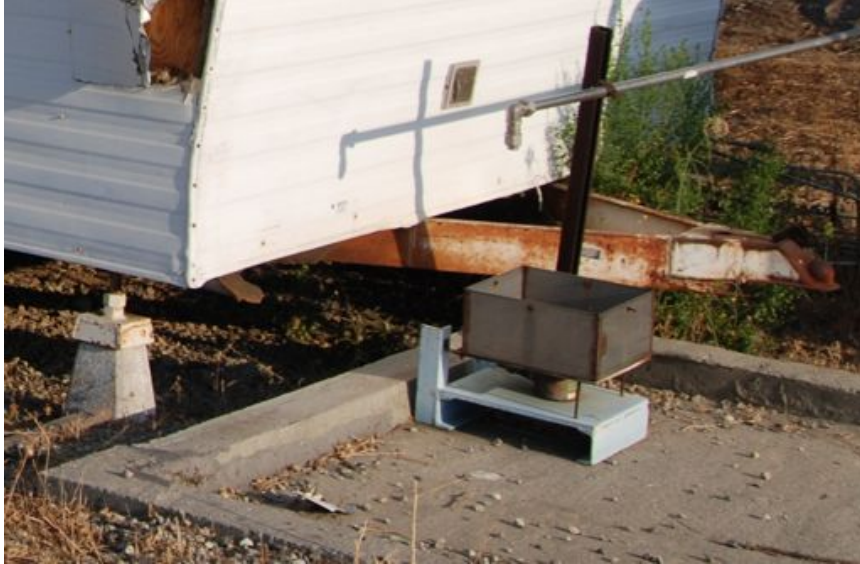
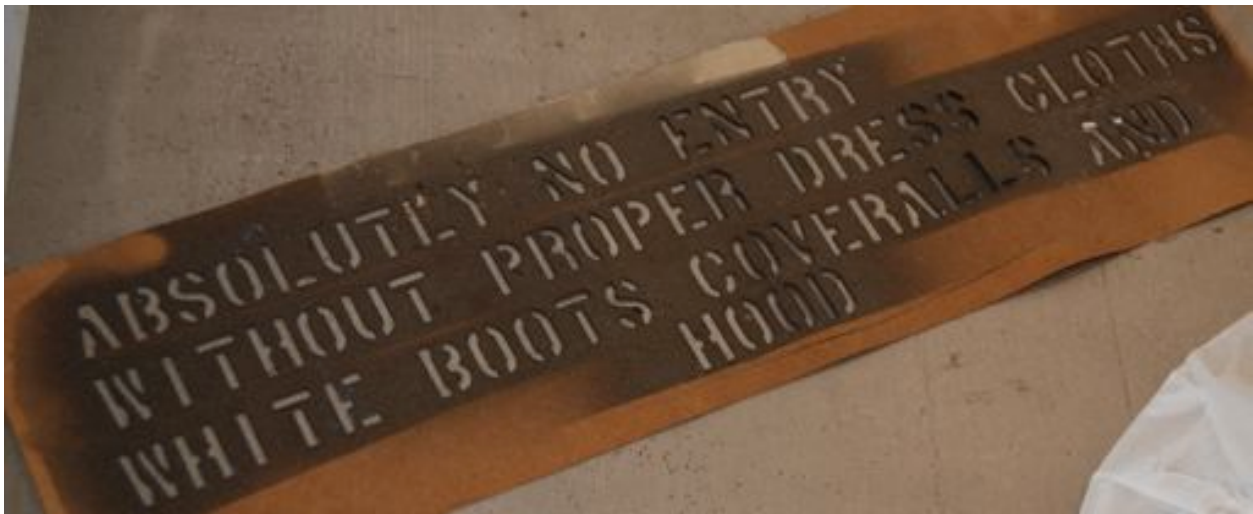
We also observed in the aerial photographs of Building 3274, these photographs indicate that the outer surface of the trailer was removed separately. Please clarify where this was disposed of, and the specific method, and reason for this disassembly.

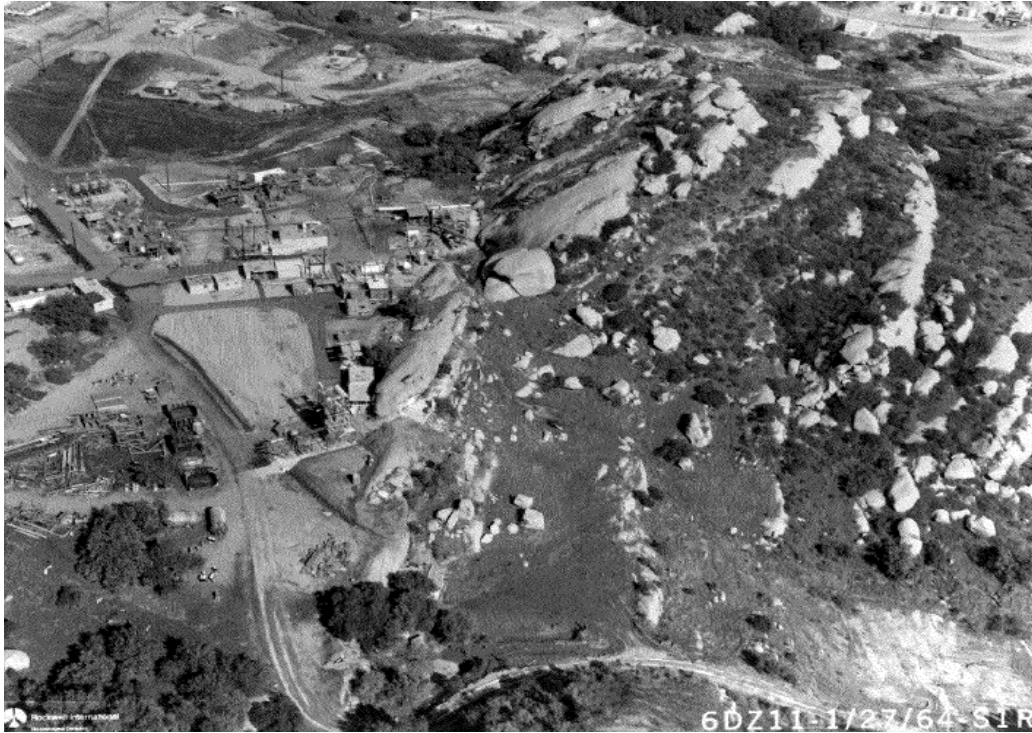
STL IV lower area where the explosives storage areas were located, also shows significant disturbed soils that are NOT shown on the map submitted in the RCRA Group 5 figures. Also, please note the area to the left of the road where a very large amount of debris is visible.

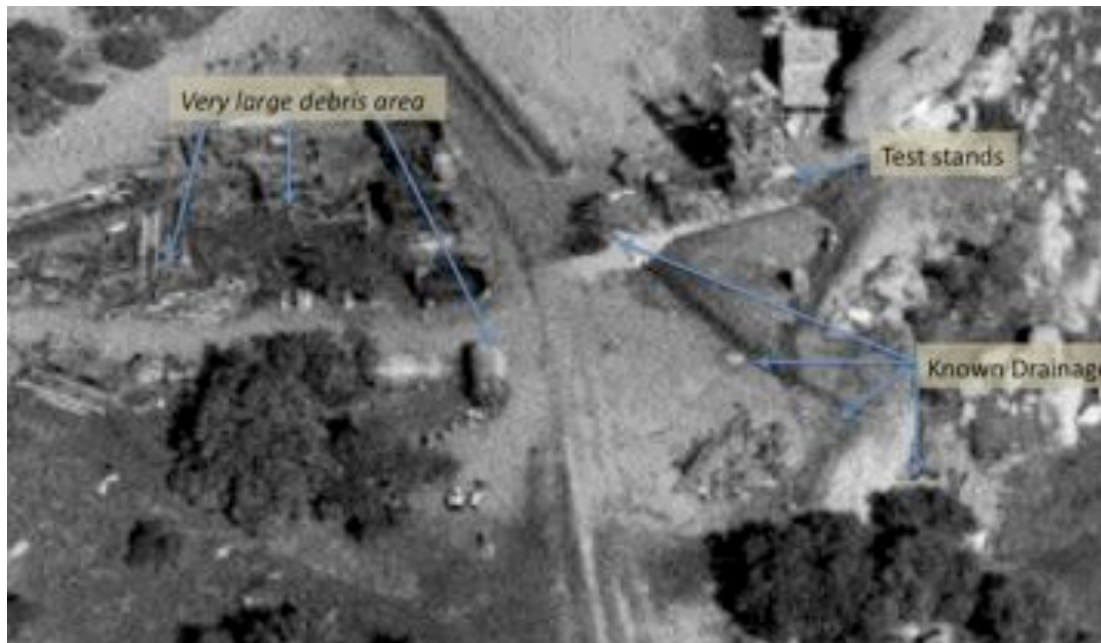
This known drainage (shown above) is where they have BMPs shown in recent aerial photographs.

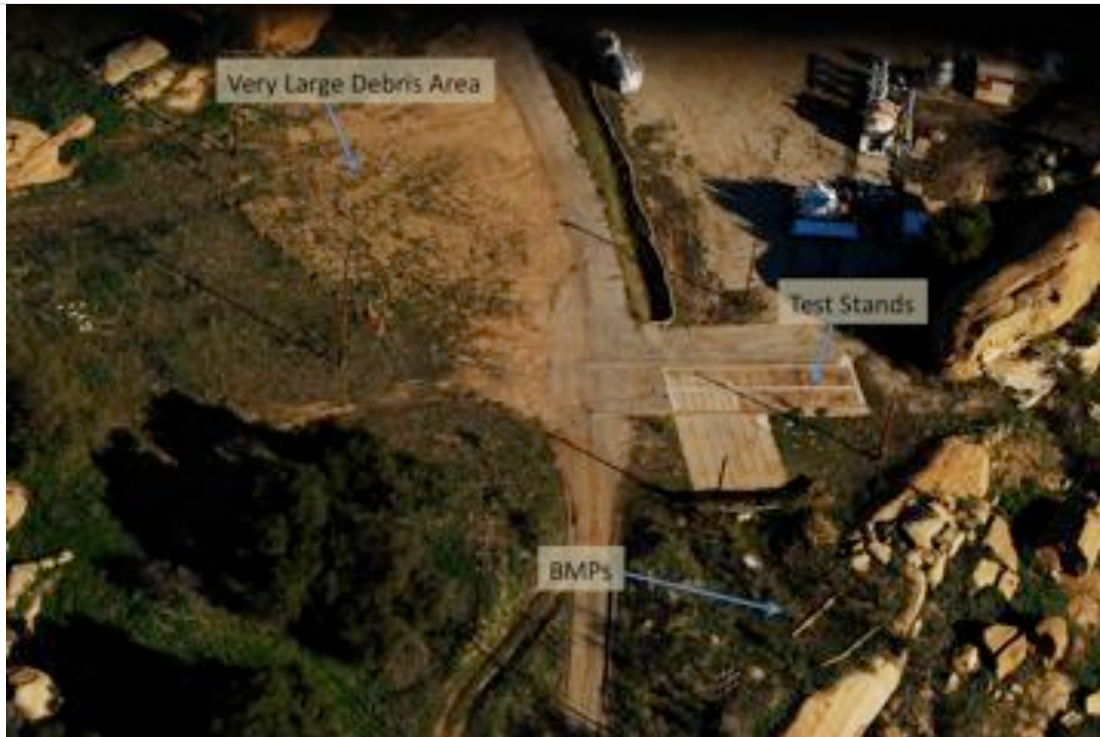
The area to the left of the road is the same area where debris was shown on historical photographs. This area is not considered, sampled or part of the CMS. On what basis can this decision be made when it took sheet runoff as well as being its' own potential source due to prior storage/disposal practices?

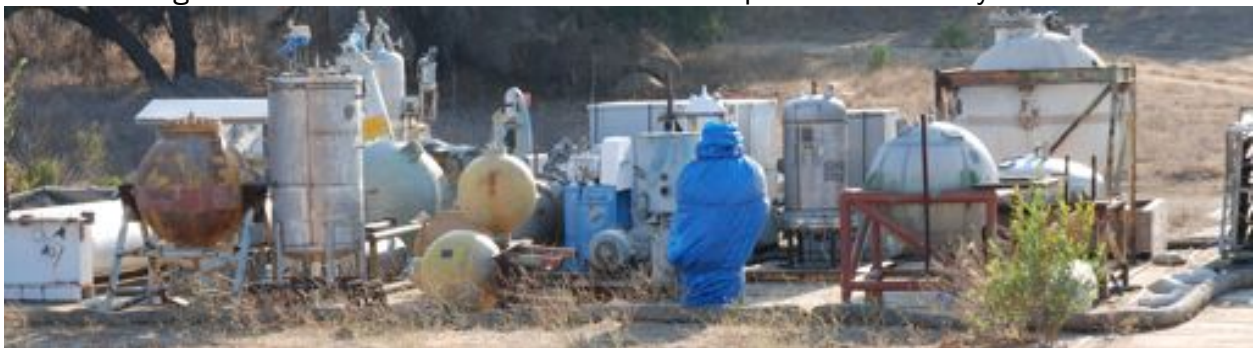
Former storage of waste and chemical containers for a period of several years:

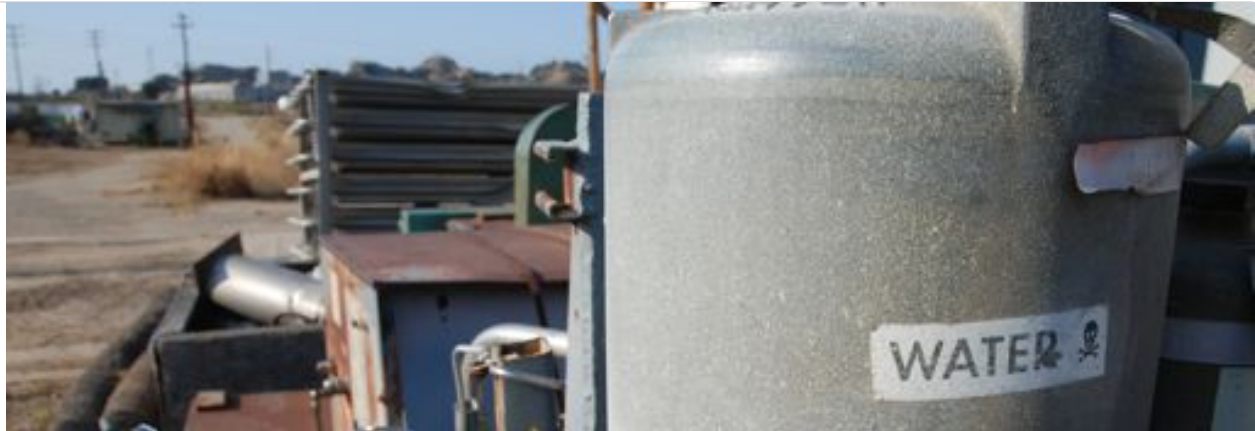
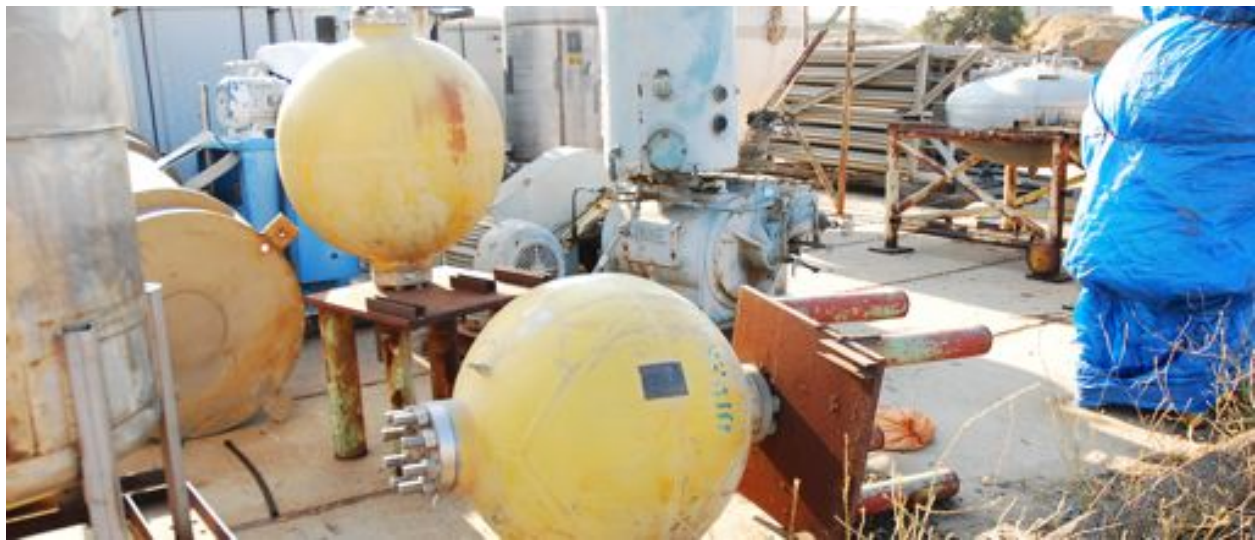
This area included a series of BMPs that consisted of straw waddling to encompass each of these areas of waste and equipment/asset storage. This activity demonstrates the understanding that contaminants may have entered the environment from these containers that are degraded in condition and may have leaked. Some of the equipment was initially tarped, and later the tarping was removed.

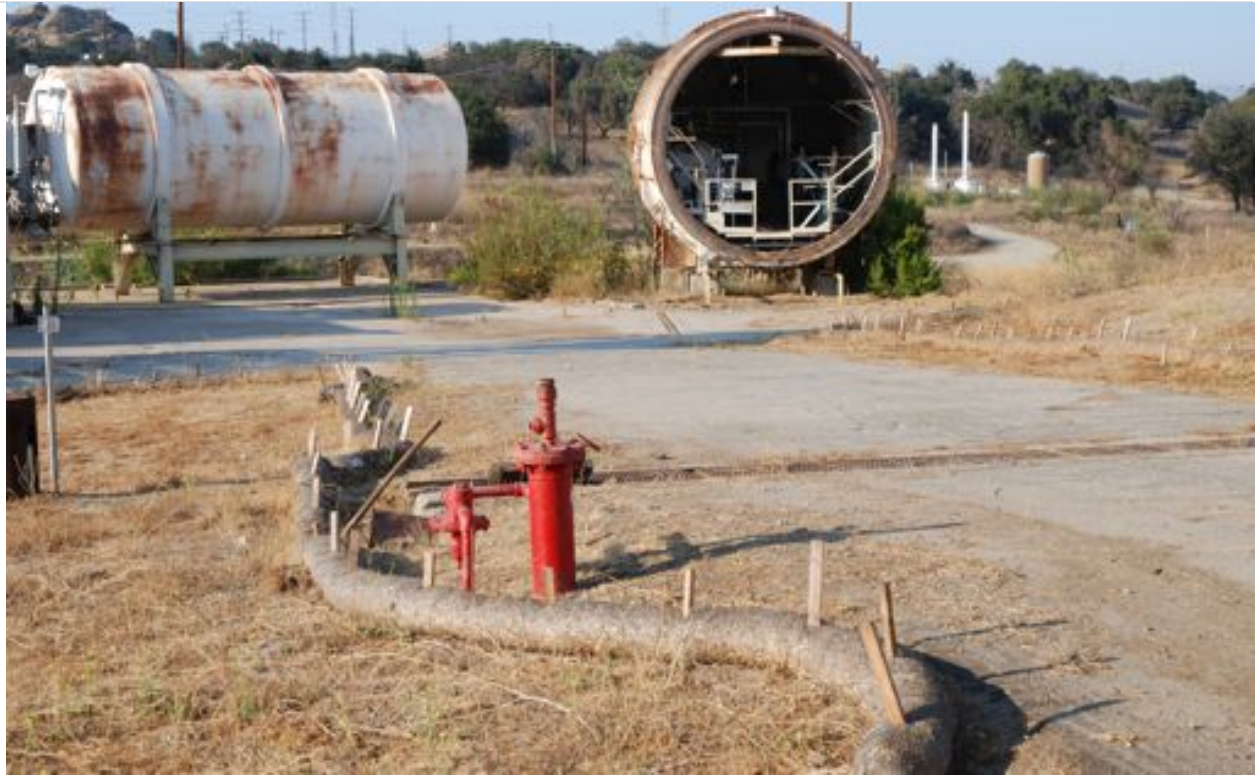
The system of drainage and straw-waddling shows an effort to manipulate stormwater runoff which, now has potentially been altered through the grading and demolition process with inadequate documentation of these important features and details. We ask that these features be documented in detail in all areas subsequent to the submission of Group 5 and that all areas that still exist in the previously submitted group reports be amended to reflect this very important information that will lead to more sound remedial decisions.

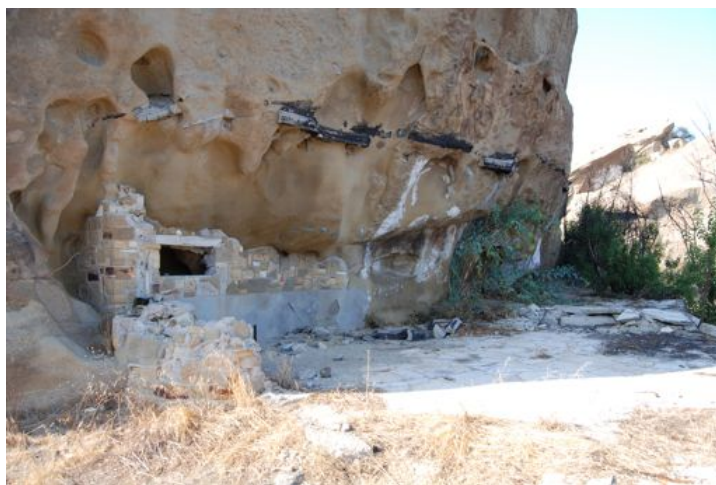
Energetics and MMH highly reactive storage was located here in addition to evidence of debris down the drainage toward outfall 2 below.

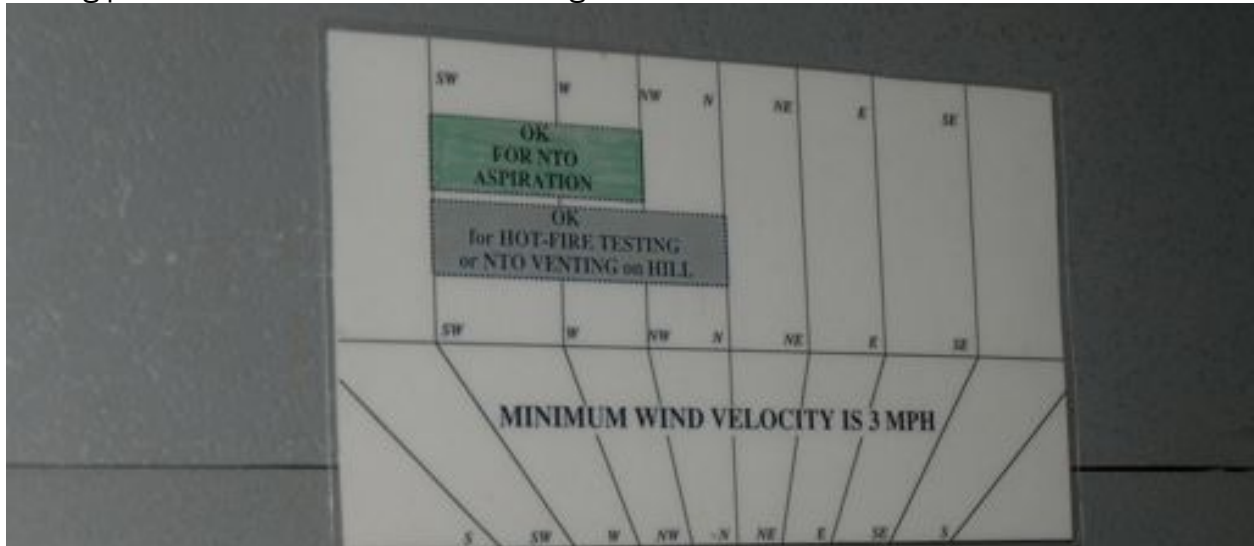
We ask that the rationale behind venting in certain directions and not others, be explained, including the wind velocity as described here as a minimum of 3 miles an hour.

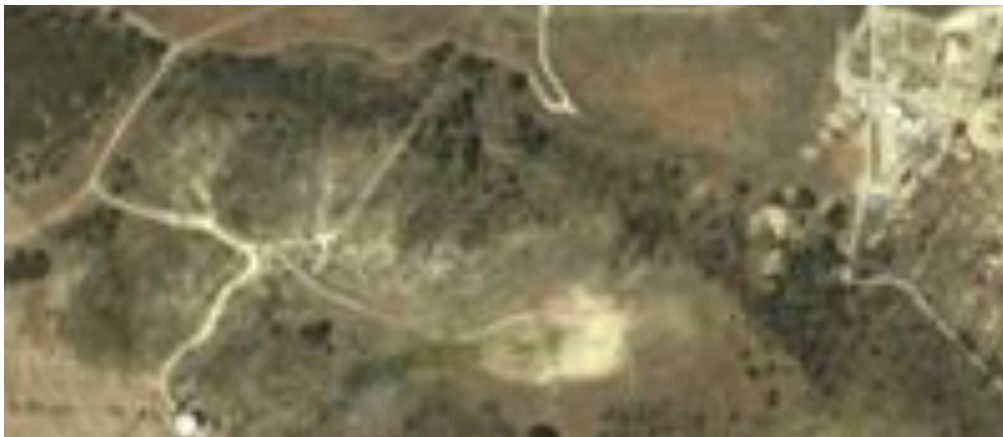
In the aforementioned photograph, it is clear from the tracks shown from truck traffic, that the area of disturbance is lower than the area where they are sampling. We ask that the entire "borrow" area be sampled, especially those areas down-gradient from the disturbed soil area.

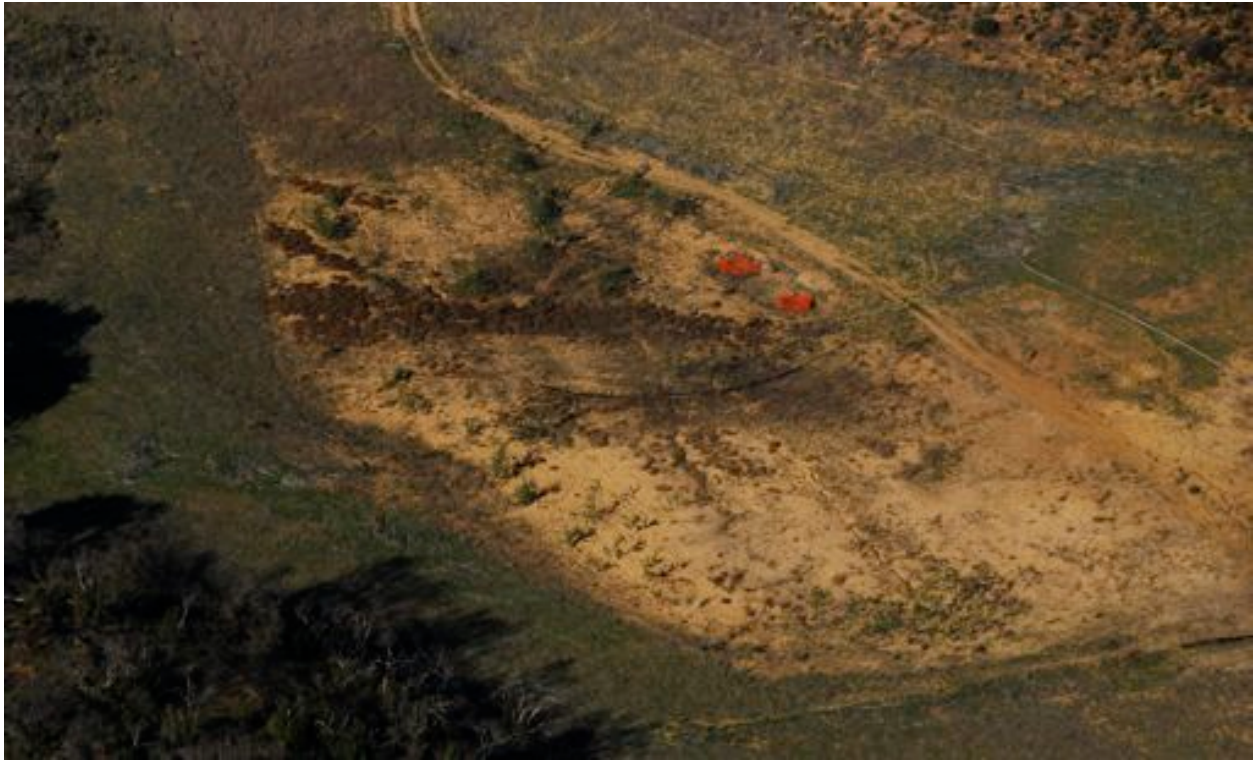
STL-IV Ponds (1960)

These specific early ponds are not clearly identified in the later building feature documentation logs. We are pleased to see these added layers in the reference maps to be used when considering sampling locations in the SAP.

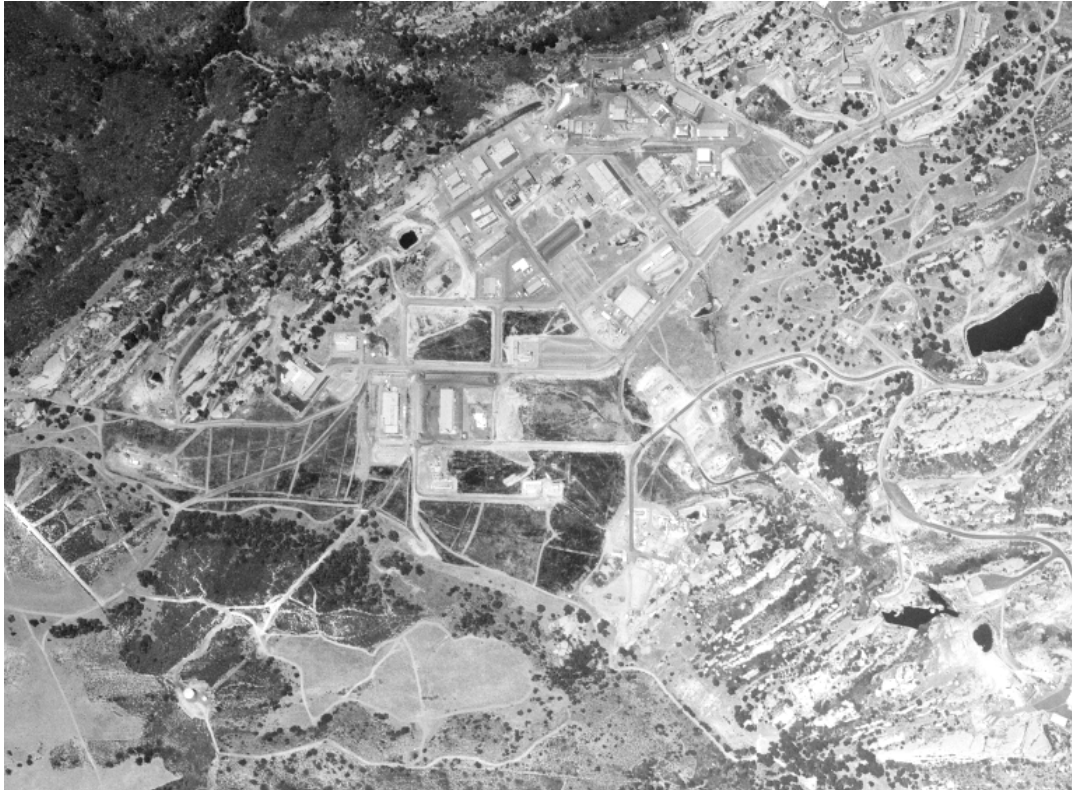
Another early photograph, where STL IV is already there, as is the disturbed soils on the lower right. This is early, when the Hot-Lab and building 55 were there, but prior to the SPTF. The shark is very apparent in this photograph and our photos show disturbed soil on the right side or “mouth” of the shark, which is also down-gradient from the areas sampled. We have questions about backfilling materials possibly deposited here, and therefore believe that sampling is justified since they did find some detects.

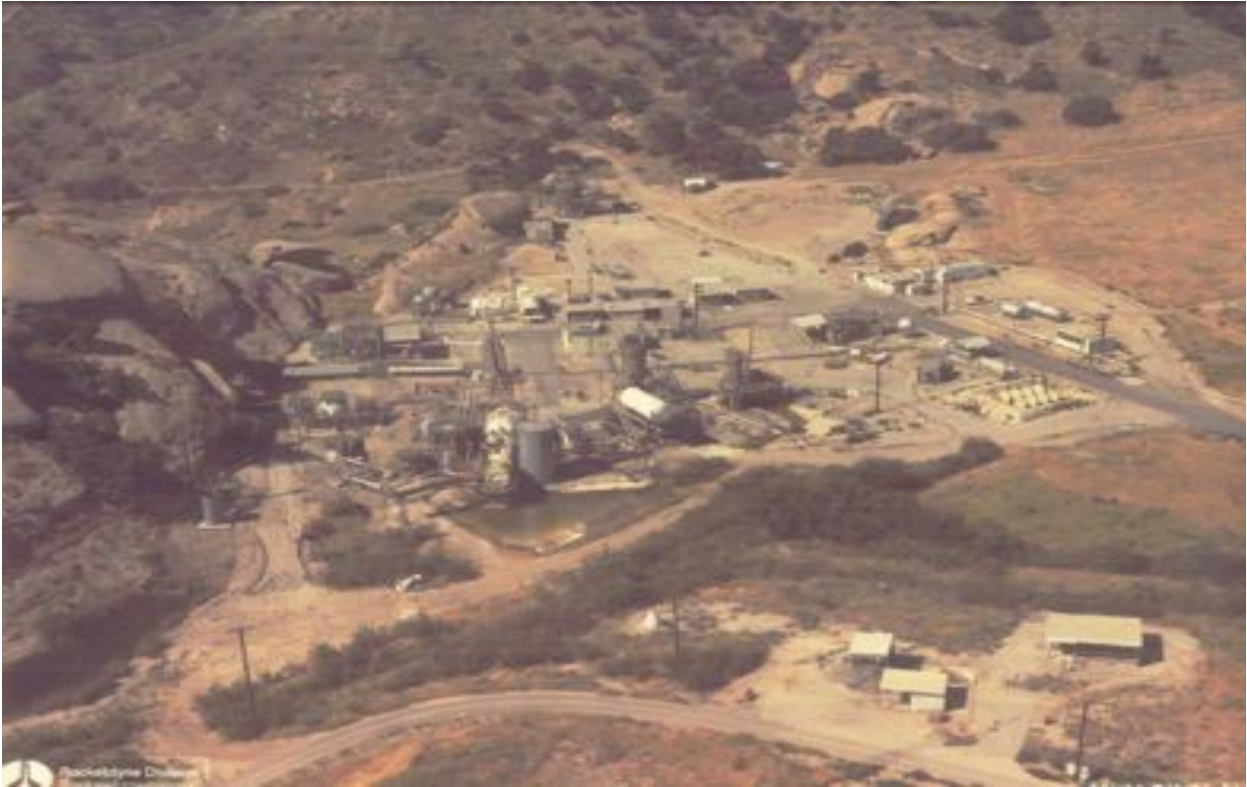
This pond was unlined until later years, and subsequent drainage should also be investigated. Currently, very few samples have been taken in the pond area.

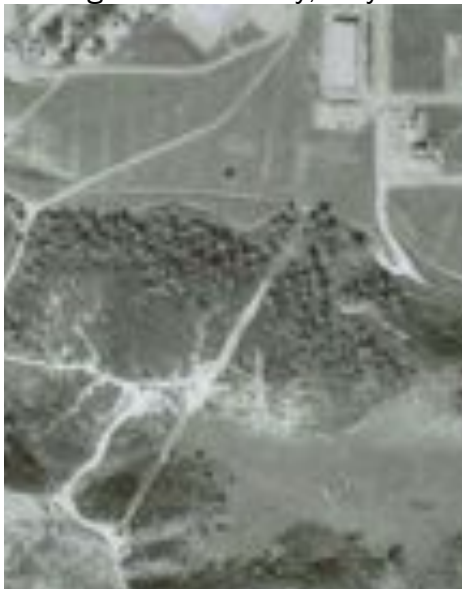
*Notice that the "shark" area is not yet disturbed with the exception of the upper "fin" area where the tanks are located.*

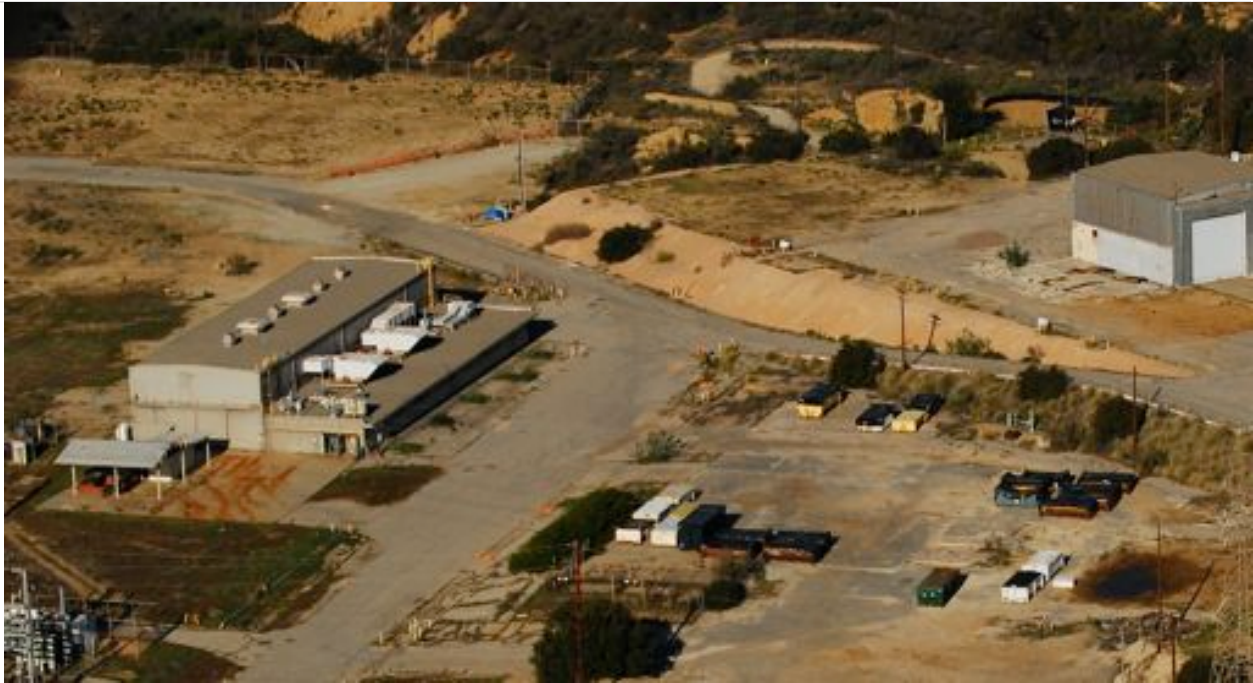
Staining of this area makes it necessary to investigate further, yet it seems to be overlooked.

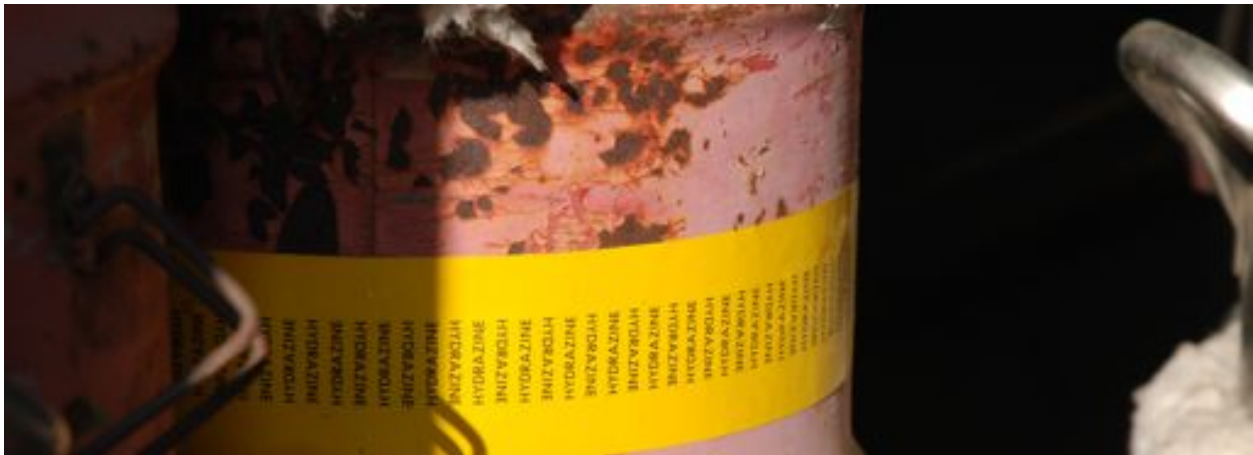
This storage of hydrazine is not noted since these materials were removed prior to the “documentation feature logs” completion. Hydrazine should be sampled for throughout this area where many buckets and other larger containers were observed.

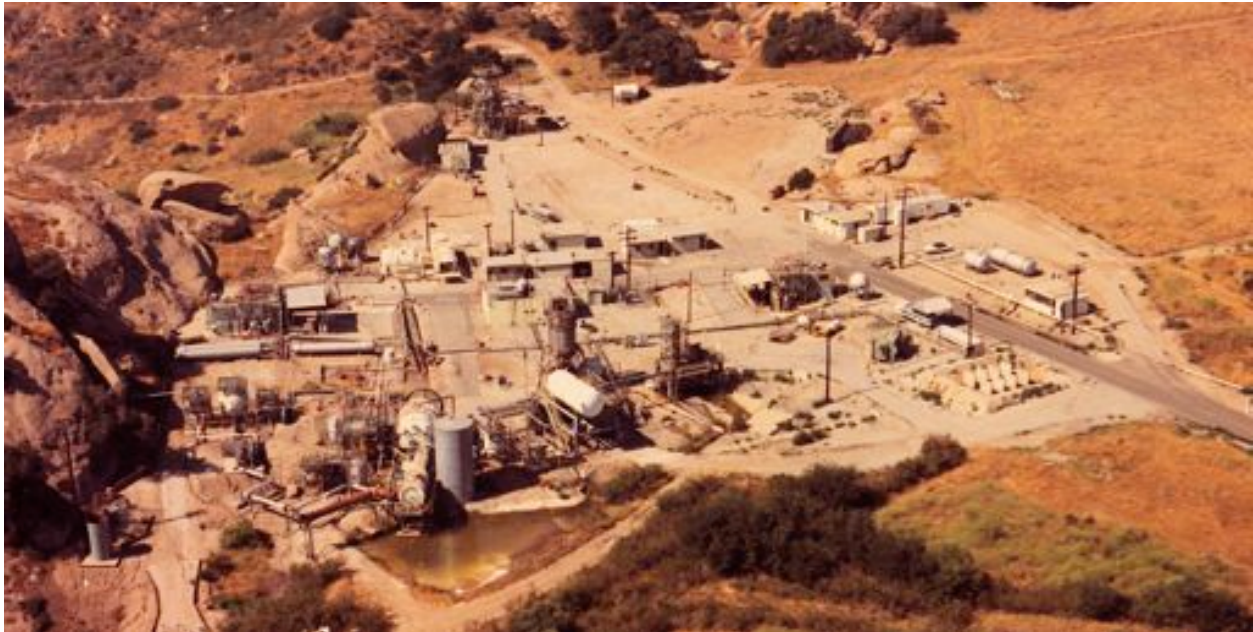
Also please note that the run-off pond is unlined in this photograph and the test stand at the top center of the photograph was later used for storage of waste containment as well as waste/chemical use tanks and other assets.
