Subject: Notification of Planned Demolition for Abandoned Water Tanks, Boeing, Santa Susana Field Laboratory, Ventura County, California.

Surplus Infrastructure Water Storage Tank Removals

WASTE CHARACTERIZATION: AREA 4 WATER TANKS July 2012

Water Tanks, Area IV Radiological Release Survey and Waste Certification Preliminary Data

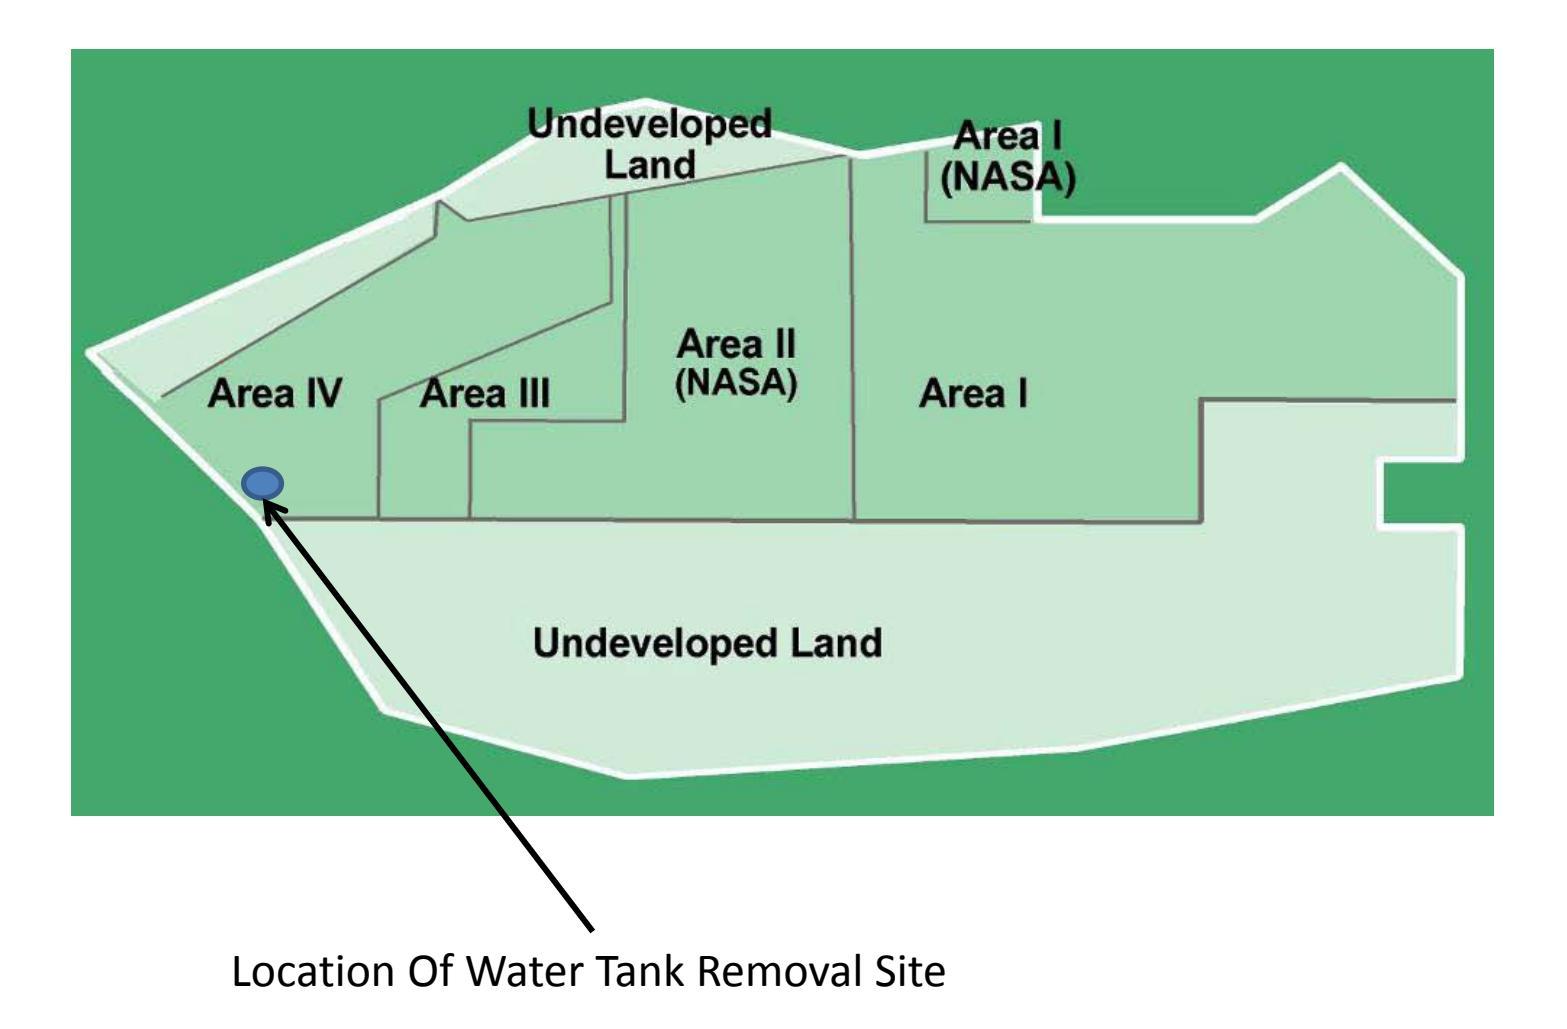
For Location reference - Bldg 4055

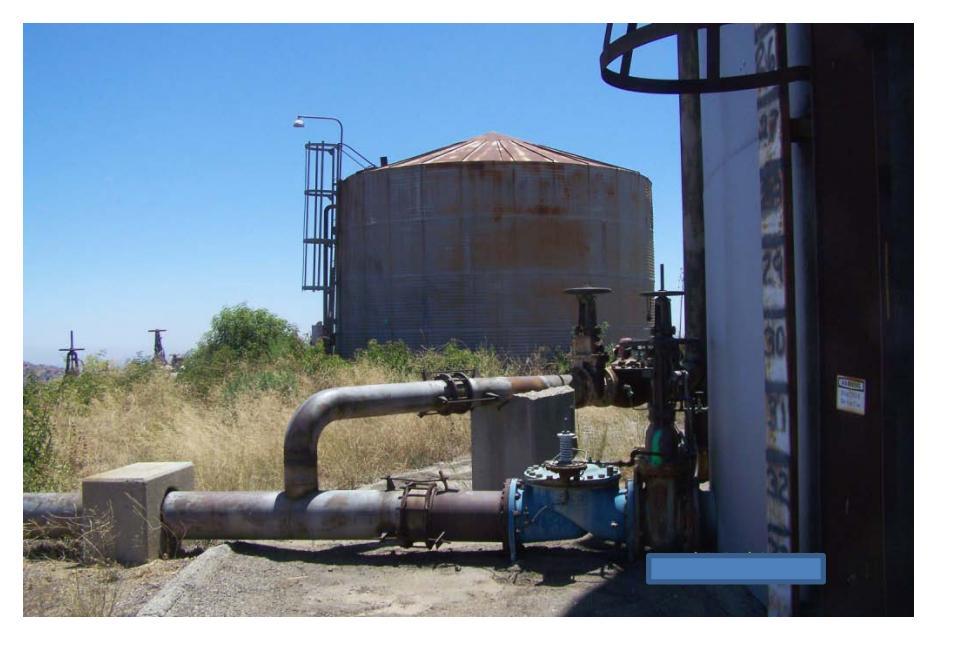
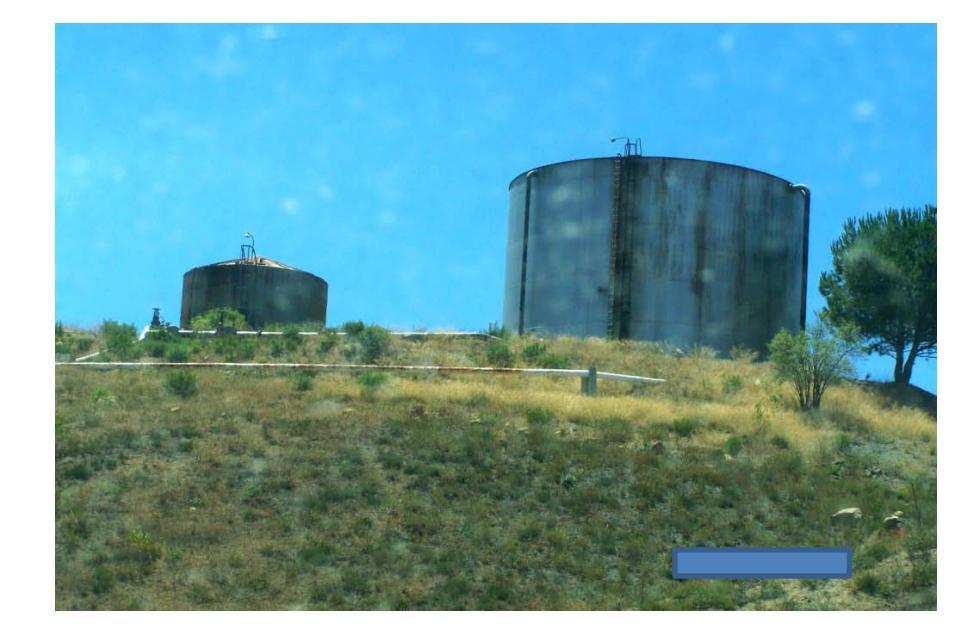
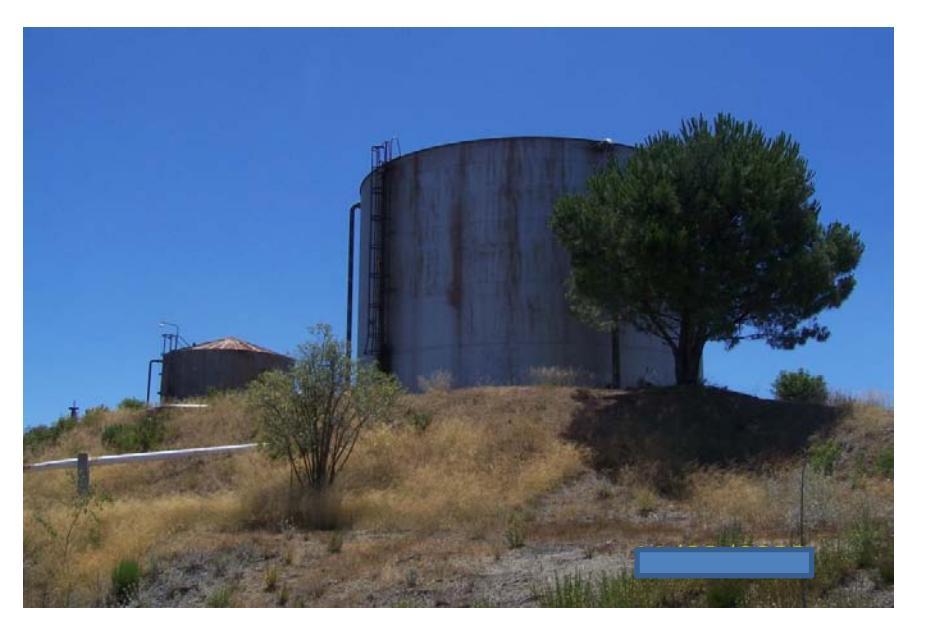
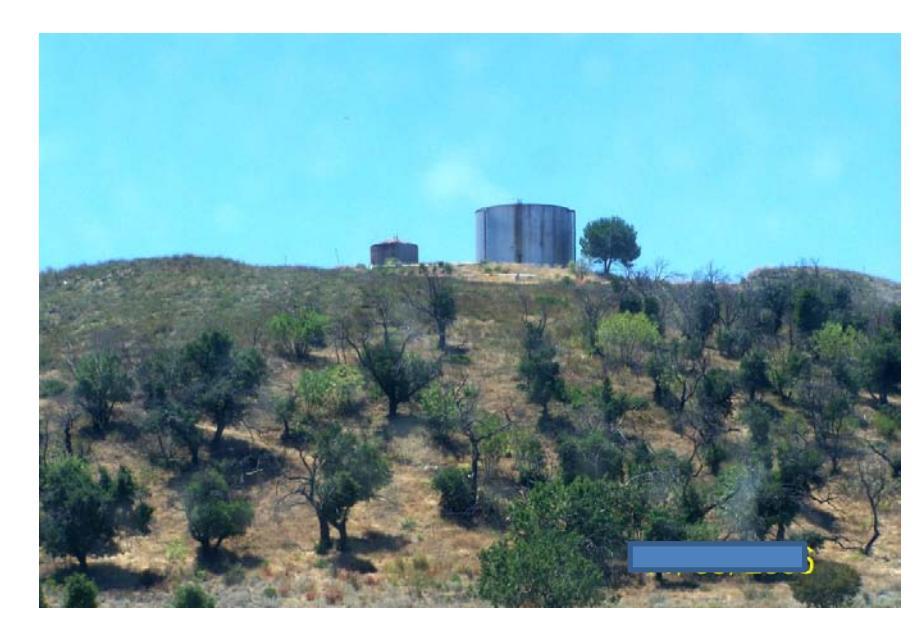
Images of abandoned water tanks to be removed

Tank No. 812 is a 500,000-gallon tank constructed of welded plate steel with an aluminized paint coating. The coating is in fair condition and well-adhered to the metal. Installation of the tank was completed in 1964. It has a diameter of 50-feet. A ten to eleven-foot wide asphalt apron is in place surrounding the tank. Additional remnant asphalt pavement, possibly an old maintenance parking area, is present to the south, approximately 20-feet downgradient from the tank.

Tank No. 851 is a 50,000-gallon tank constructed of corrugated, galvanized steel. It has a diameter of 22-feet. The steel sections are riveted together and the seams have been soldered to seal them. The tank itself is in very poor condition, with some areas that are corroded completely through the metal. This tank has been out of service for an indeterminate, yet extended period of time. Gravel surrounds the tank, expanding outward to a distance of approximately 10 feet. Some small patches of asphalt are present on the southeast side of the tank near the perimeter of the gravel.

Tank No. 812 is coated with aluminized paint. During the inspection, paint on the tank was found to be tightly adhered, with no significant peeling. The asphalt apron surrounding the tank was very weathered but there were no signs of chemical contamination. Furthermore, there were no signs of paint migrating from the tank to the asphalt. Additionally, the asphalt has been subject to very minimal vehicular exposure as a result of the site location and accessibility difficulties. Without a source of significant surface contaminants, which is the case due to the lack of paint residues and the absence of vehicular traffic, the opportunity for chemical impacts to the asphalt and any underlying base material is absent. No other potential concerns were noted.

Galvanized metal was used to construct Tank No. 851. The tank exhibits substantial corrosion, especially on the top and the upper ¼ of the sidewalls. These areas are almost completely rusted. There are eight areas where corrosion has completely penetrated the metal, with holes ranging from quarter-sized to one that is larger than a baseball. The large areas of severe corrosion indicate that zinc salts will have migrated down the sides of the tank to the

surrounding gravel. Furthermore, the gravel surrounding the tank displays rust-colored staining, which also suggests the presence of Zinc. No other concerns were noted.

The steel from both tanks is SCRAP METAL and will be shipped to a metal recycler.
