ACME Comments - DRAFT Historical Site Assessment Sub-Area (HSA) 5-B October, 2010

Enclosed in this correspondence are comments on the Draft Technical Memo of Sub-Area HSA-5B (Historical Site Assessment) Santa Susana Field Laboratory (SSFL) Site AREA IV Radiological Study – Ventura County, California prepared for the United States Environmental Protection Agency (EPA) Contract Number EP-S7-05-05 prepared by HydroGeoLogic, Inc. (HGL).

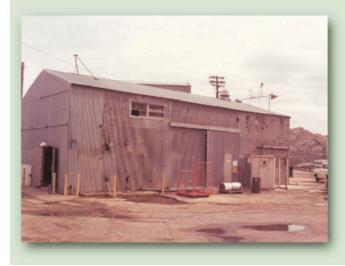
We believe Building 10 is the likely source of the tritium.

- Constructed in 1959. Featured three subsurface vaults extending at least 14 feet below grade
- A prototype space nuclear reactor was tested in one of the vaults until 1960 and again from 1963 to 1965
- A nuclear reactor produces energetic particles called neutrons
- Tritium is a hydrogen atom with two extra neutrons
- Tritium was found in the concrete vault
- Found highest concentrations to date in the bedrock samples near building 10
- Building 10 was decontaminated and demolished in 1978

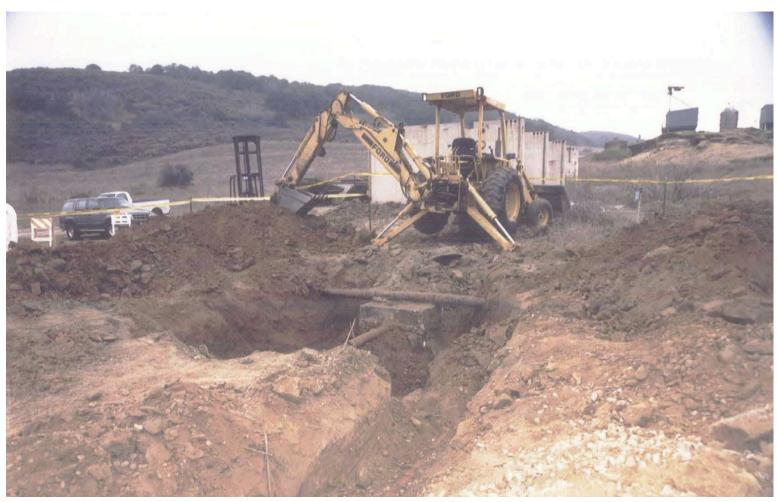
The above photo may help in some identification of pipes to and from Building 4011, this is the 2001 excavation of the Building 11 Leach Field.

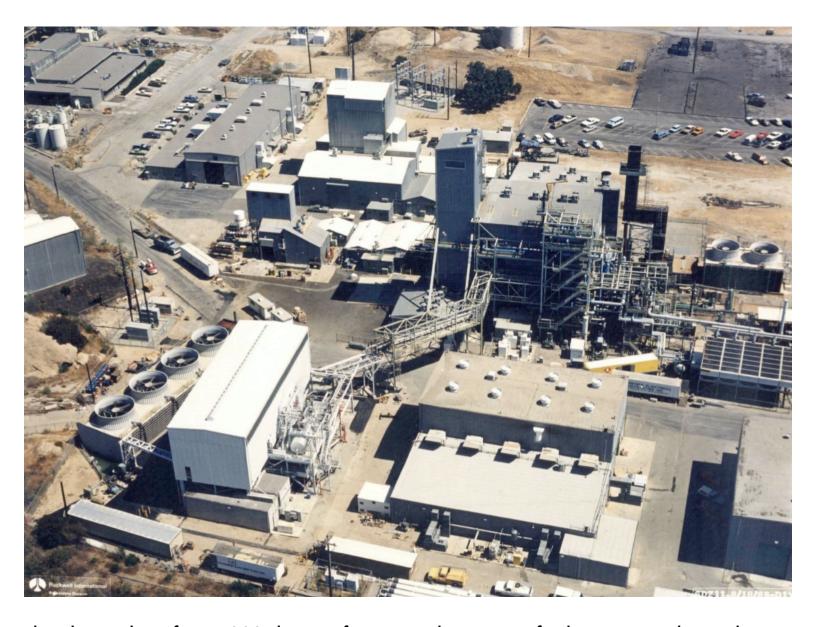
The above photo from 1988 shows a few areas that are not facilities, yet might need extra investigation as a potential radiological or chemical Area of Concern (AOC). In the upper right we see the Central Parking area of the HAS – 5-B reporting area that has what appears to be roll off bins that are charred and could be used in waste destruction. Just to the left of this is Tank #735 which was used as Fuel Storage, not Water, this needs to be addressed. To the North of the Central Parking area, we see an Open Field with what appears to be a pond and debris storage. From several aerial photographs this area indicates that is was used for waste storage and/or destruction and the fact that there is/was no facility located here this should be listed as an AOC. There appears to be a storage area of blue 55 gallon drums under the 4010 Facility, and needs to be investigated. We see Building 13 in the bottom middle and to it's left we see how Building 12 has been modified from it's original design as seen in the black and white photograph on the following page. Have the responsible parties given EPA use to such photos as the above. We need to examine more of these and insert them in all portions of the HAS.
