ACME (Aerospace Contamination Museum of Education) Comments - Historical Site Assessment(HSA)5D, April 18, 2011

Enclosed in this correspondence are comments on the Technical Memo of Sub-Area HSA-5D (Historical Site Assessment) Santa Susana Field Laboratory (SSFL) Site AREA IV Radiological Study - Ventura County, California prepared for the United States Environmental Protection Agency (EPA) Contract Number EP-S7-05-05 prepared by HydroGeoLogic, Inc. (HGL).

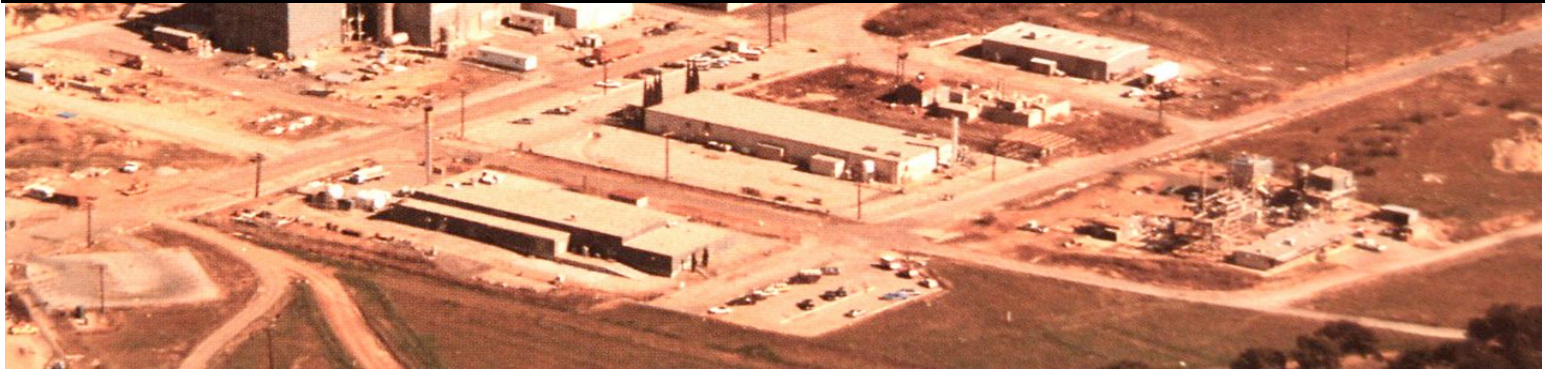
In Section 2.1.1 of the HSA 5D (Parking Lot 4509 AREA - Shown Above Far Left) please note that for the past several years there have been Baker Tanks staged on this platform to collect tainted stormwater runoff that could impact this area and the areas around. I have spoken with a former employee who alleges cleaning of sodium contaminated items on this lot. Click on the link below to read the Rockwell Unusual Occurrence Report regarding Building 4009 that connects to this parking lot. Has HGL or EPA asked The Boeing Co. for these reports or are they unaware of these reports? These reports could help in the remainder of the HSA groupings.

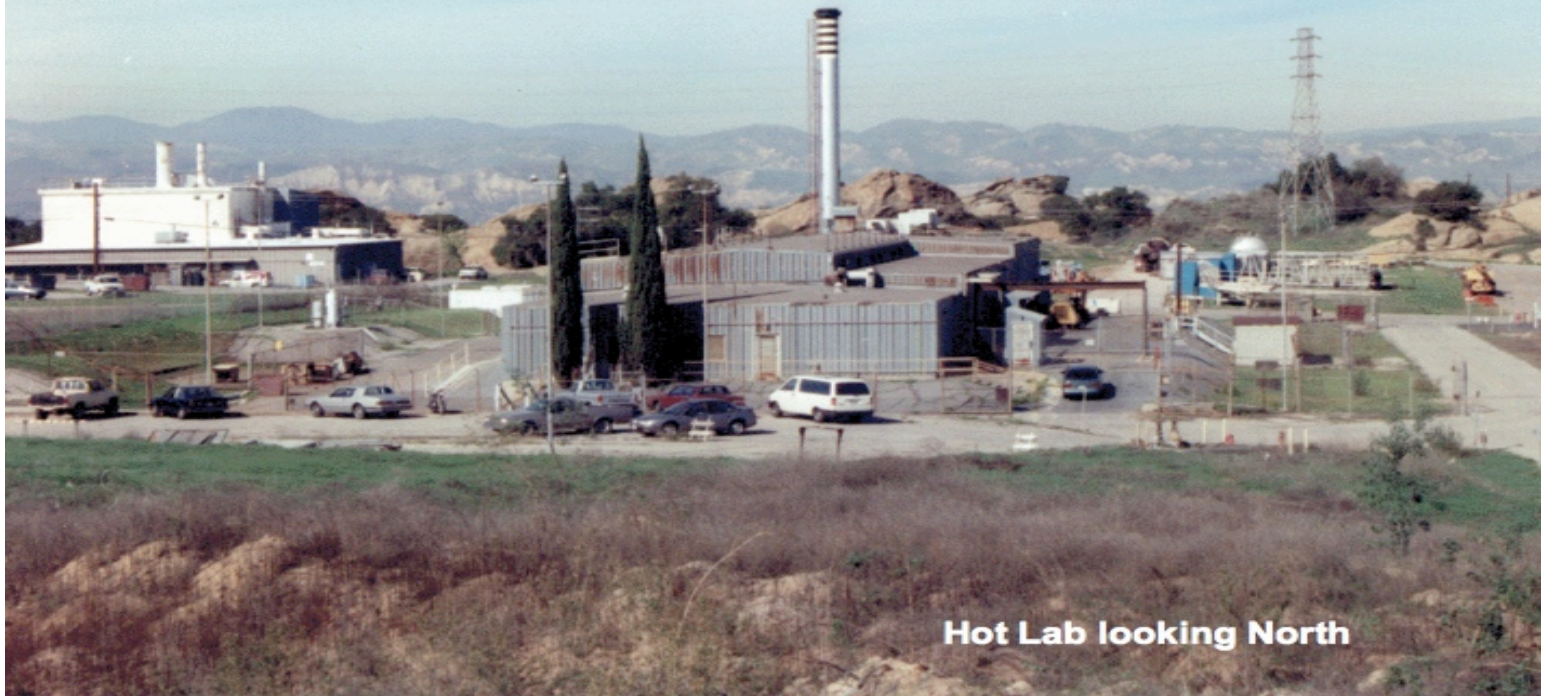
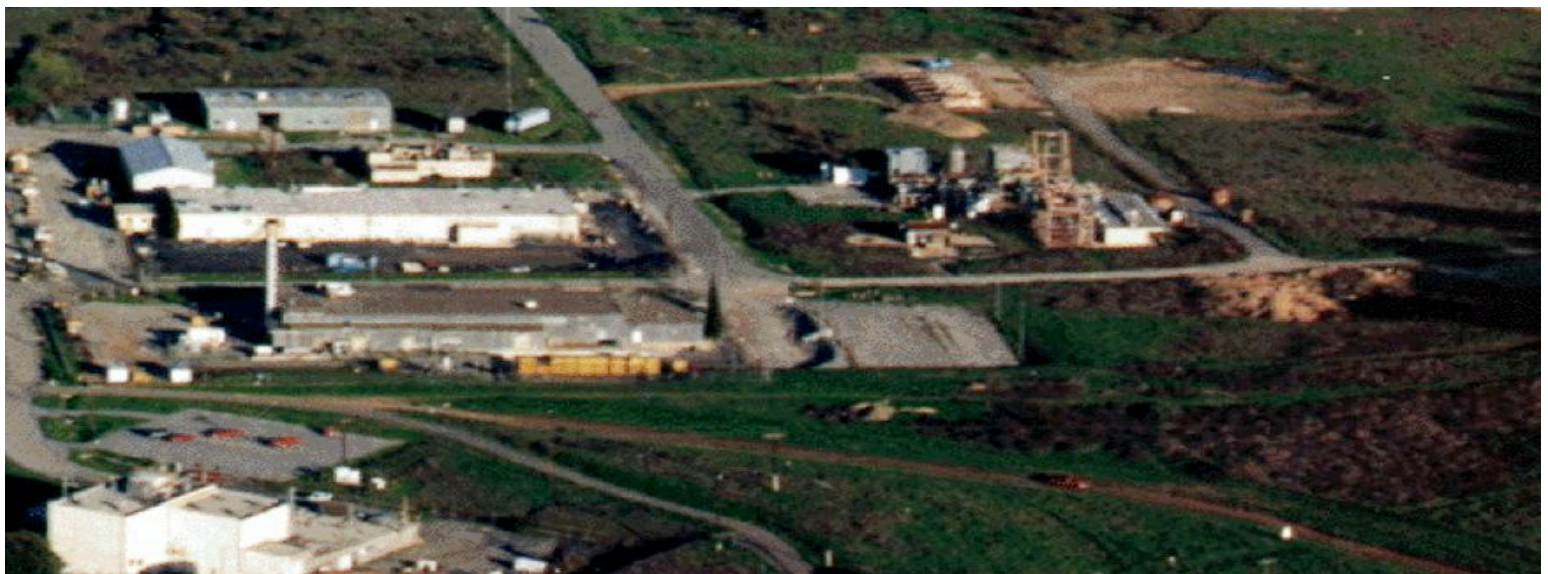
Please note the mounded material in the above and below photos, investigation is needed. Also note in the below photo the location of the yellow "Casks" or "Coffins" that are storing radioactive waste on the West end of the RIHL, please investigate as well.

The Decontamination Plan for the RIHL needs to be investigated to determine the depth of excavation of the facility and core sampling needs to go down at that depth and further.

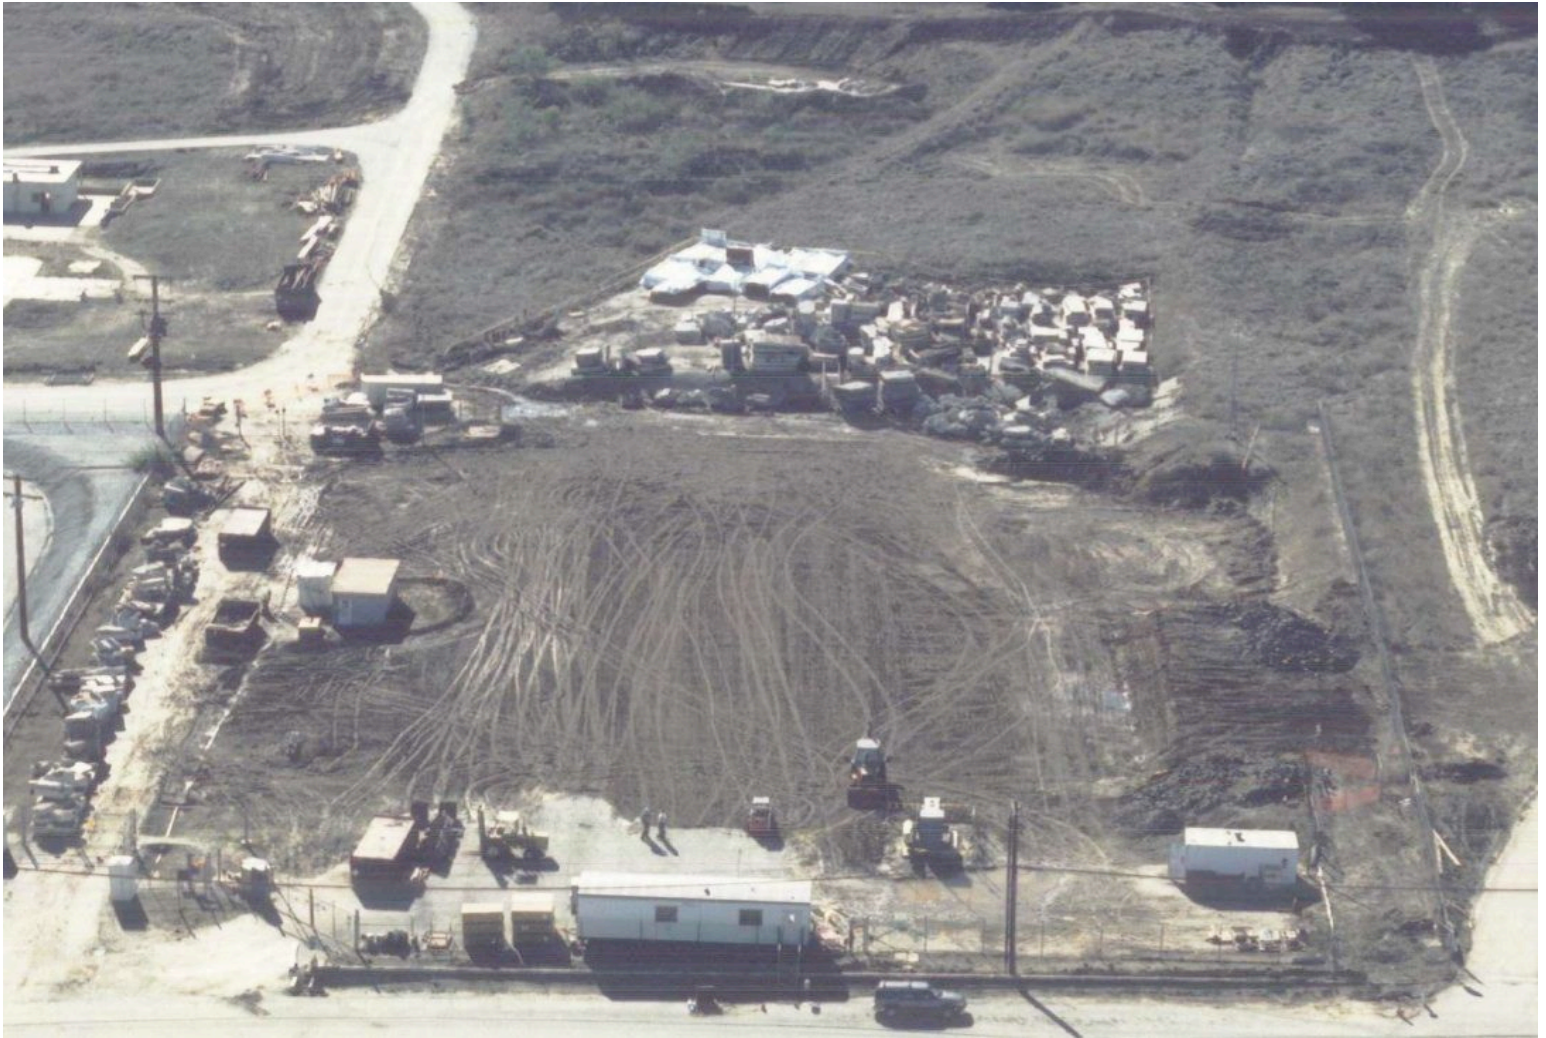
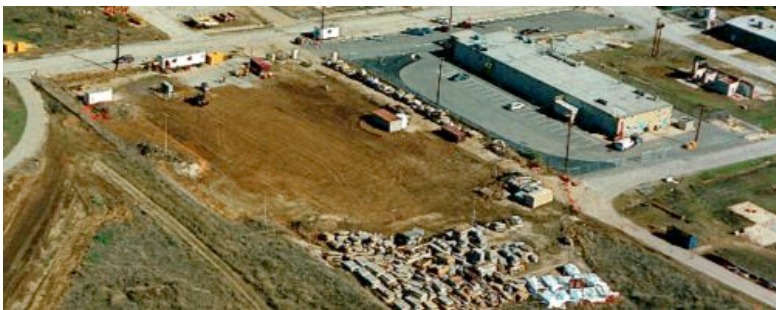
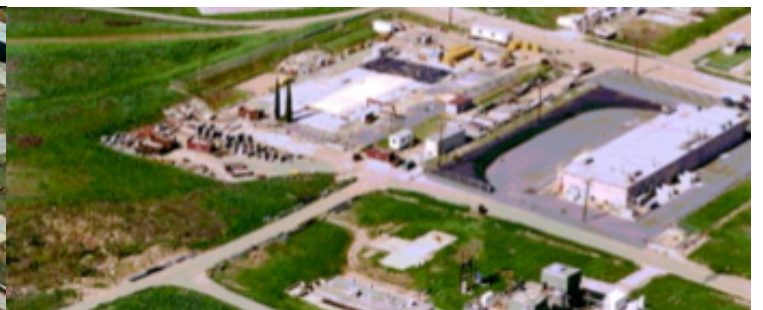
In Section 2.2.3 of the HSA 5D is 4520, the (RIHL) Hot Lab Parking lot (Photos Below). This area is non-radiological, yet should be investigated as radiological as (seen in photos) was a staging area for the Demolition Activities of the closure of Building 4020 RIHL and could have radiological impact potential.

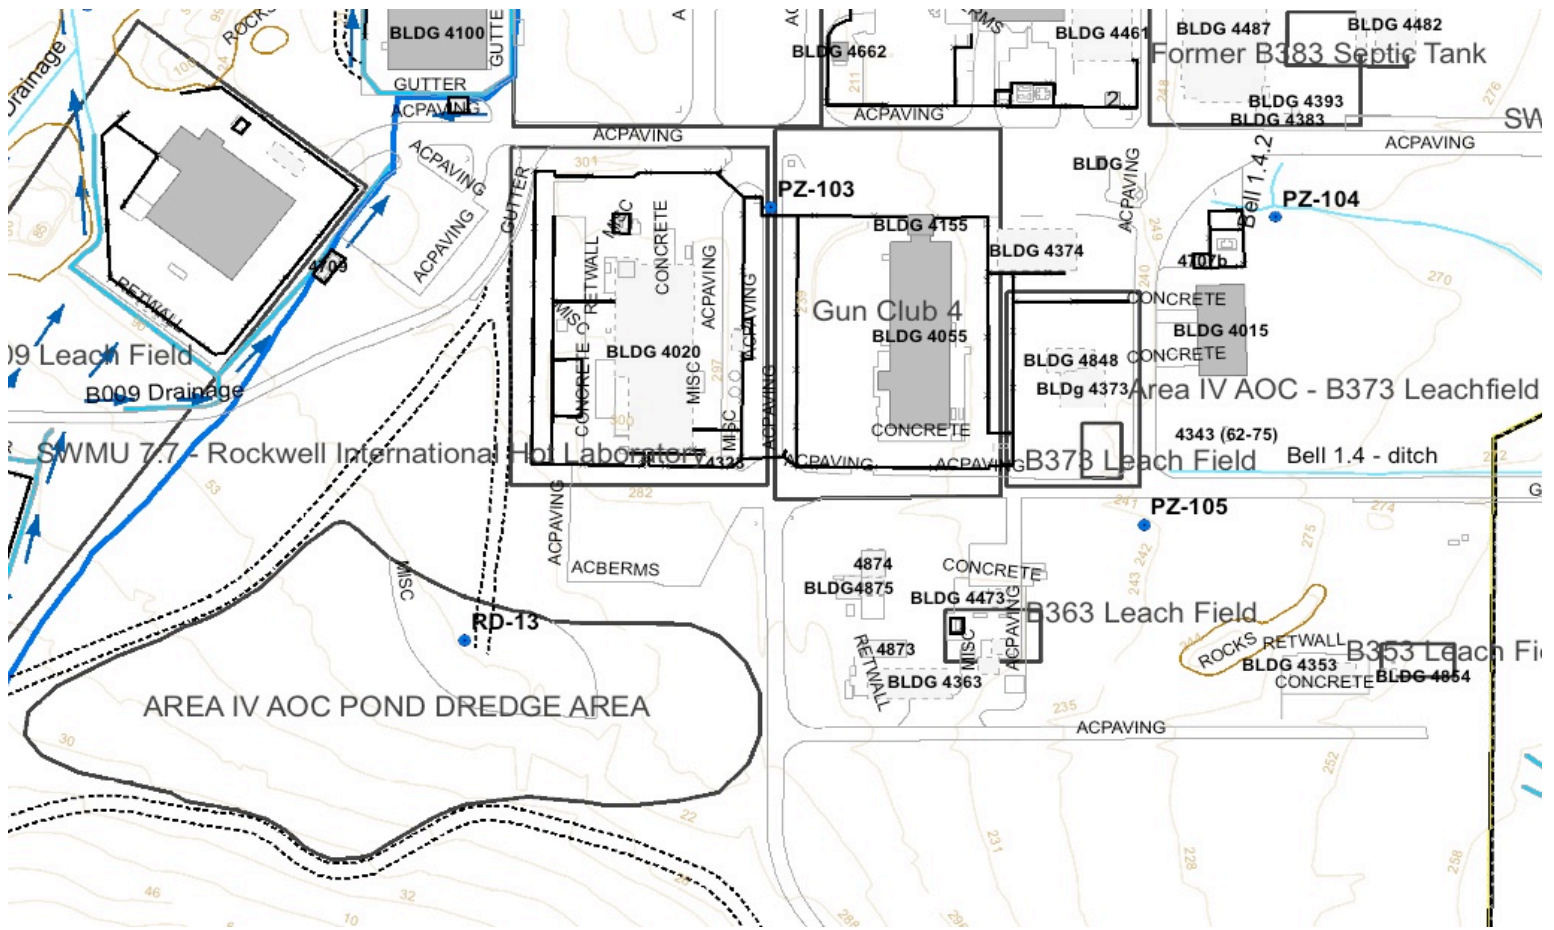
In Section 2.2.4 of the HSA 5D Building 4055 was the Nuclear Materials Development Facility (NMDF – Next Page FIVE) where the manufacturing of Plutonium and Uranium Fuels were contracted for the Atomic Energy Commission (AEC) and the United States Department of Energy (DOE) between, 1967 and 1979.

Prior to the development of Building 4055 it was a Gun Club and with the known projectiles of depleted uranium the ground under the building needs investigation.
