ACME ADRS

5/7/2010

United States Environmental Protection Agency (EPA) Region IX (Via Electronic Mail)

ACME (Aerospace Cancer Museum of Education) Comments on the Historical Site Assessment(HSA)5-C of April 9, 2010

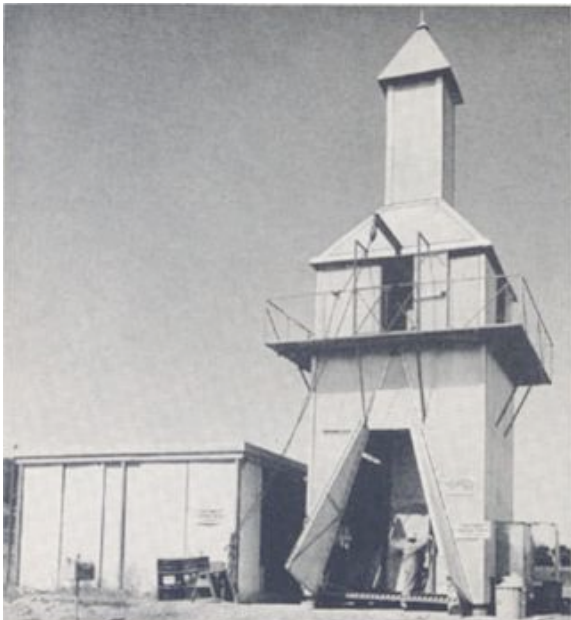
TINY TOWER—This 40-ft. instrumentation test tower, small in comparison to another AI tower of 102 feet, is used for sodium instrument tests. P. C. Borbon stands at the base.

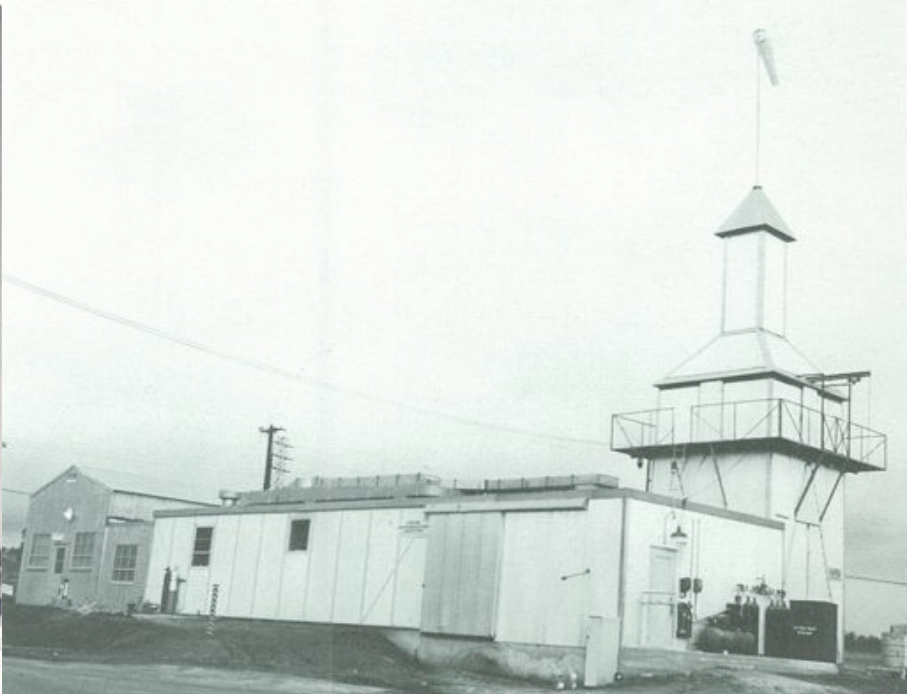
The Above Facilities, the Sodium Instrumentation Building (Building 4383) and the Sodium Instrumentation Tower (Building 4393 Shown Above) were designed to function under the conditions required for Sodium Graphite Reactors (SGR). The SGR program involved the development of many specialized items of equipment that were not yet available. Necessary, for the Atomics International Division (AI) of North American Aviation (NAA) as a special facility for the experimental investigation of various components and techniques. This was accomplished through the modifications of an existing structure. Within this facility instruments were developed to determine liquid level, flow, pressure and oxide content in Sodium Systems. All instruments are tested and calibrated here before installation in a reactor.

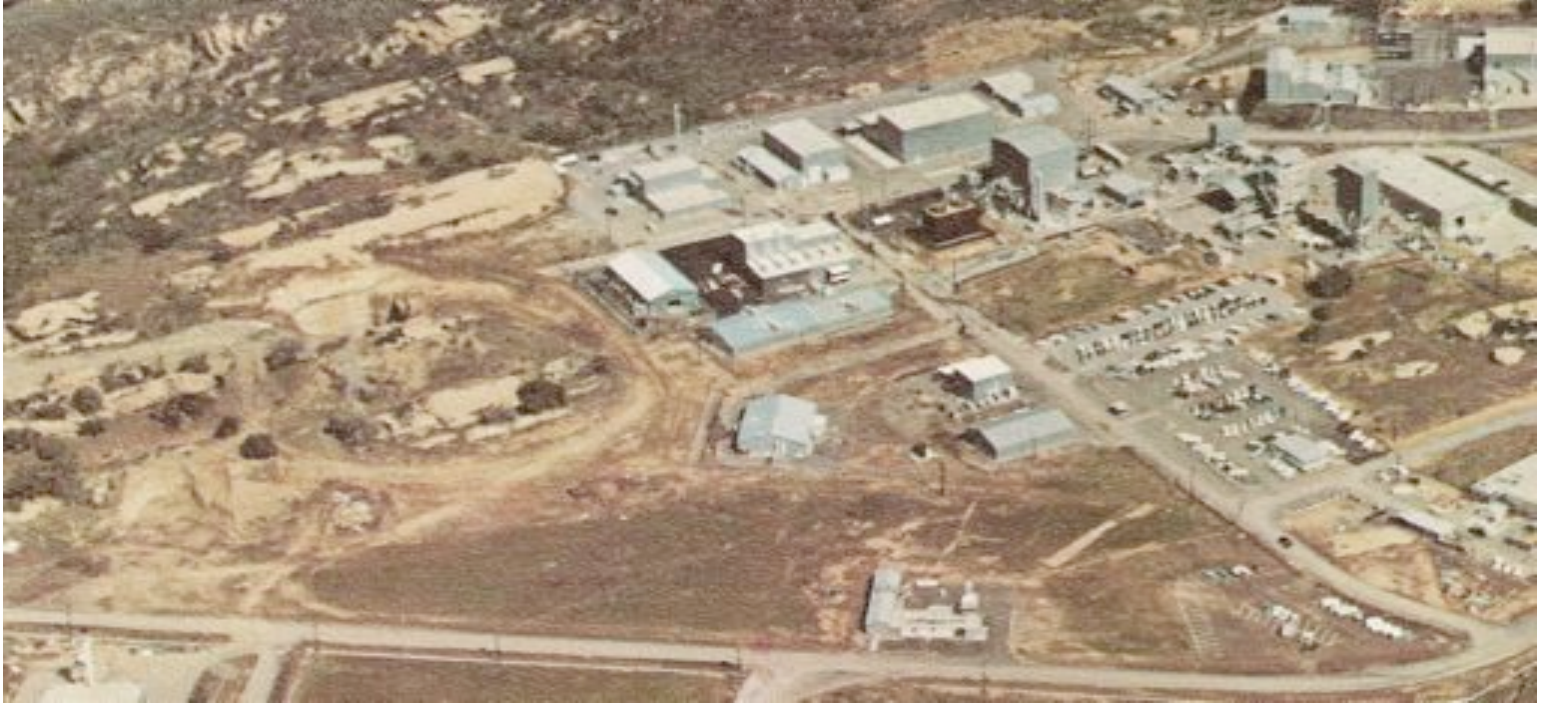
There looks to be a potential storage area to the North of the Facility (Below Photograph). These areas should be noted as potential areas of Radiological Concern.

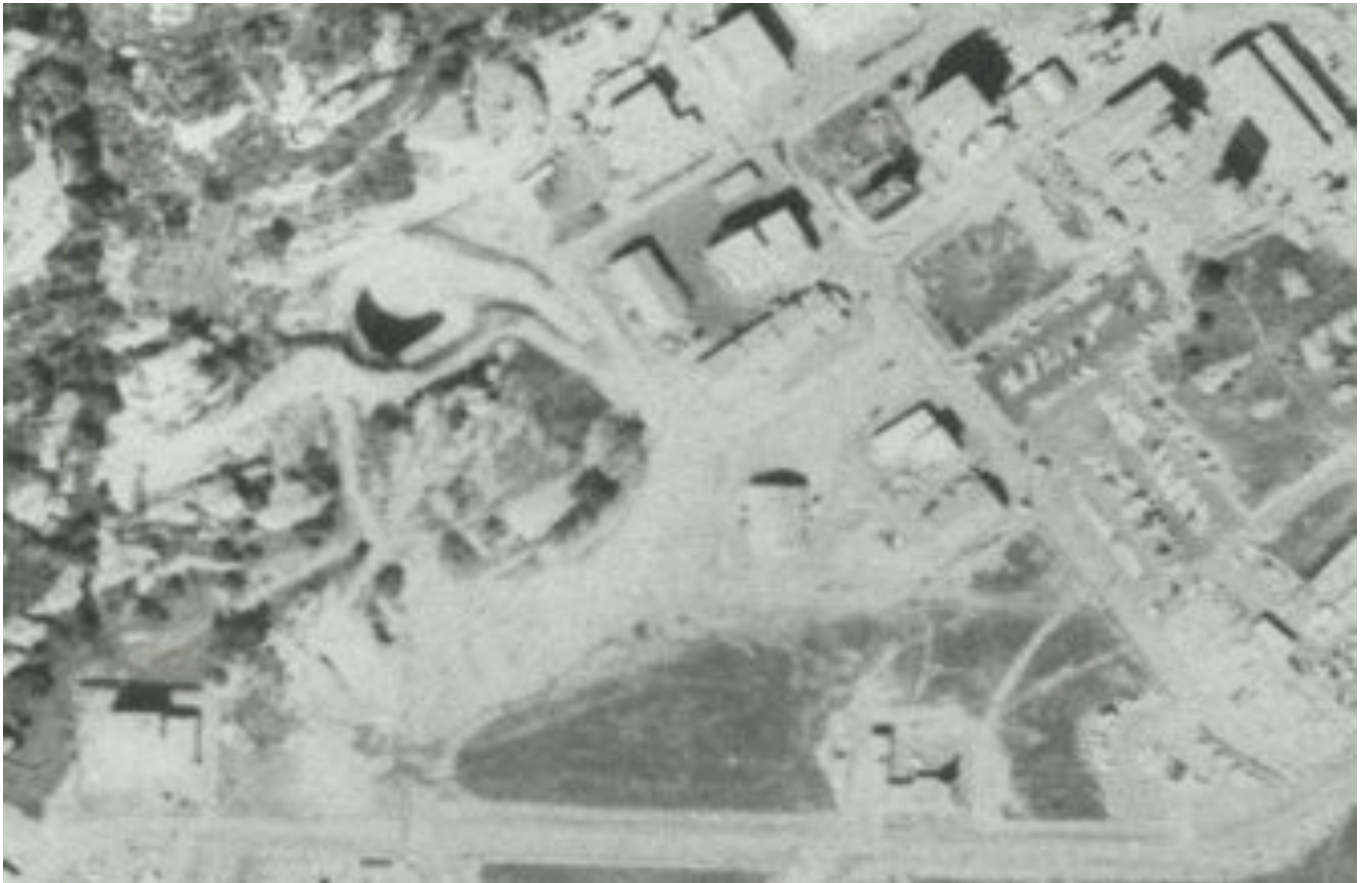
Below we see an aerial view of Buildings 4383 and 4393 in the year 1965.

This is also the area of the Former Building 383 Septic Tank and should be located.

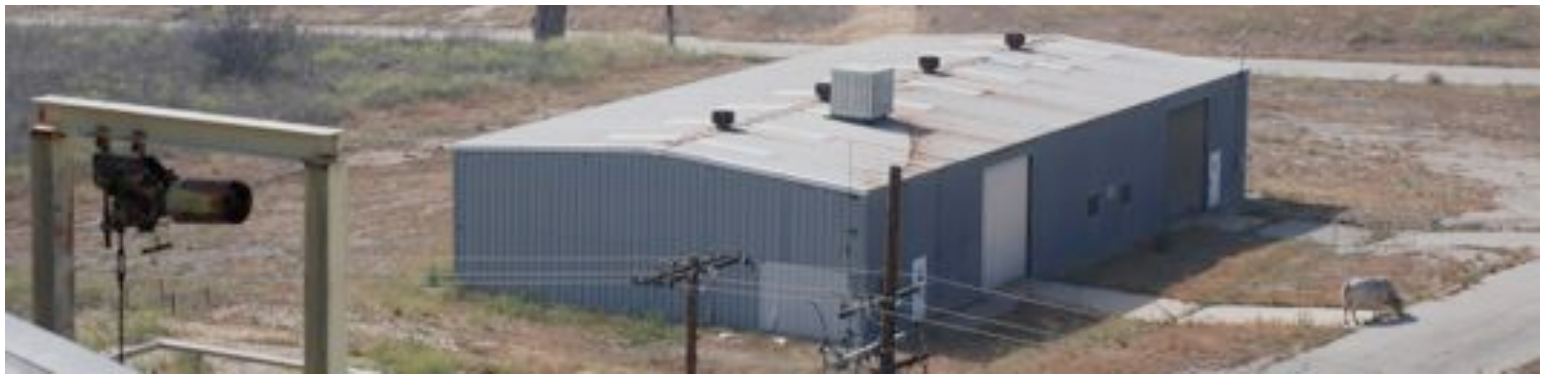
Below is the current location of Building 4015 (Photo 2007 with grazing cow in the area).

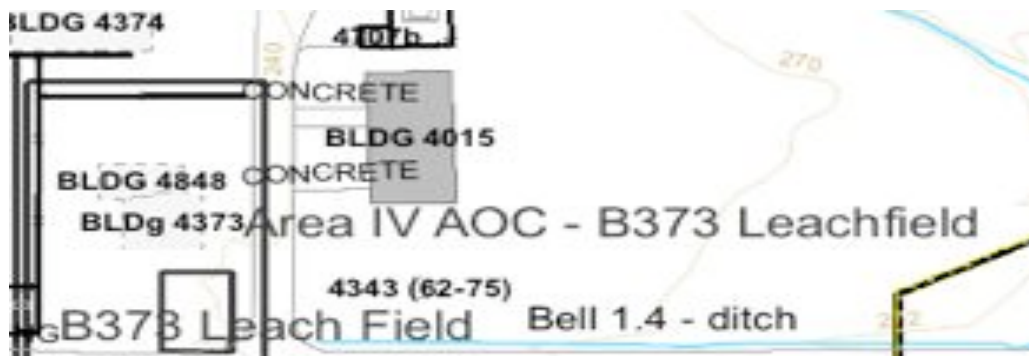
The Building 4373 Leach Field could impact this group even though located outside.

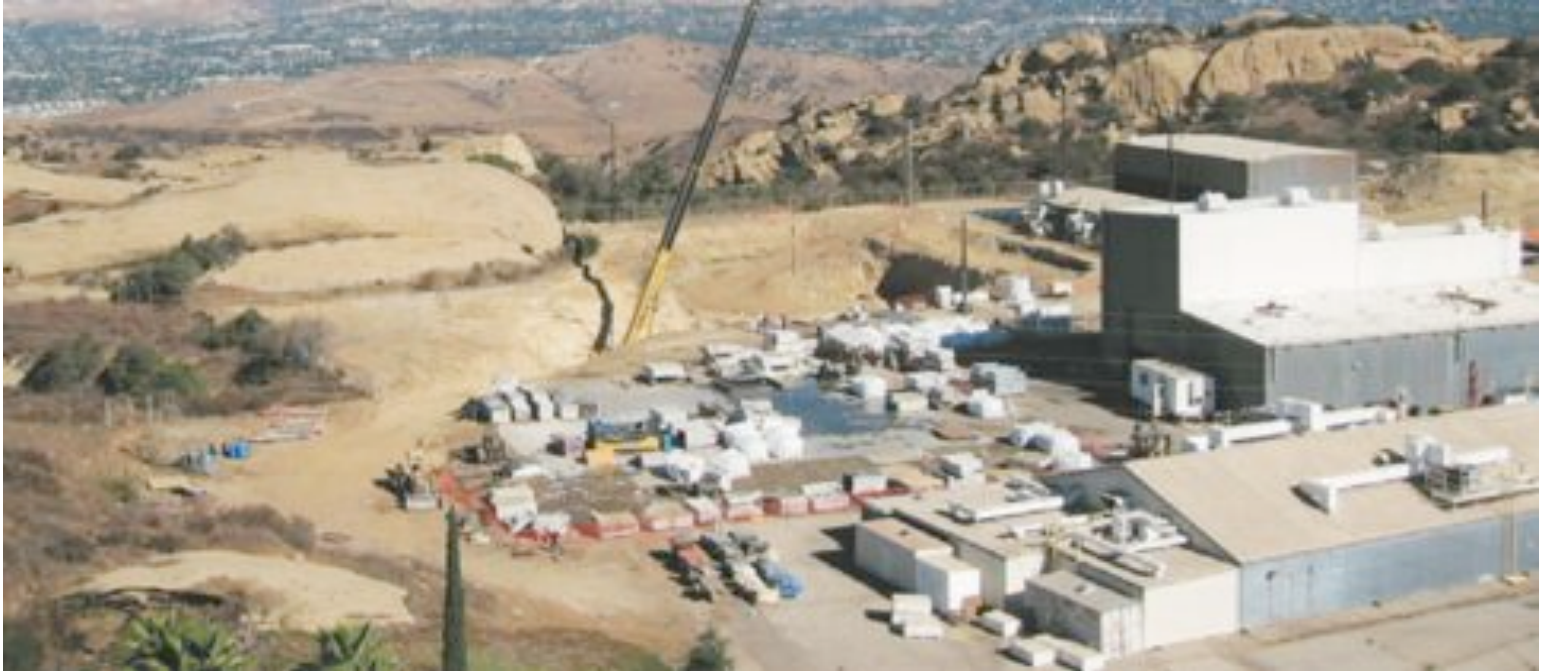
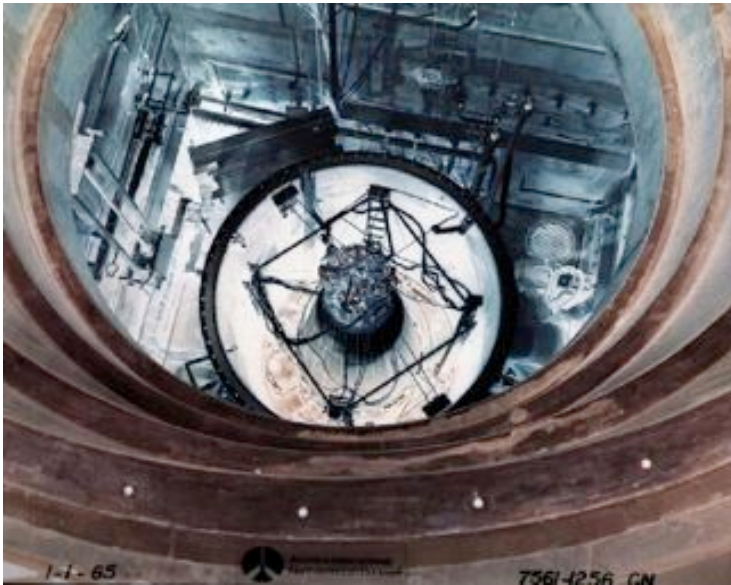
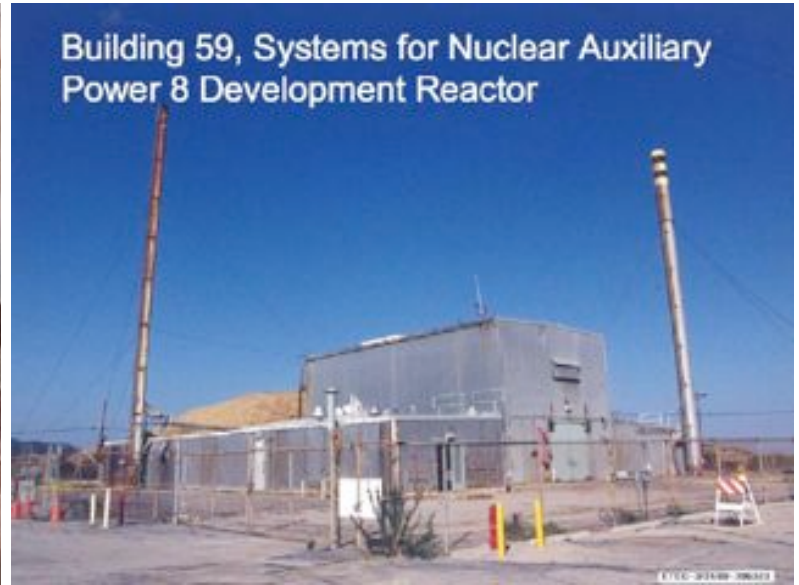
The below areas were used as staging during the Demolition and Decontamination (D&D) of the Building 4059 Systems for Nuclear Auxiliary Power (SNAP) Facility. There have been many examples of using parking lots in the past as radiological storage. More study of historical photography needs to be implemented to target certain areas for a proper cleanup.

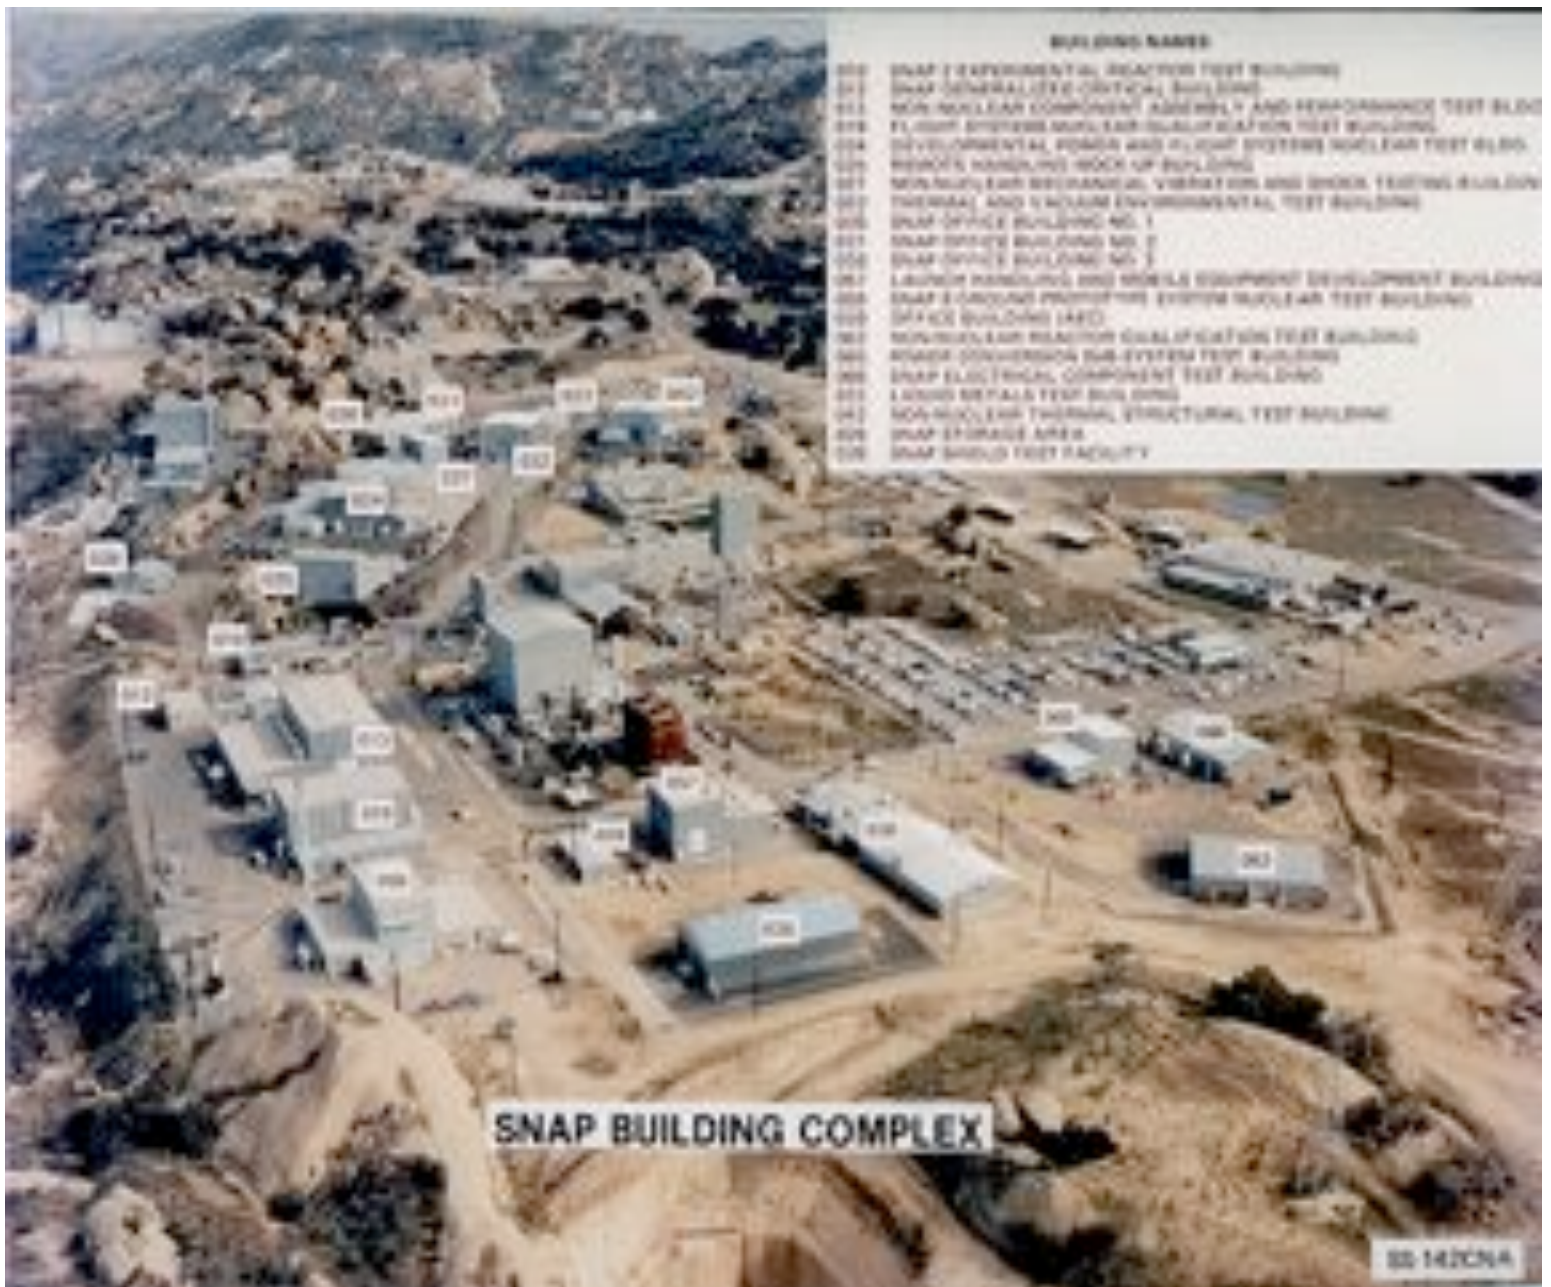
The above photo should help in identifying some outdoor storage areas that could be a potential Radiological Concern. There needs to be a more in-depth study of these type of photographs. The September 2004 Presentation Poster on the Energy Technology and Engineering Center (ETEC) Website notes that the Building 59 area is a possible Tritium source and should be addressed.

It should be noted that on February 12th of 1970 in the Building 59 Test Vault during the D & D of the SNAP 8 DR a Vacuum Filter ruptured contaminating various areas. Again in February of 1970, there was a reported incident where an employee was cutting a NaK Line in Pipe Chase Room in Building 59 that caused a fire. This report should be obtained and looked into further.

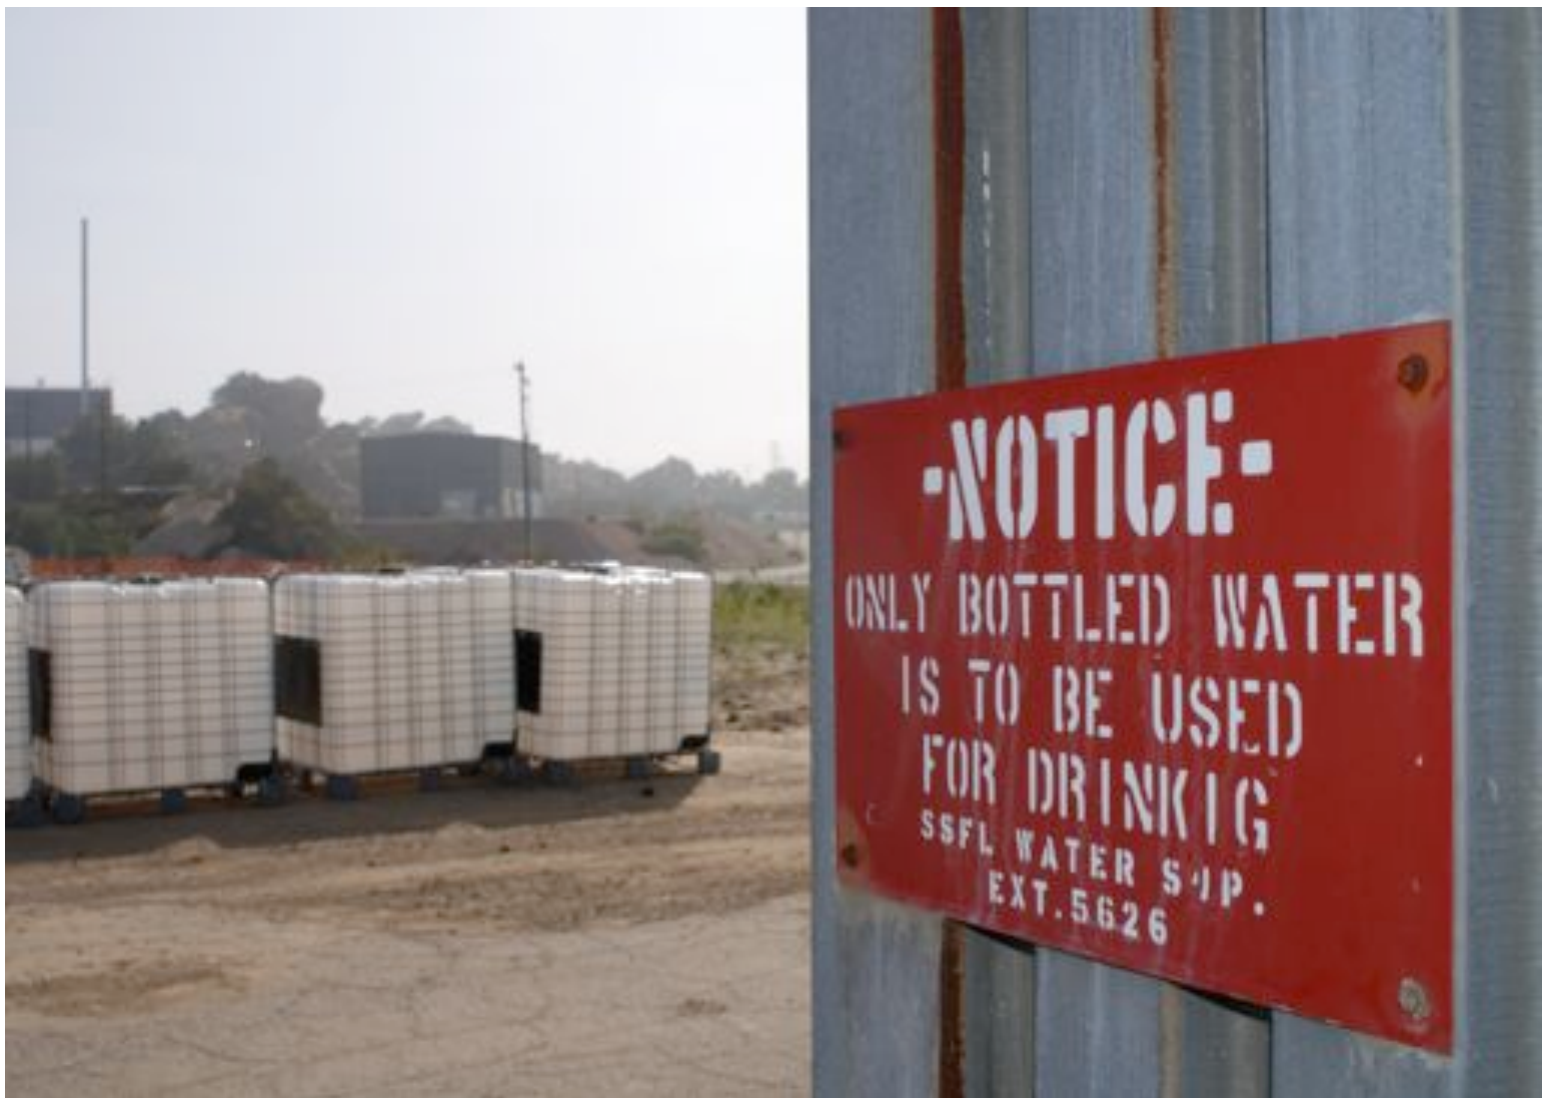
The below photo is taken from outside of Building 19 and should be noted that this area was used for staging of debris, soil and water that could have a potential impact. There are also documents that note a Reservoir under this facility and there is a large welded cap of a circle larger than 10 feet across. More investigation of the past operation of this facility need to included in the HAS 5-C section.

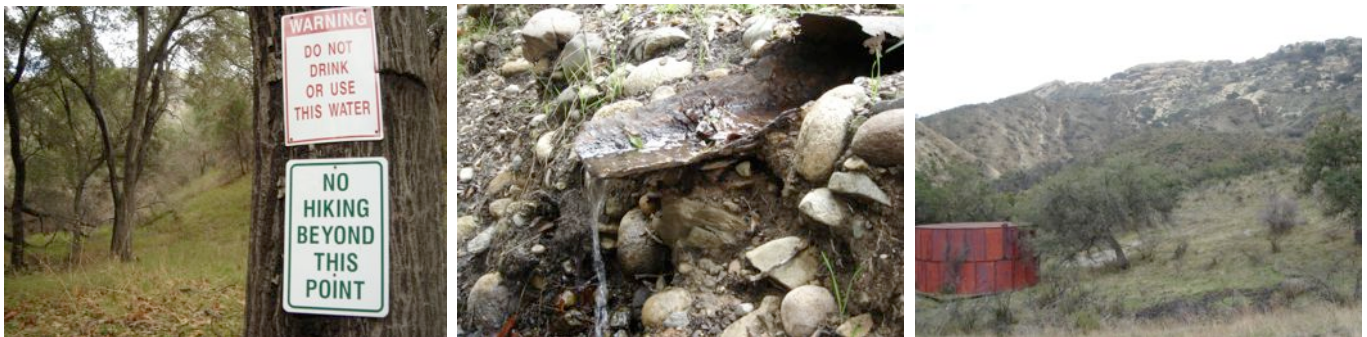
The majority of the HAS 5-C of the Santa Susana Field Laboratory (SSFL) AREA IV surface drainage of the SSFL drains into the Los Angeles River via Bell Creek, yet this reporting area is a portion of the 257 acres of northern surface of the total 2850 acres of the SSFL that drain onto the Simi Valley side onto the property of the American Jewish University's Brandeis-Bardin Campus.

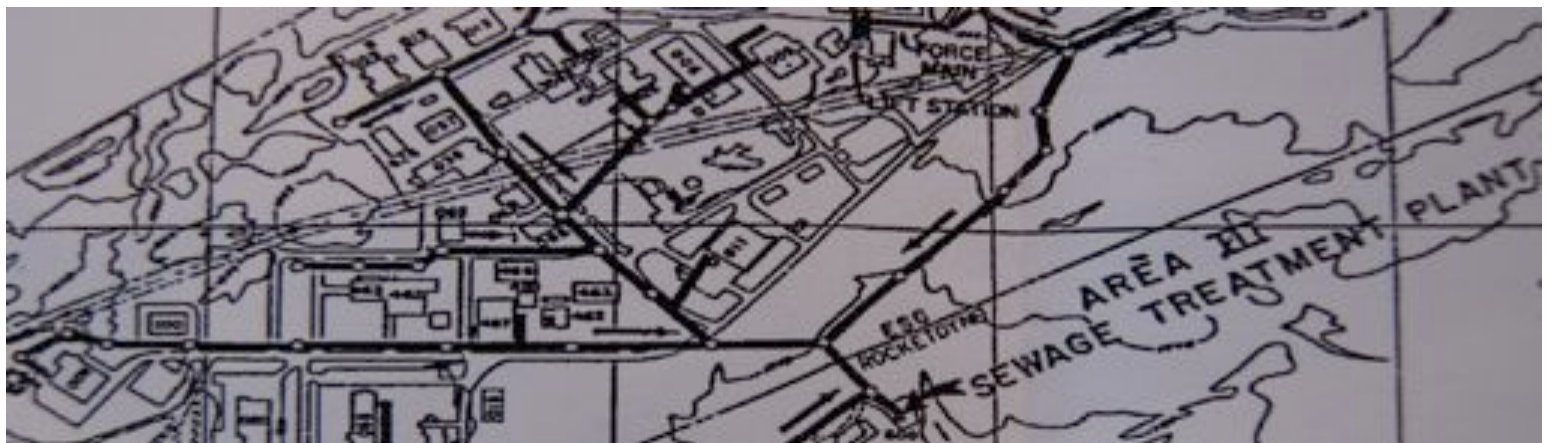
Yet all the Sewers run from the HAS 5-C reporting area connect to the AREA III Sewage Treatment Plant and contamination should be followed as per the Multi-Agency Radiation Survey & Site Investigation Manual (MARSSIM). See Below Map for Reference.

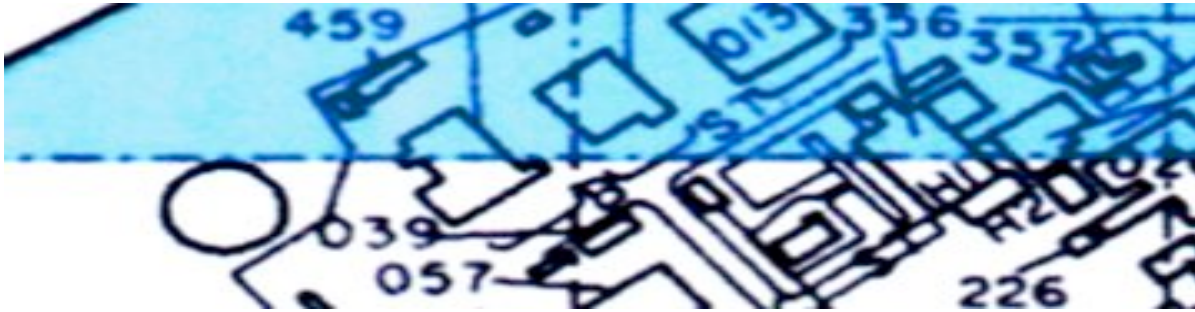
Building Numbers are cut off in some cases incomplete. Where the number belongs and almost make out what number is to be placed there. Please check all of these map pages. On page 19, there is a missing building (4374 - The Test Loop Enclosure).

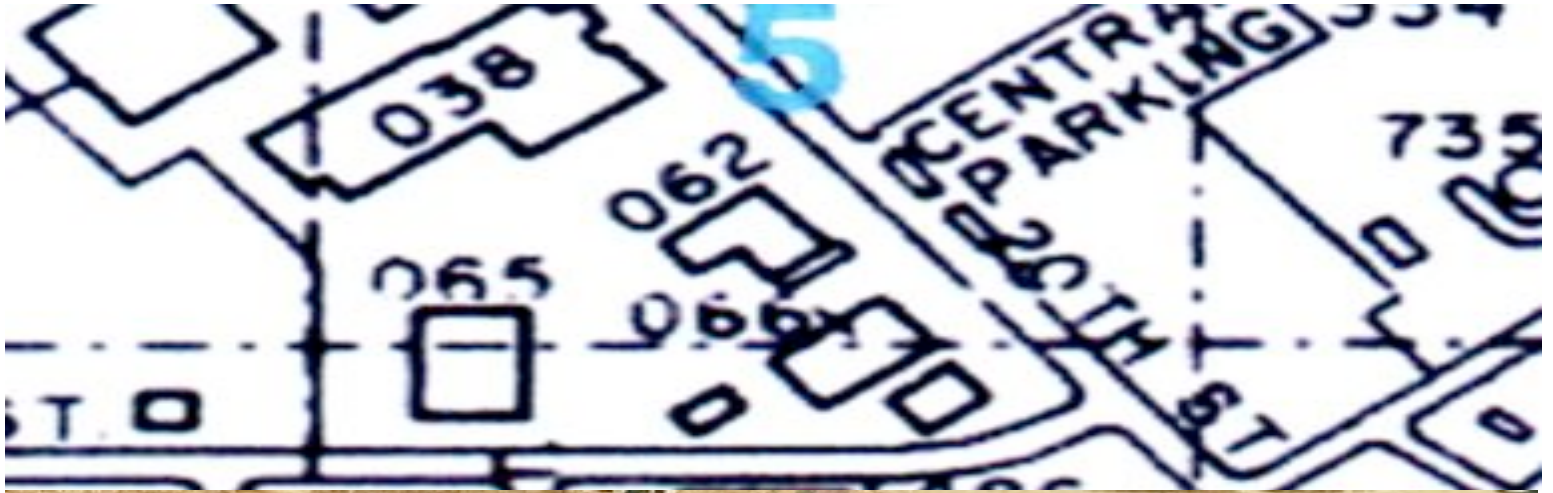
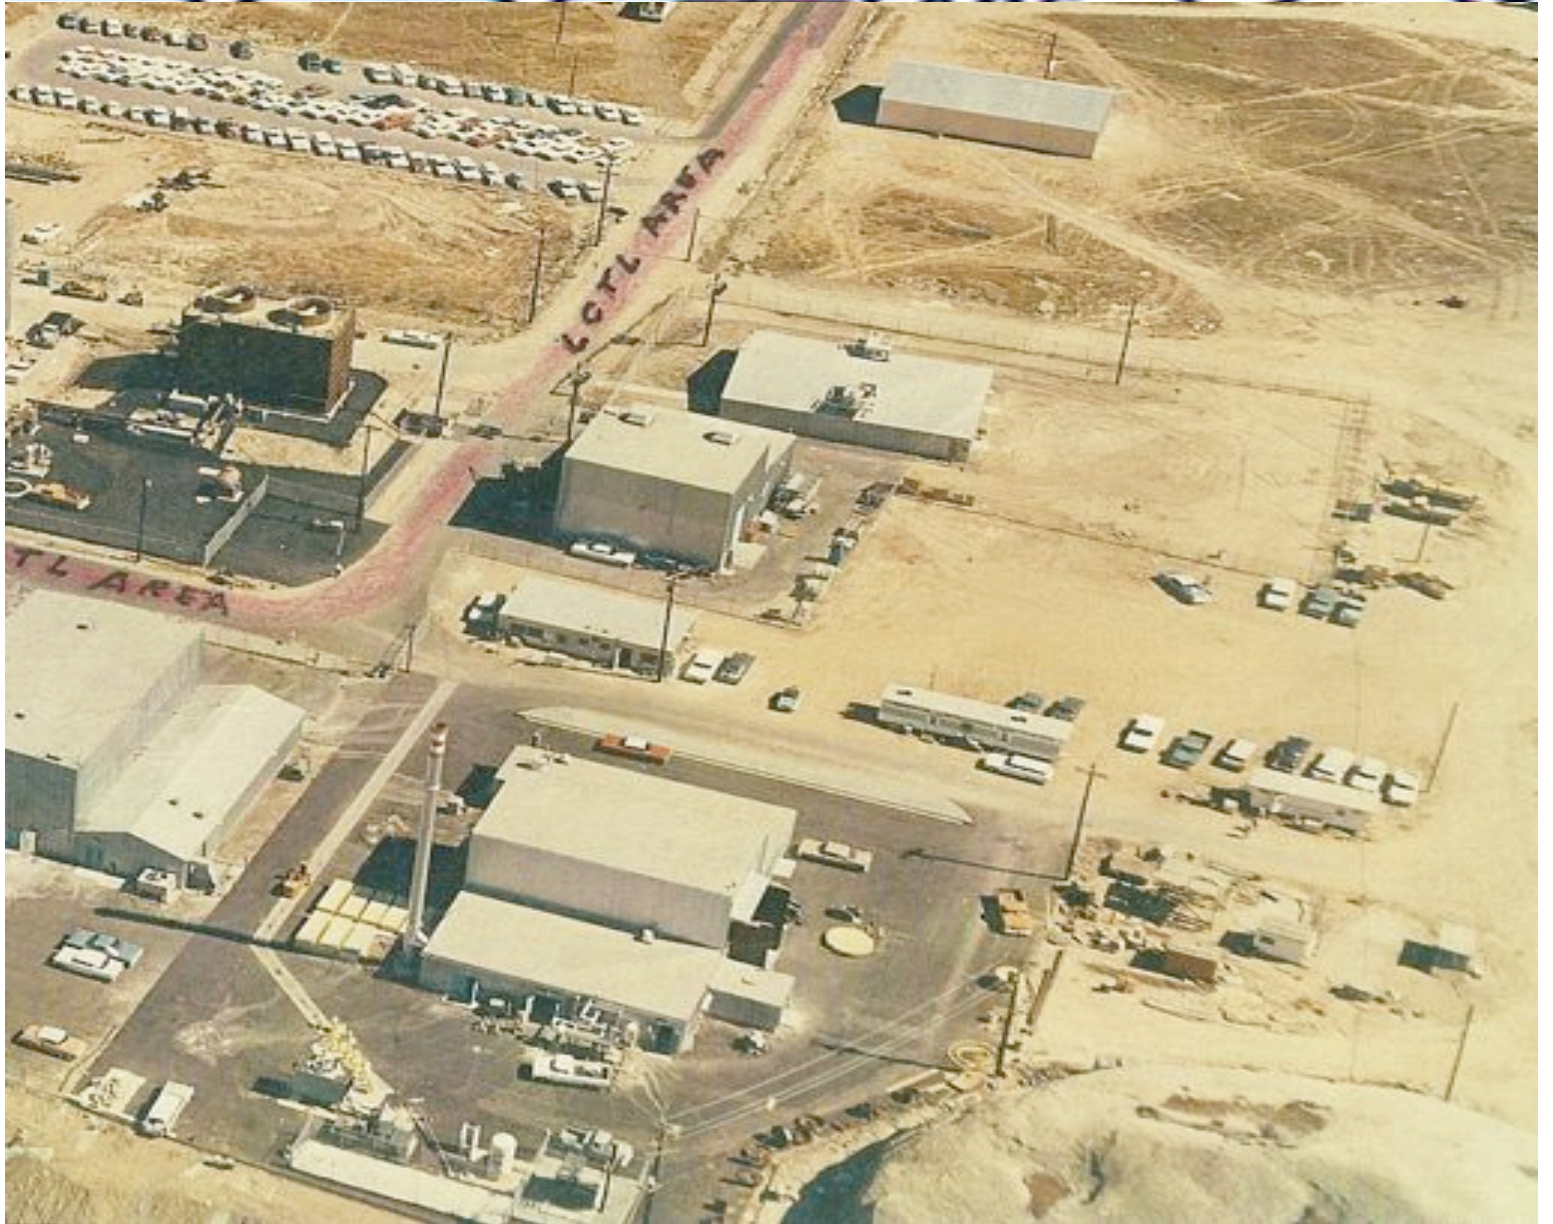
Some of the areas that are removed and reused should be looked into closer than usual in the example of Building 4065 - ETEC Chemistry Lab and the fenced yard behind building 38 (Below) that now has a structure covering it from the expansion of Building 4038.

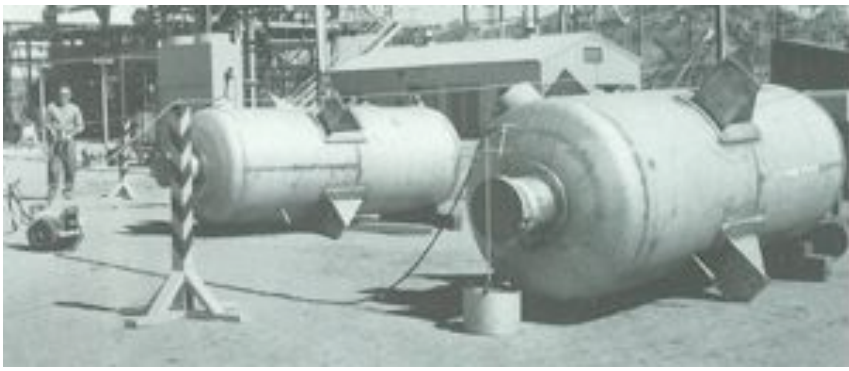
Here, a portable iridium-192 source is being used for gamma graphing of weldments on field installations. It also has a 3½-curie cesium gamma graphing apparatus, and also has a 5-curie cobalt-60 source, for the examination of dense materials.

I would like Gregg to explain the process in the above photo and if it's a concern.

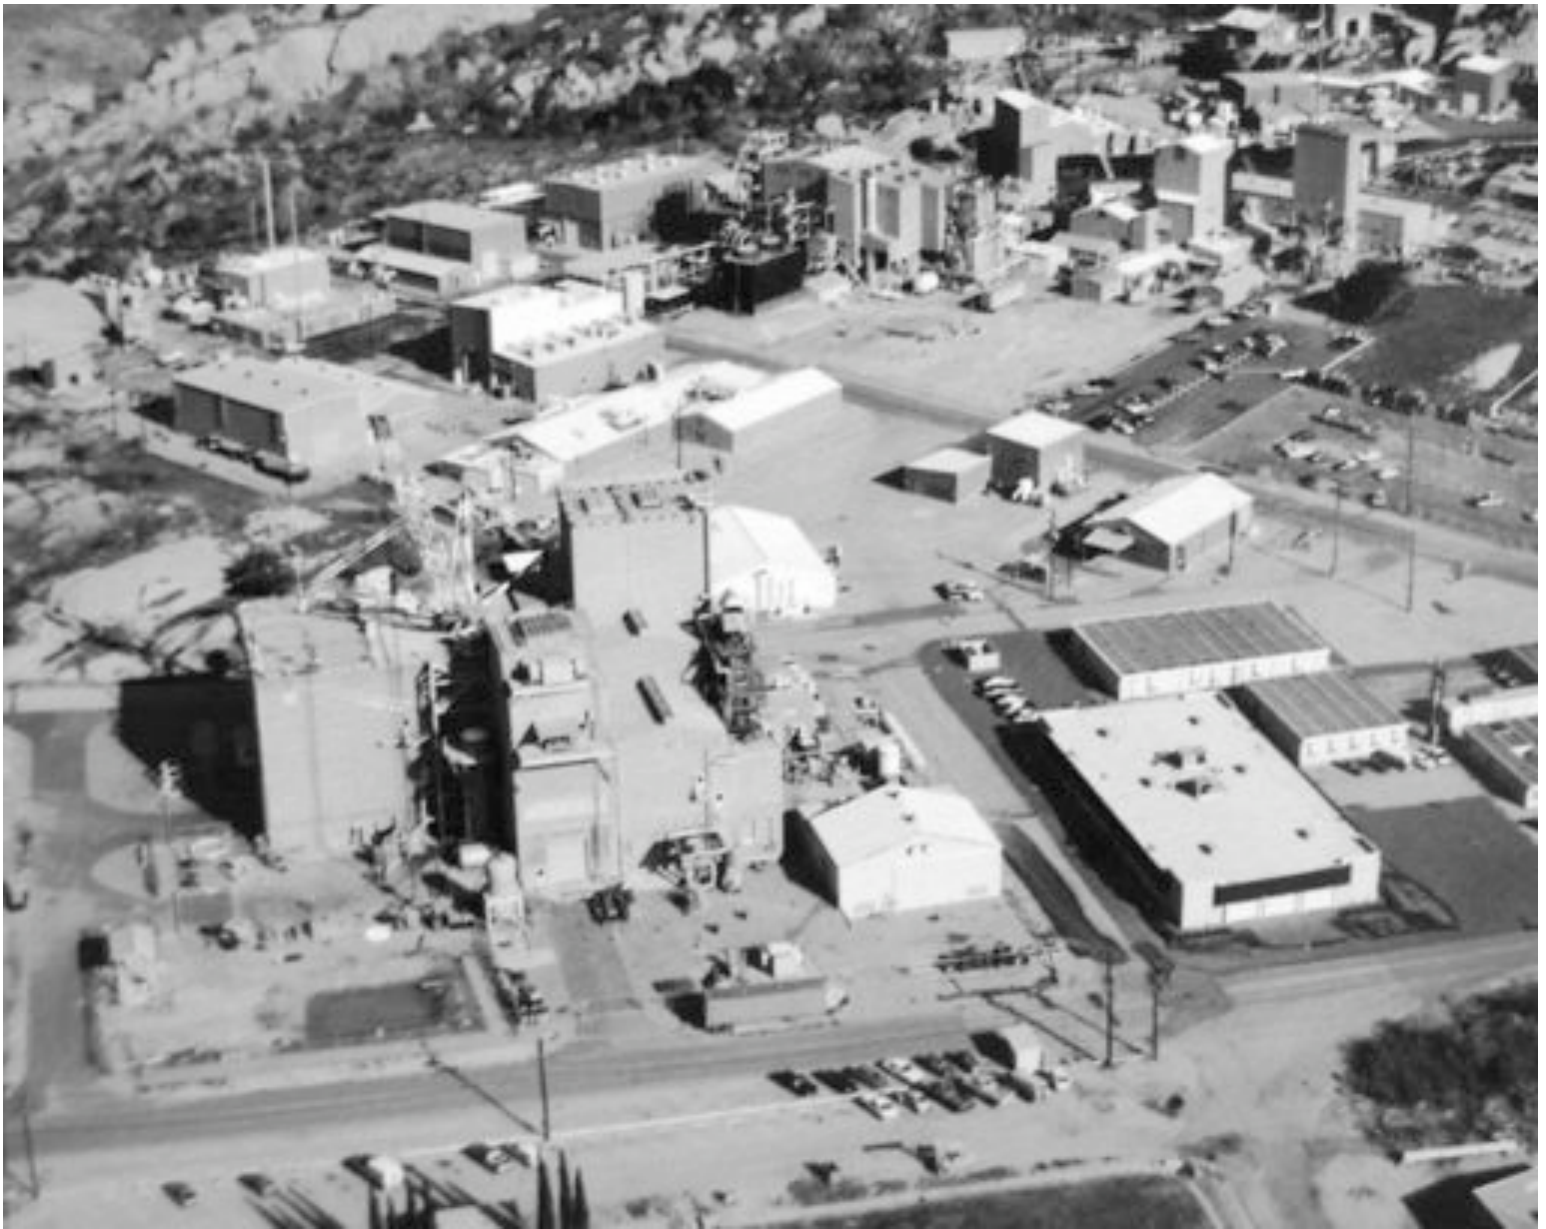
The pond next to concrete pad 4662 of the SPTF is a concern and should be noted more with further investigation needed. In the above photo it appears to be Unlined.

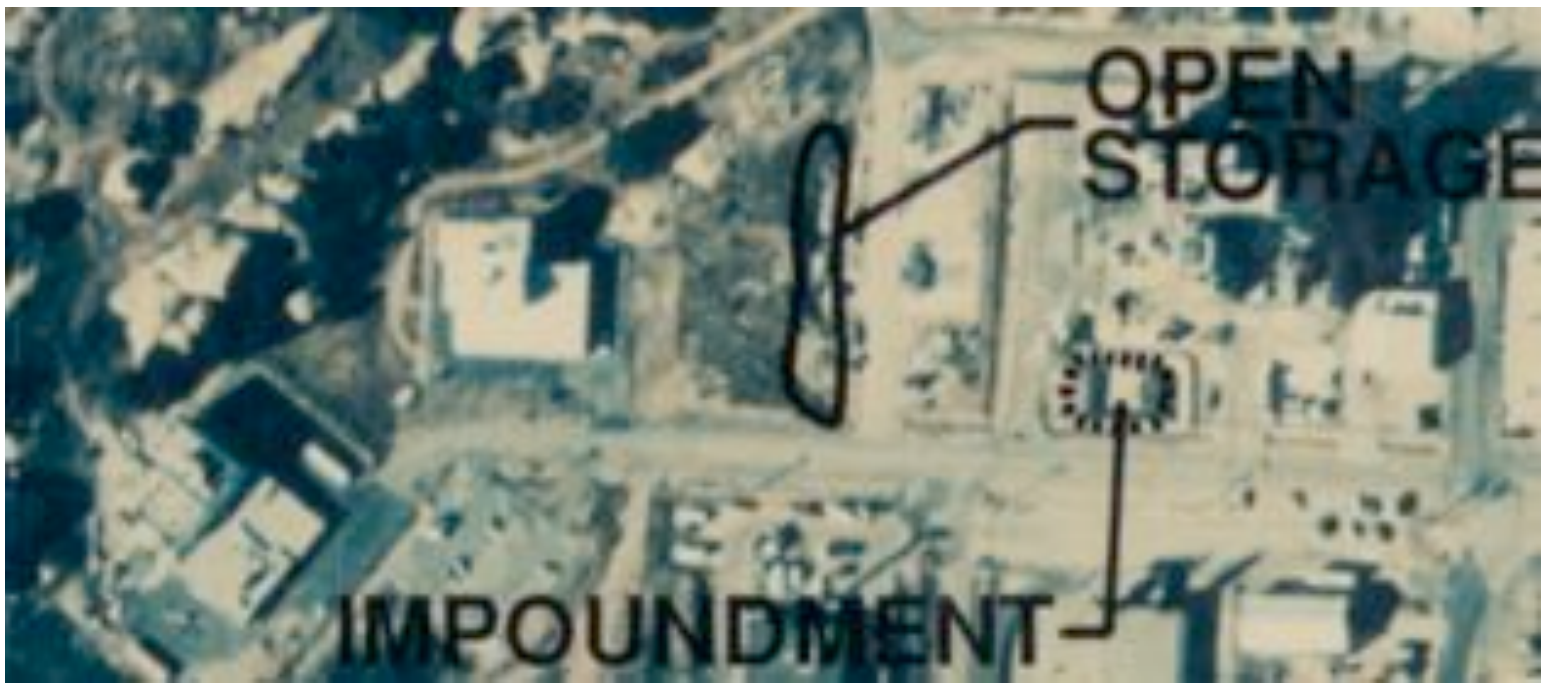
The Above photo shows the pond next to concrete pad 4662 of the SPTF noted as IMPOUNDMENT. We also see OPEN STORAGE, which could be the area of the Building 100 Trench. The exact location of the building 100 Trench should be noted as it has been disputed over the years.

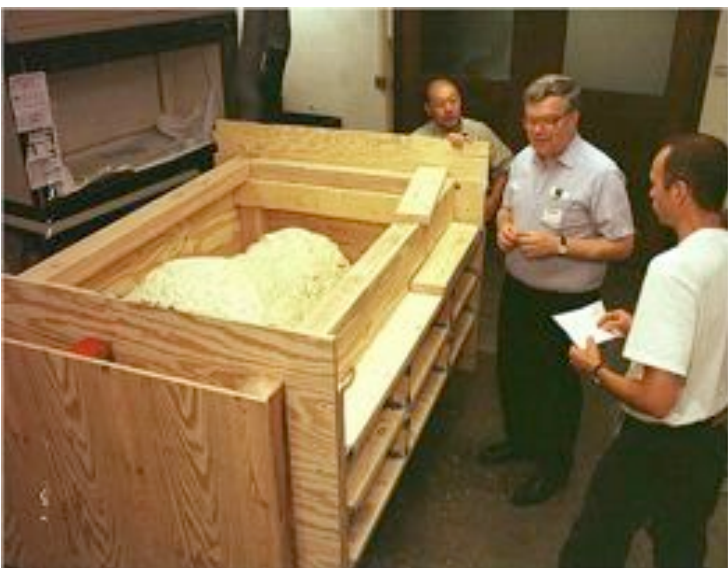
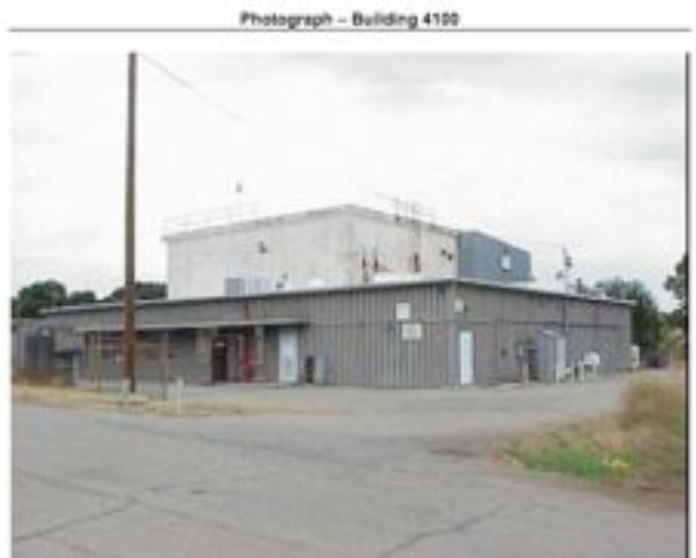
On Page 64 it should be noted that the Computerized Tomography (CT) Scanner is the property of NASA and was featured in a National Geographic program where a dinosaur was investigated with this machine.

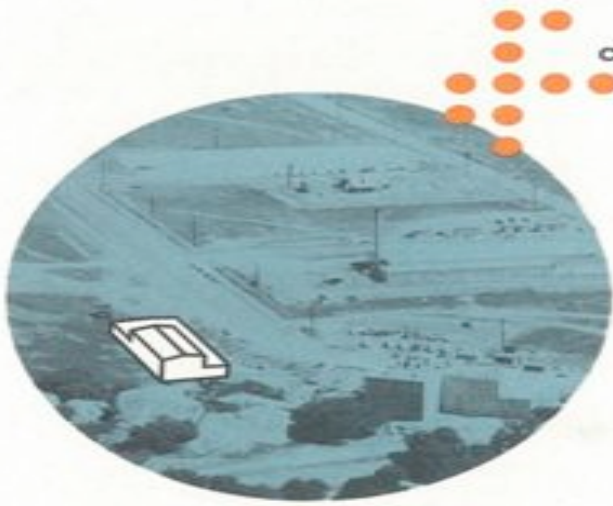
critical experiments

Building 100 was also used for the Advanced Epithermal Thorium Reactor (AETR).

Critical experiments are planned to establish the validity of the analytical data and provide experimental data on the nuclear performance of the AETR. Due to a limited supply of U^{235} Atomics International has developed a novel critical assembly design for use in the AETR program.
