Enclosed please find my comments on the Group 1a Resource Conservation Recovery Act Facility Investigation Report (Group 1a RFI Report) representing results of contamination and debris in the AREA I portion of the Santa Susana Field Laboratory (SSFL).

William Preston Bowling - Founder/Director

ACME (Aerospace Cancer Museum of Education)

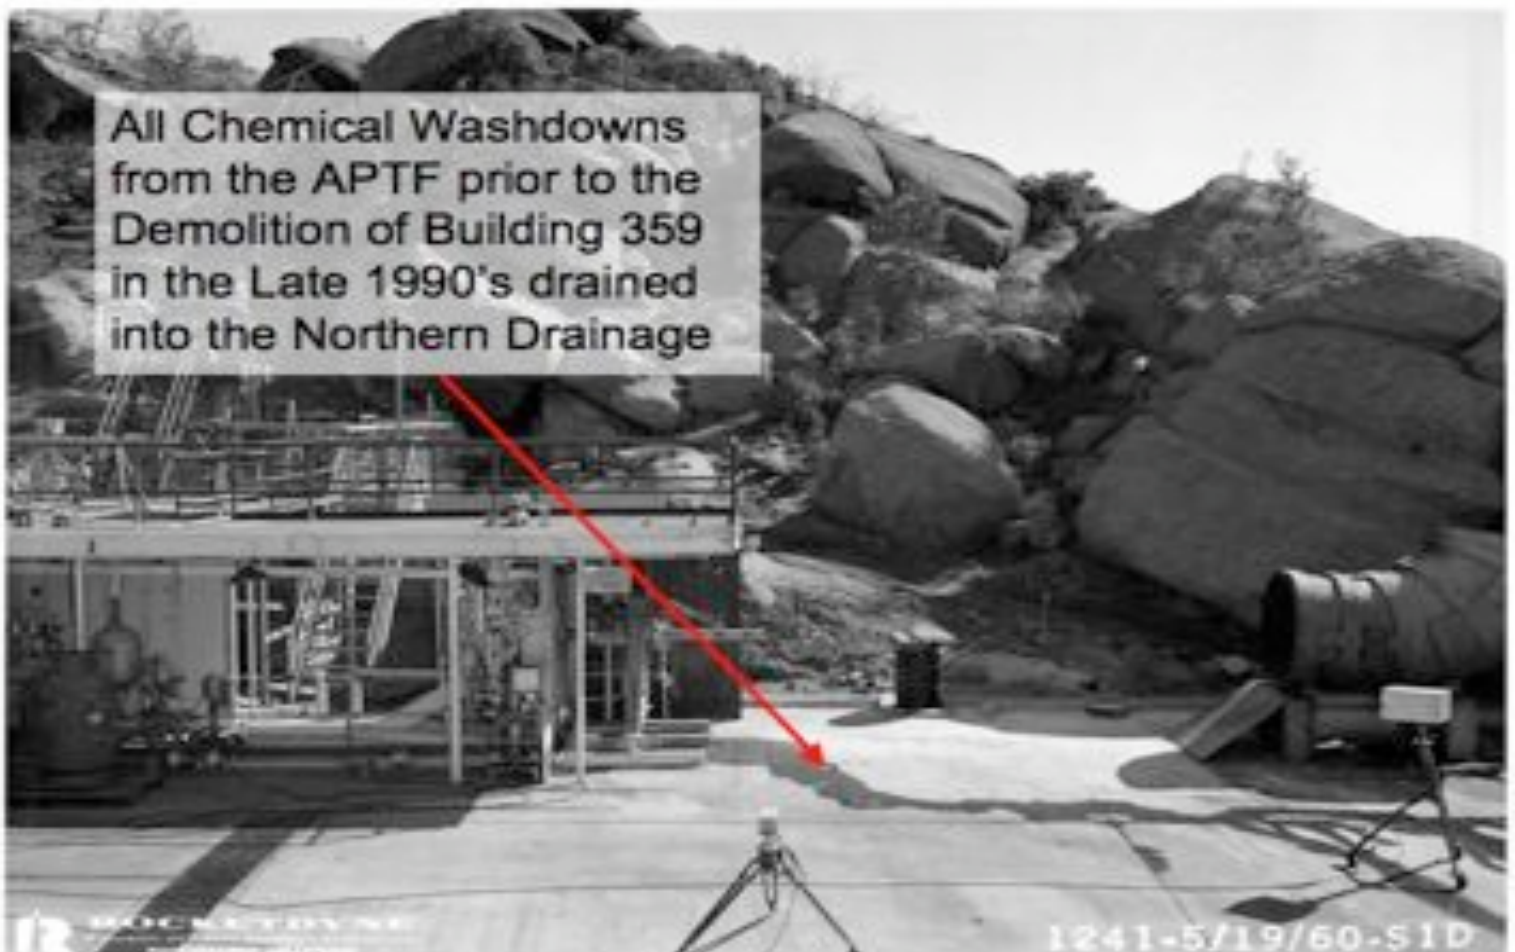
Prior to 1996 the Drainage from the Facilities area within the Building 359 complex was diverted into the Northern Drainage through a series of Swales & Pipes, now it is diverted to the South into the Perimeter Pond near the AREA I Burn Pit.

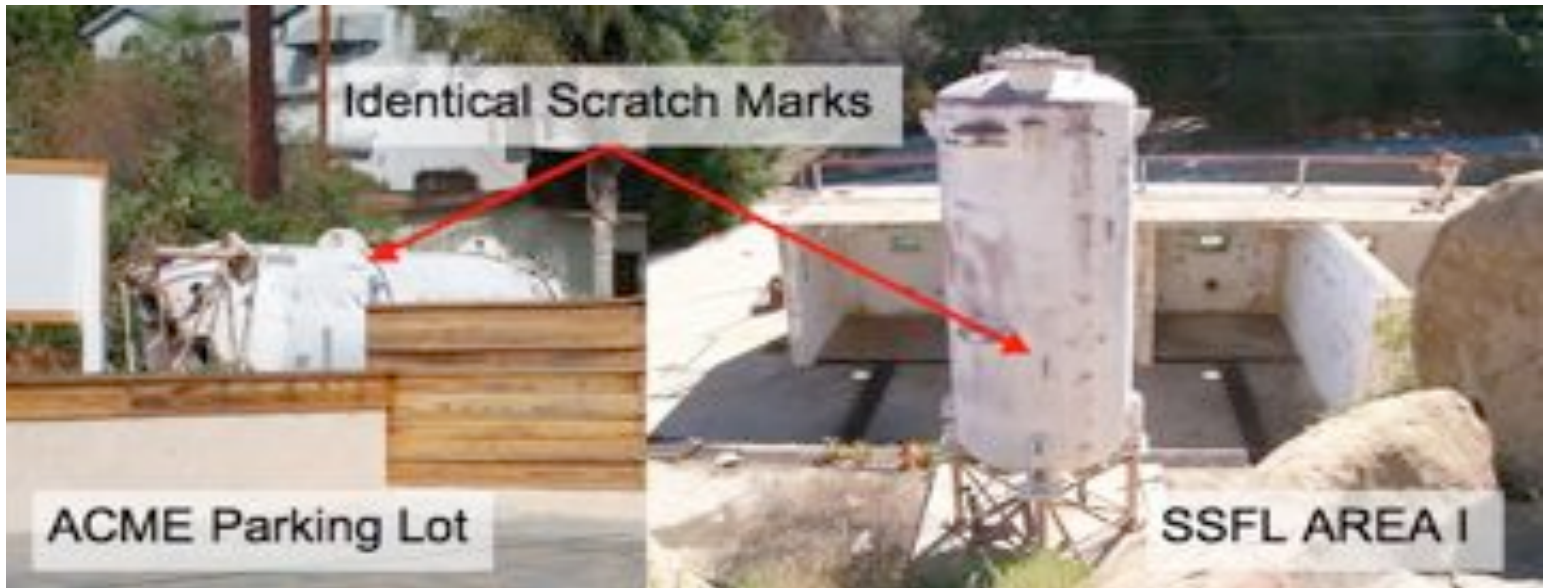
In the above photograph we see a tanks on a flatbed truck passing by ACME on Lake Manor Drive, apx. 1.5 miles from the front gate of the SSFL. The photo next to it shows the same tank in place in AREA I of the SSFL. Notice the markings on the tank are identical. According to Figure E.2-4 of the Group 1a Soil Disturbance Area Map is indicates this is a DMH (DIMETHYLHYDRAZINE) Tank. These tanks are taken to other Aerospace Facilities across the greater Los Angeles area for reuse and in some cases their previous contents are unknown. As seen in the photo below, many of the assets from the SSFL such as tanks and parts are stockpiles at the Pratt Whitney Rocketdyne (PWR) Facility in Canoga Park next to the Topanga Westfield Shopping Center.

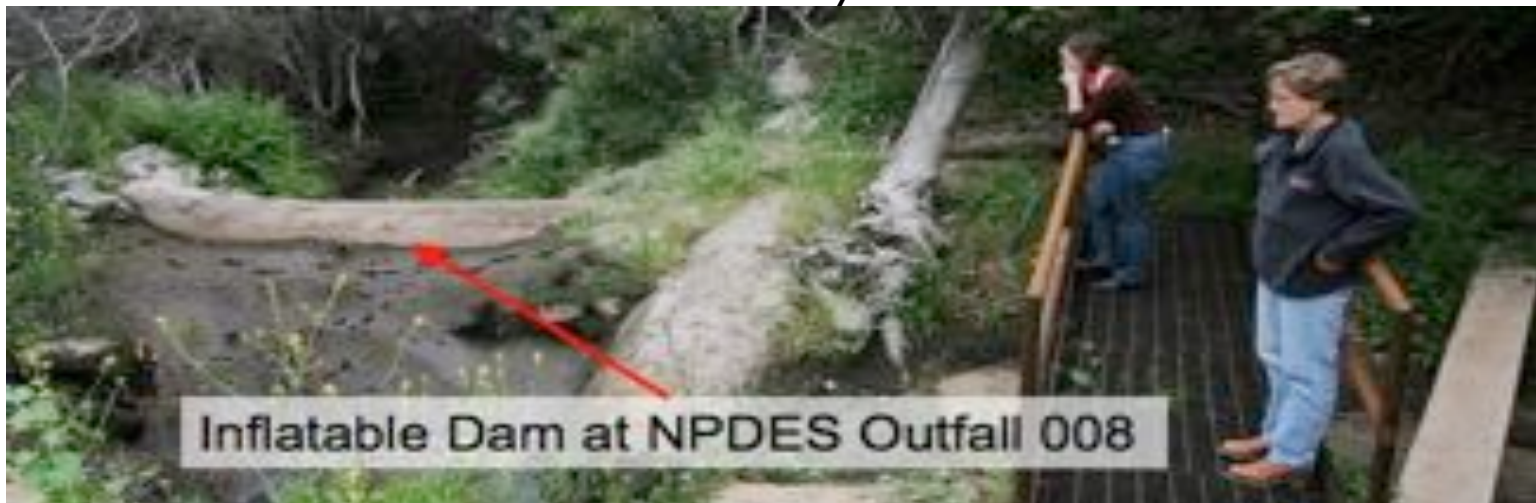
There is a Source Removal Action currently underway at NPDES Outfall 008 and upon it's completion we need to see the Happy Valley area in Group 1a be remediated as well to ensure there will be no contamination in the newly remediated Outfall 008 Watershed.

The Group 1a RFI Report indicates that there are no seeps and springs in the reporting area. This is False. The entire watershed of NPDES Outfall 8 is surrounded by seeps and springs and in several areas of the IEL Fault there are seeps and springs as well.

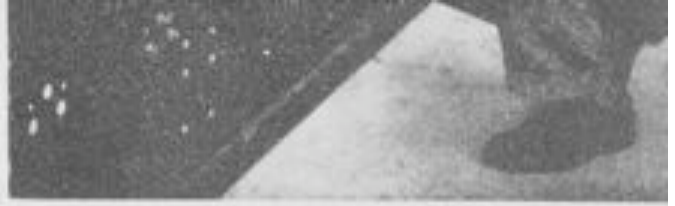
A bulldozer matches its weight with a Santa Susana boulder in the process of building a roadway to the laboratory site.

We have to remember that the NPDES Outfall 008 Watershed was the original road to Rocketyne (See Above Photo, an illustration of the rugged terrain that could have been a potential hazard in transportation of Solvents and Chemicals up and down the mountain) as explained in the link below.

This could offer an explanation to why there were high findings of perchlorate in the offsite area of Dayton Canyon. The high findings were actually found on the original road to Rocketyne and Dayton Canyon should be investigated further up onto this road towards Woolsey Canyon. These areas drain into Dayton Creek, a tributary to the Los Angeles River. These headwaters to the L.A. River and the impacts from the SSFL have the potential to reach 52 miles into the harbor of Long Beach.

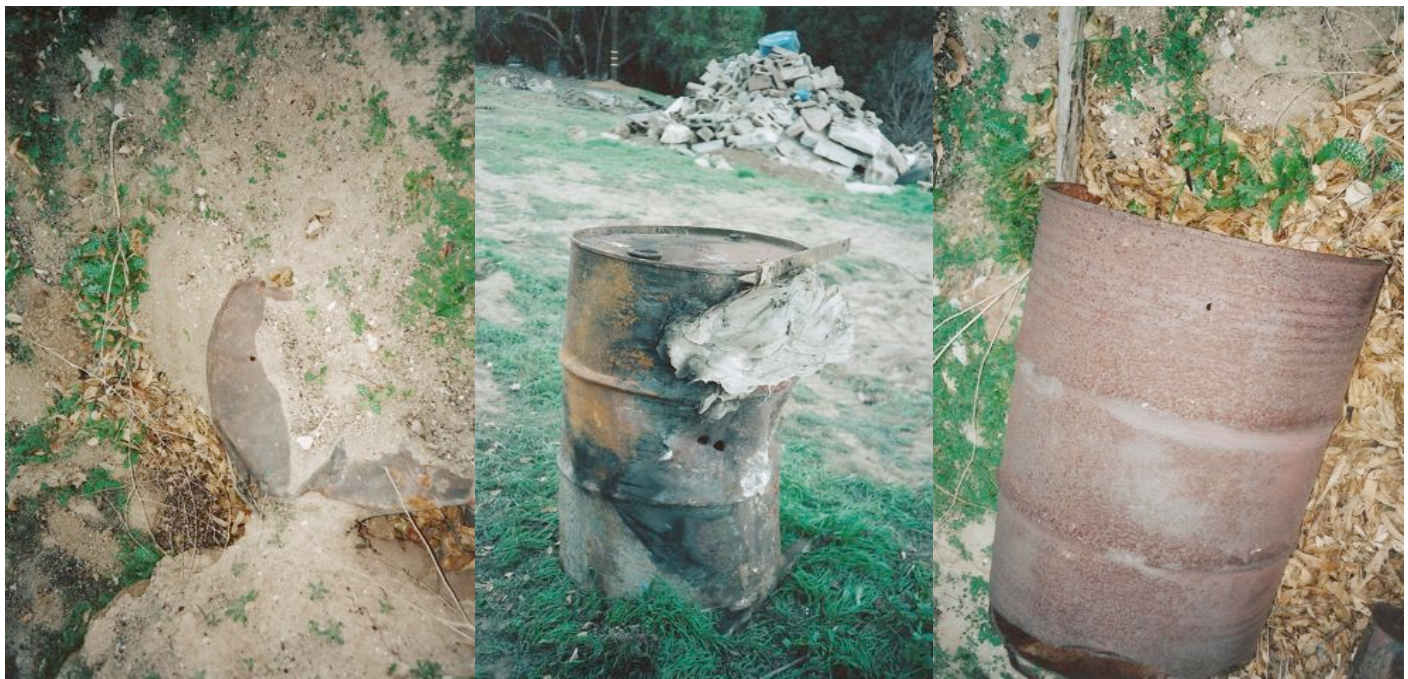
A picture is worth a thousand words or every picture tells a story. We see 55 Gallon Drums found on the banks of Dayton Creek, a tributary of the L.A. River. An interview with a former employee who worked at the AREA I Burn Pit (adjacent to Happy Valley & Dayton Canyon) recalls that "On Several Occasions" when burning waste, "Some would Get Away". The reaction from Chemicals and Radionuclides stored in drums have the potential to travel several feet to several hundred yards when coming in contact with other Chemicals, Fire, Air or Water. These Drums could have potentially been thrown and rolled onto it's current banged up position from it's launch from the AREA I Burn Pit. We must not forget examples of the impacts waste destruction most notably in the July 1994 Chemical Explosion that killed Otto K. Heiney and Larry A. Pugh (Heiney vs. Rockwell Int'l - Filed July 1995 U.S. District Court). The Practices of the AREA I Burn Pit have been proven to be in the Building 359 Facility and impacting it's watershed.

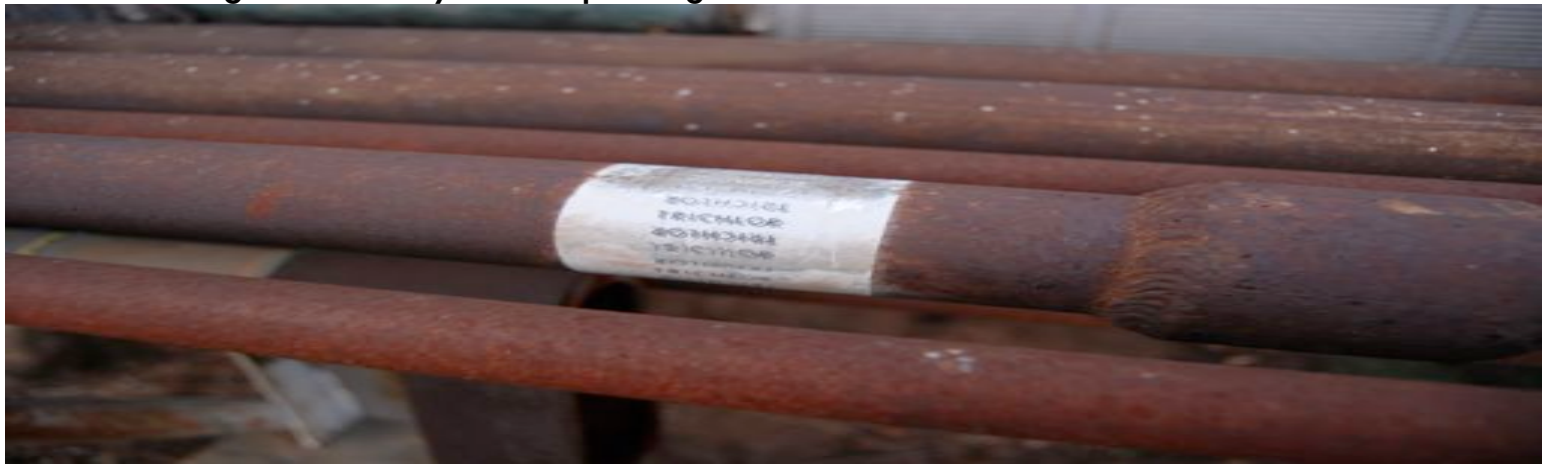
The Canyon Area and it's Trichloroethylene (TCE) use and deliveries made from the "Old Road to Rocketyne" should be investigated further. If the paths of the TCE lines are not documented then one has to assume that the entire miles of pipe should be looked into for potential areas of impact.

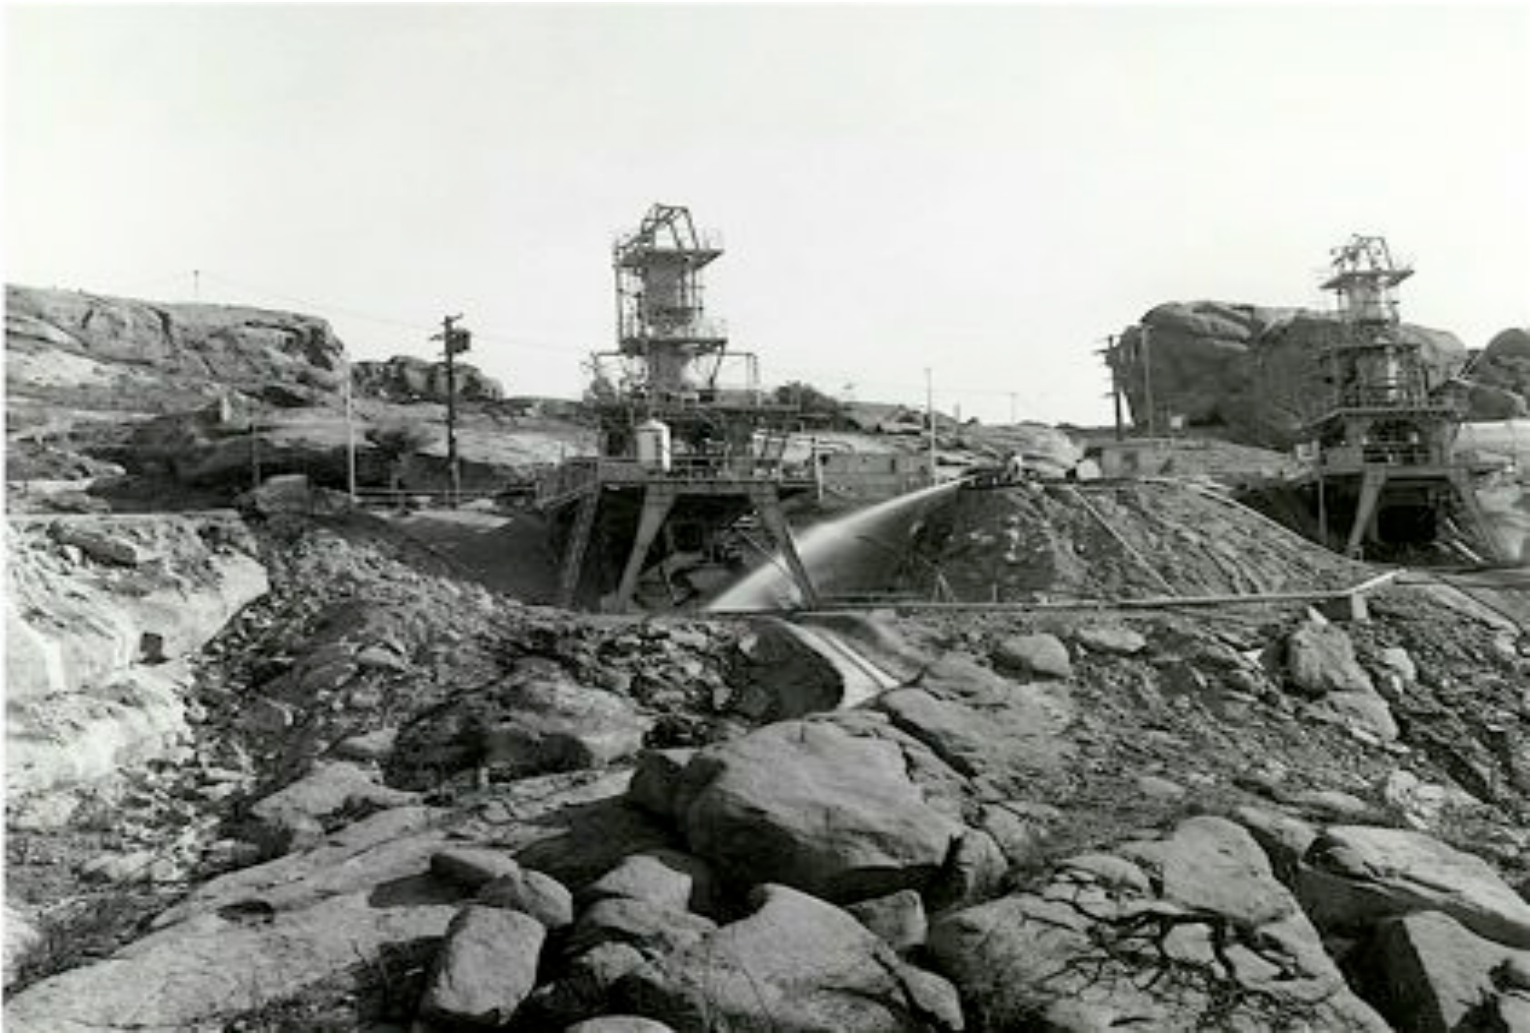
The Canyon Area was a user of TCE from it's activation in 1954 until the late 1960's.

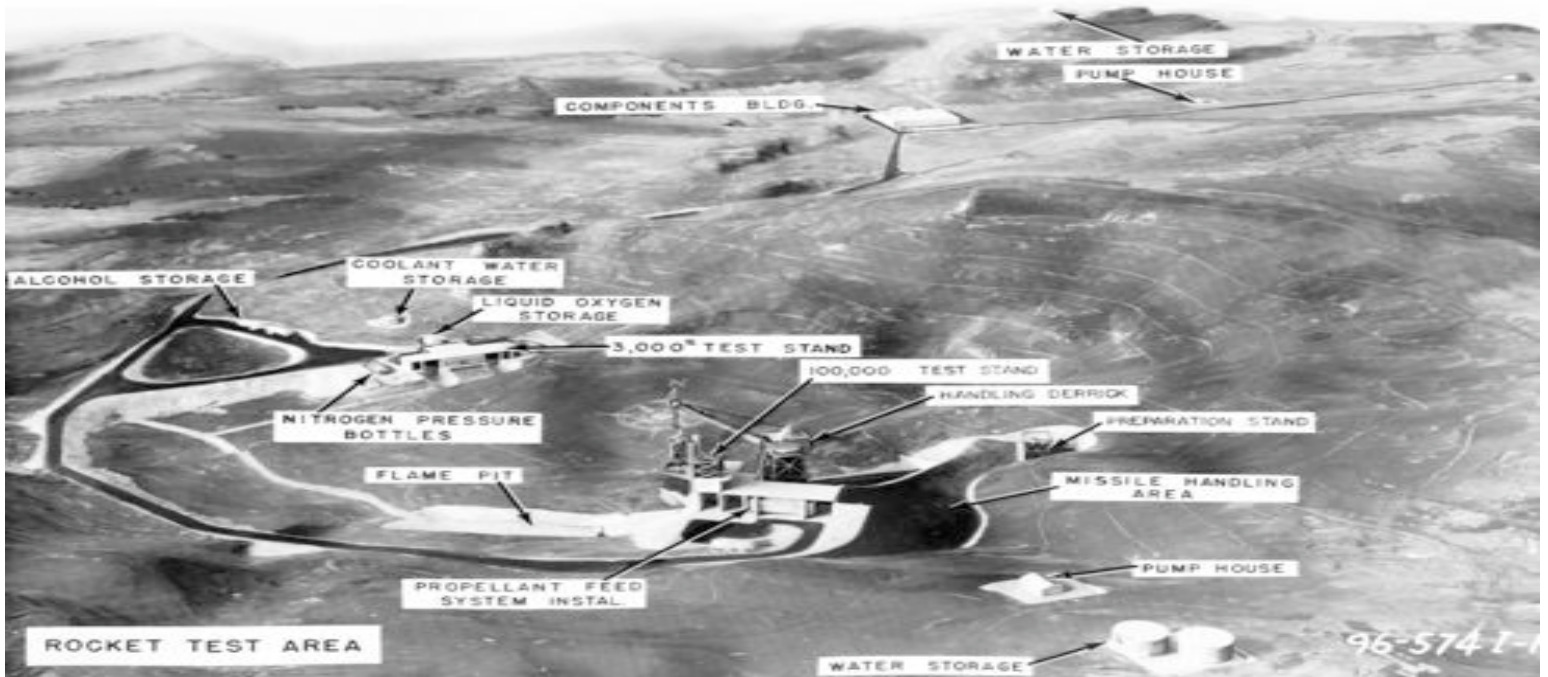
CTL I was used as the Components Building for the Bowl Rocket Engine Test Stands and all related activities should be considered in both Group 1a and 1b.

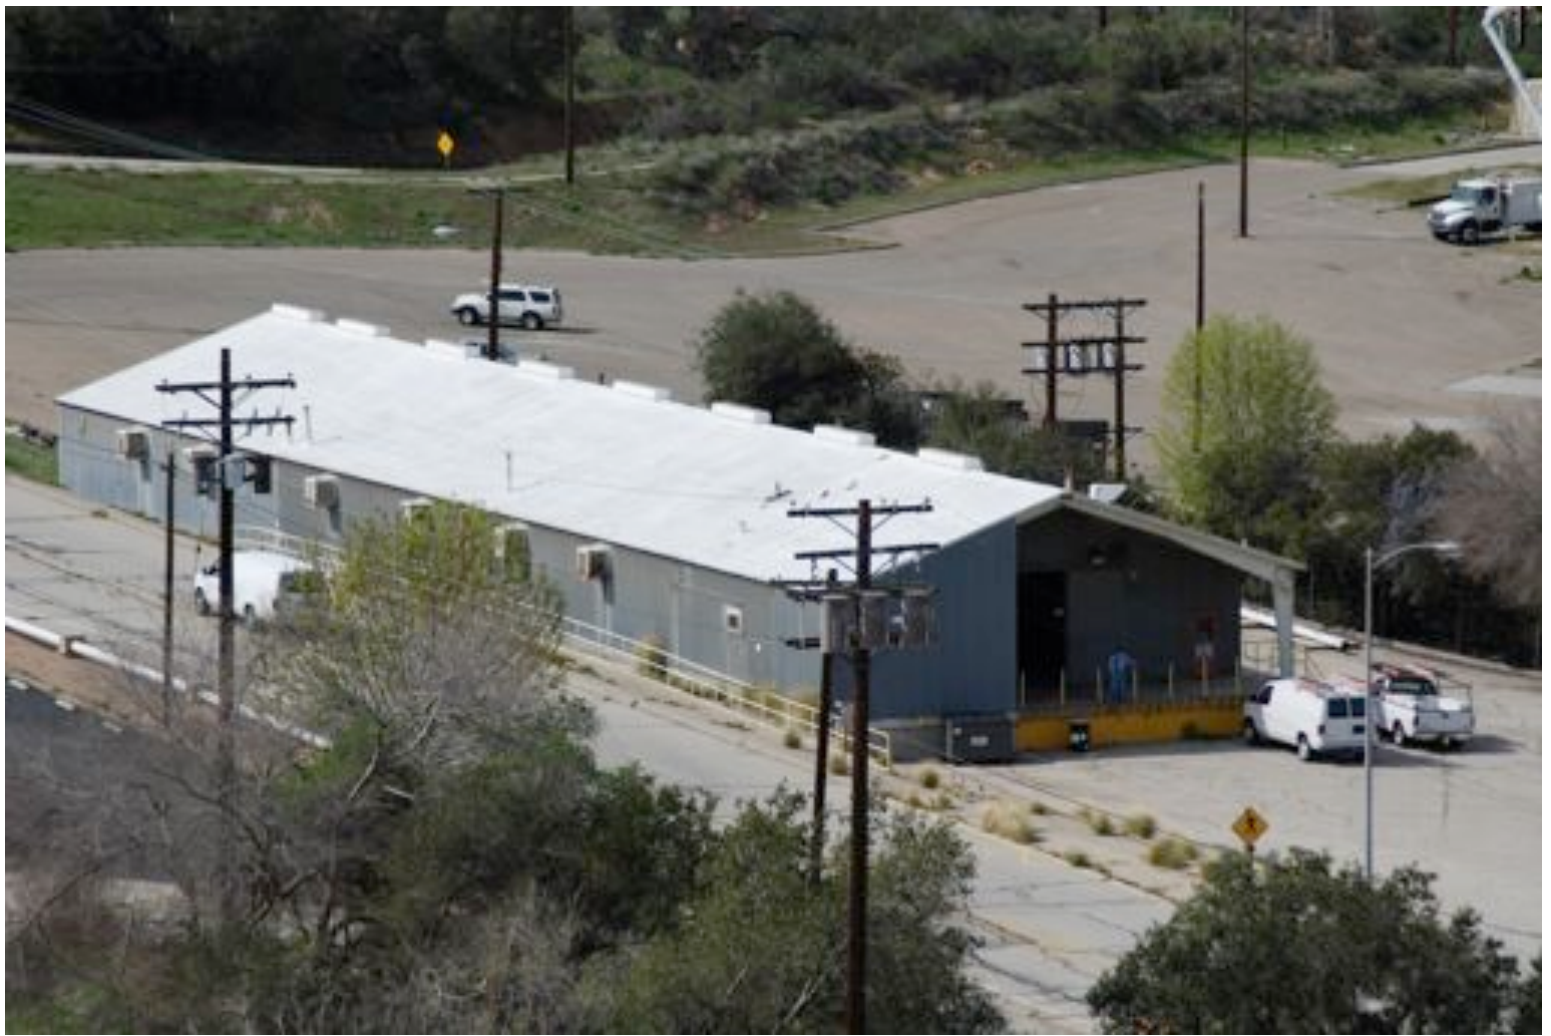
As you first enter the SSFL from Woolsey Canyon, on your right side is the former location of Building 435. Prior to its demolition earlier this year in 2009 it was used for Shipping & Receiving. With all of the potential Chemicals and Radionuclides Shipped and received, Building 435 needs further investigation. You can see a Hazardous Waste Labeled 55 Gallon Drum sitting outside the loading bay on the asphalt.

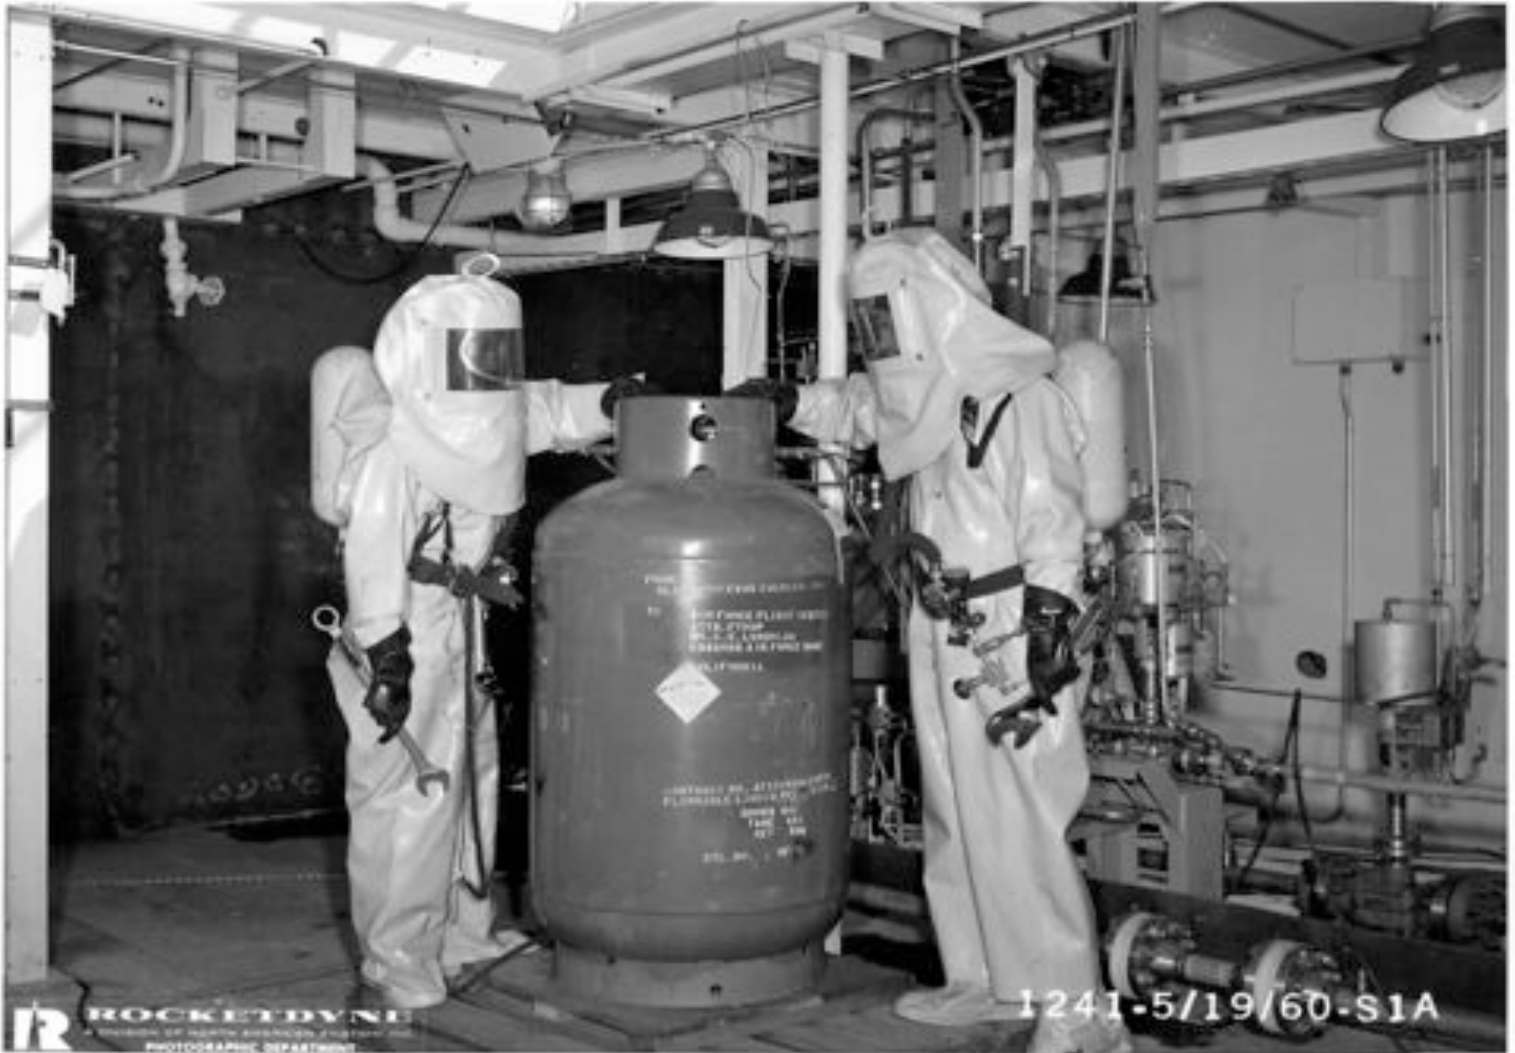
In the above photo we see Rocketdyne Employees at the Advance Propulsion Test Facility (APTF) handling Pentaborane, a chemical compound considered in the 1950s as a good prospect for a rocket or jet fuel by both the U.S. and Russian armed services, a so-called "exotic fuel". Its chemical structure is that of five atoms of boron compounded with nine atoms of hydrogen (B_5H_9); it is one of the boranes. Because simple boron compounds burn with a characteristic green flame, the nickname for this fuel in the U.S. industry was "Green Dragon".

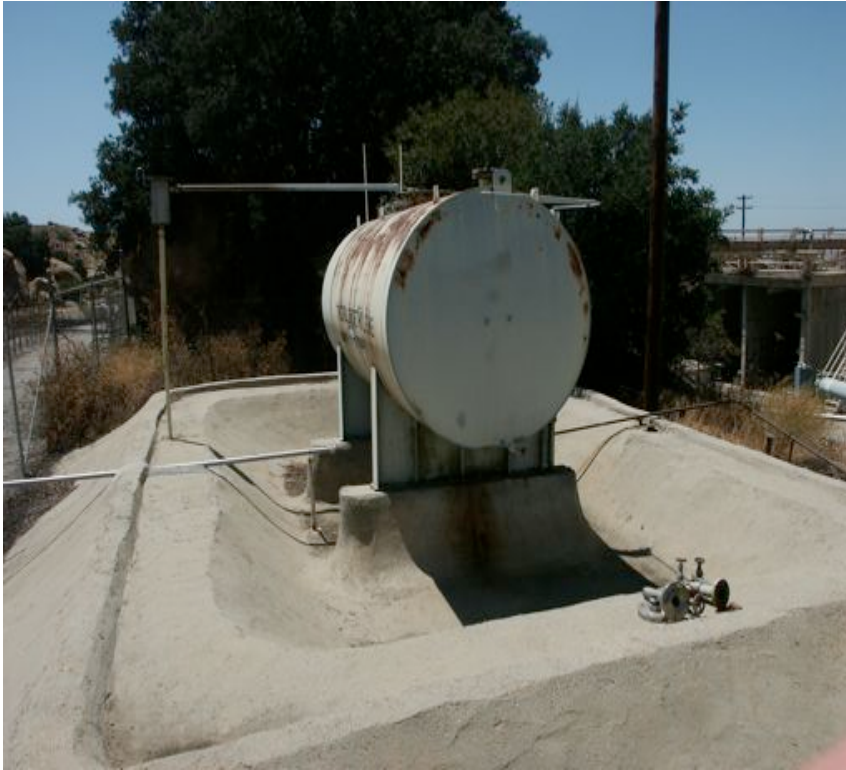
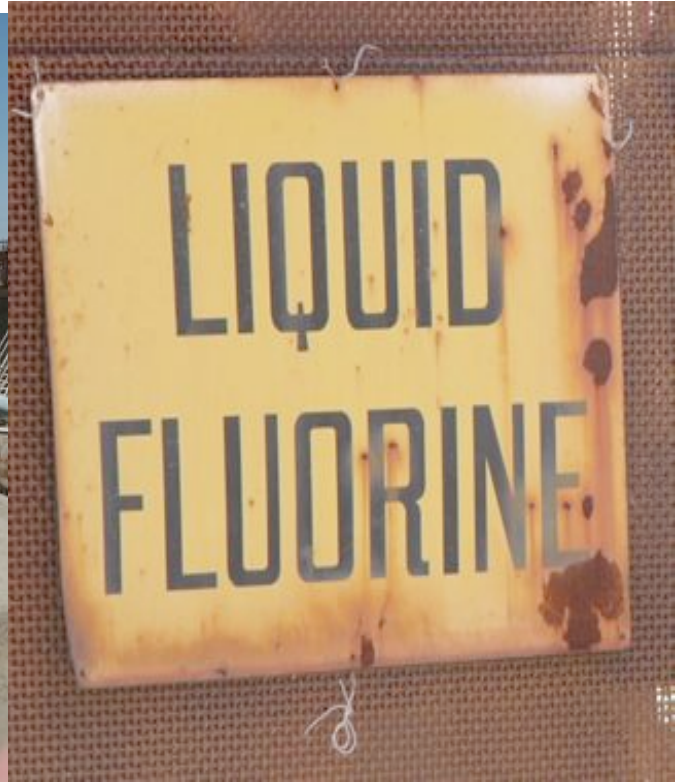
Why is the Fluorine Burn Box adjacent to LETF-8 Test Pad 3 not on the SVOC's chemical data results LETF/CTL-I RFI site northwest area figure h.3-2A The highest specific impulse chemistry ever test-fired in a rocket engine was lithium and fluorine, with hydrogen added to improve the exhaust thermodynamics (making this a tripropellant)[1]. The combination delivered 542 seconds (5.32 kN·s/kg, 5320 m/s) specific impulse in a vacuum. The impracticality of this chemistry highlights why exotic propellants are not actually used: to make all three components liquids, the hydrogen must be kept below $-252\text{ }^{\circ}\text{C}$ (just 21 K) and the lithium must be kept above $180\text{ }^{\circ}\text{C}$ (453 K). Lithium and fluorine are both extremely corrosive, lithium ignites on contact with air, fluorine ignites on contact with most fuels, and hydrogen, while not hypergolic, is an explosive hazard. Fluorine and the hydrogen fluoride (HF) in the exhaust are very toxic, which damages the environment, makes work around the launch pad difficult, and makes getting a launch license that much more difficult. The rocket exhaust is also ionized, which would interfere with radio communication with the rocket.

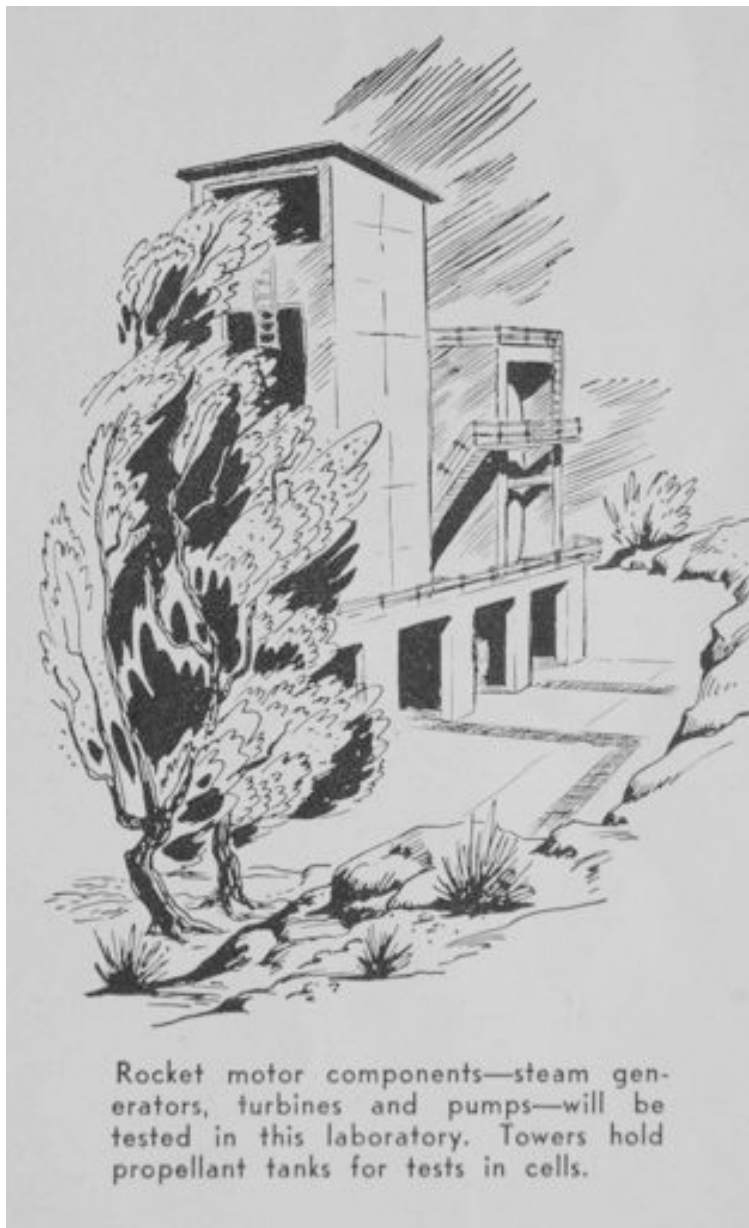
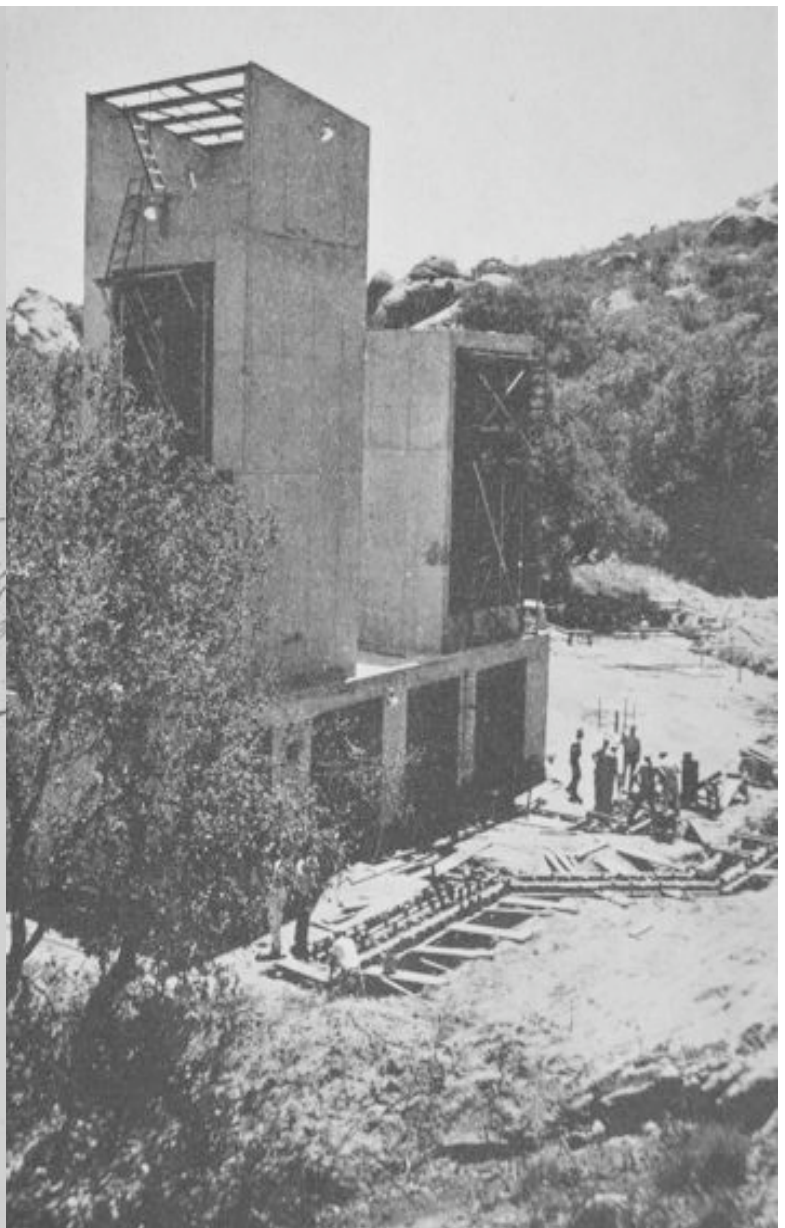
The above photos are of an Artists Rendering prior to construction (Left) and a construction photo (Right) of the Components Test Laboratory (CTL I). Notice the preparation for the pouring of the concrete drainage swale, they went very deep into the ground. Deeper hand Auger sampling needs to be done in this area as the contamination could potentially exist in the deeper soils under the former trench. We cannot take any chances in the risk of continuing to impact the surrounding communities from the SSFL. With the recent finding of Tritium within the footprint of this facility we need to be extra attentive to the collection and delivery of samples to laboratories selected by the contractors. This is the area of the Sheer Zone and a northward traveling plume of contamination and extra steps need to be taken to make sure the Tritium and other potential Radionuclides and Chemicals are not migrating offsite. We have seen truckloads of contamination removed from the Santa Monica Mountains Conservancy Parkland at Sage Ranch from this plume.

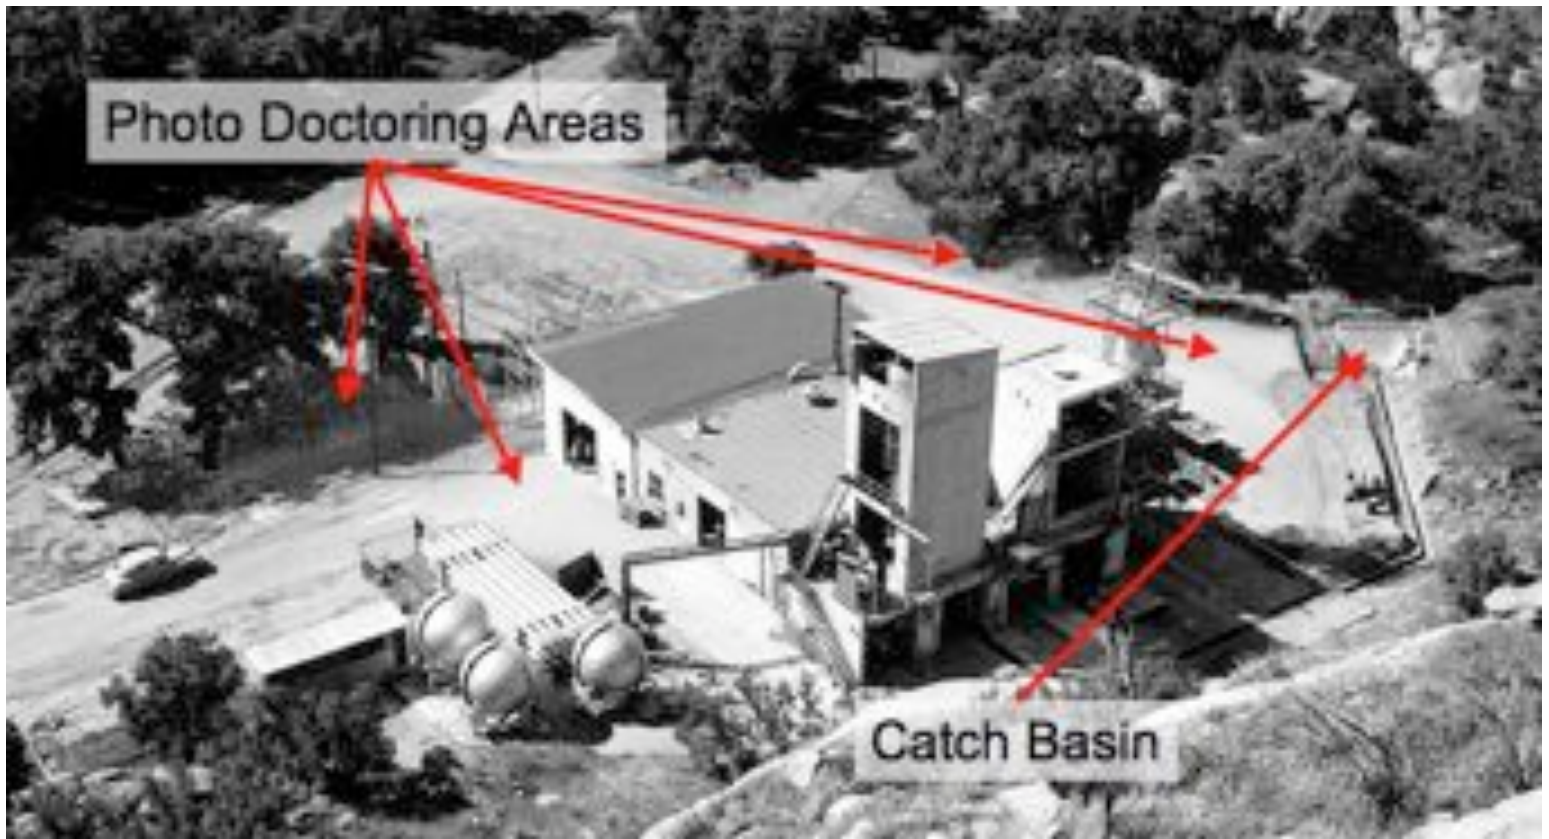
The above areas of this unclassified photo of CTL-I that appear to be doctored need to be further evaluated.
