NASA Informal Technical Meetings SSFL Group 2 Investigation Report

Group 2 RFI

- Former LOX Plant
- Area 2 Landfill
- Expendable Launch Vehicle (ELV)
- Former Incinerator and Ash Pile
- Sewage Treatment Plant

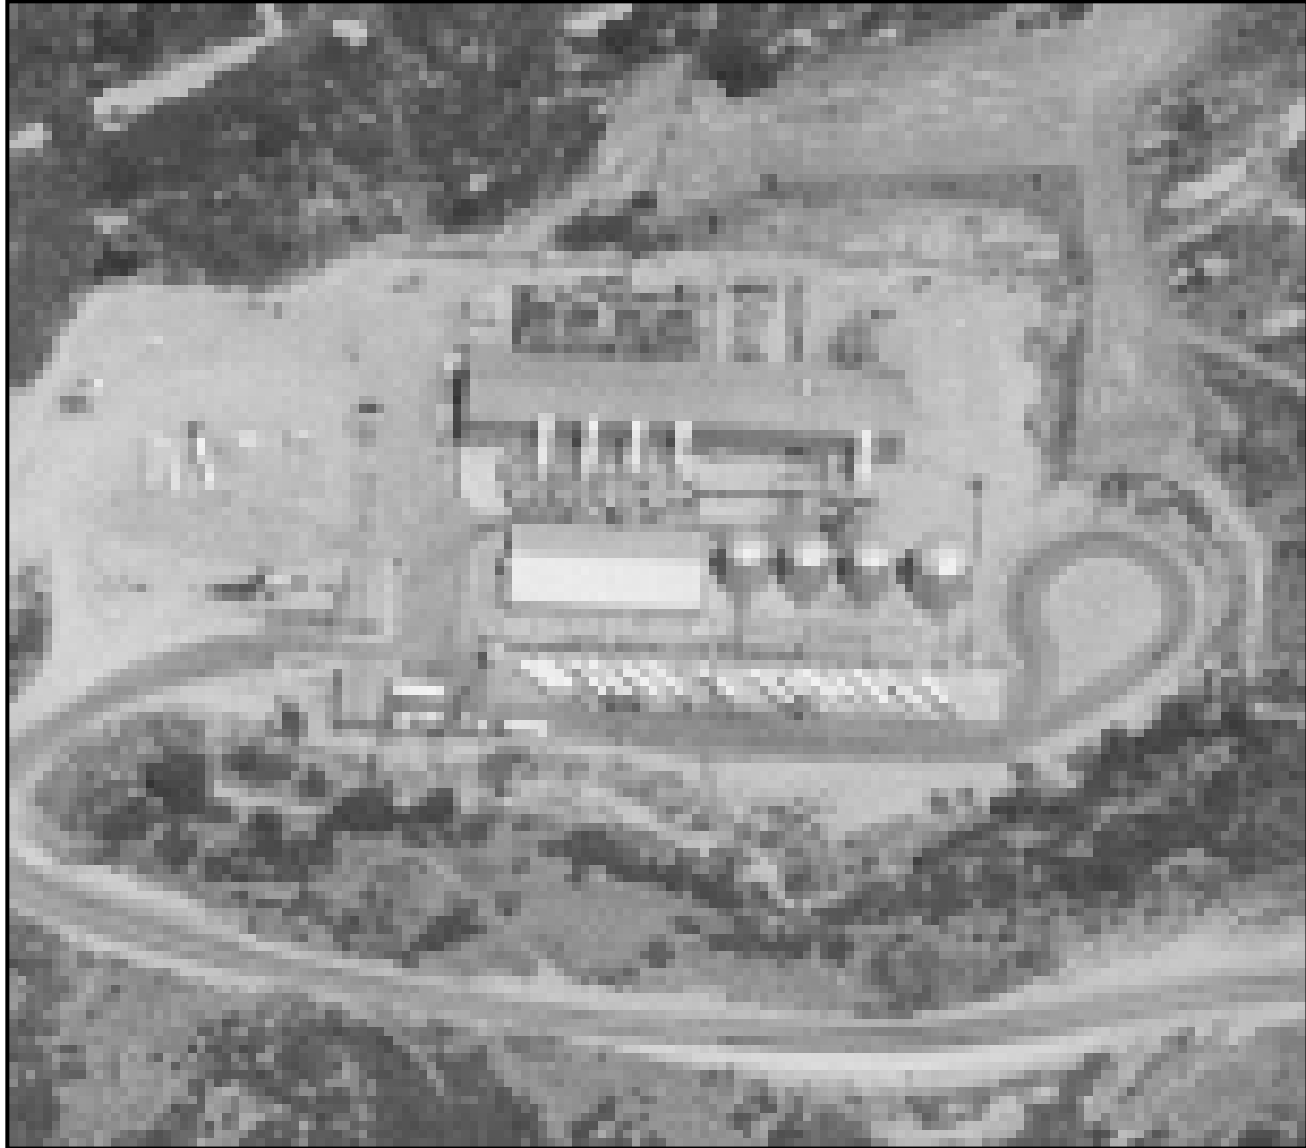
Group 2 – Former LOX Plant

- Owned by the U.S. Air Force and operated by Air Products, Inc. until the late 1960s
- Liquid oxygen (LOX) was produced at the site from liquefied air using a cryogenic process
- Buildings and LOX tanks were removed in the early 1970s, and the concrete foundations (of tanks) were removed in 1996
- Sump and clarifier were excavated and removed as part of the accelerated cleanup program in 1993
- Asbestos and Drum Disposal Area was removed in early 1990s
- Additional debris containing asbestos was removed from drainage ditch in 2007 (Sage Ranch area)

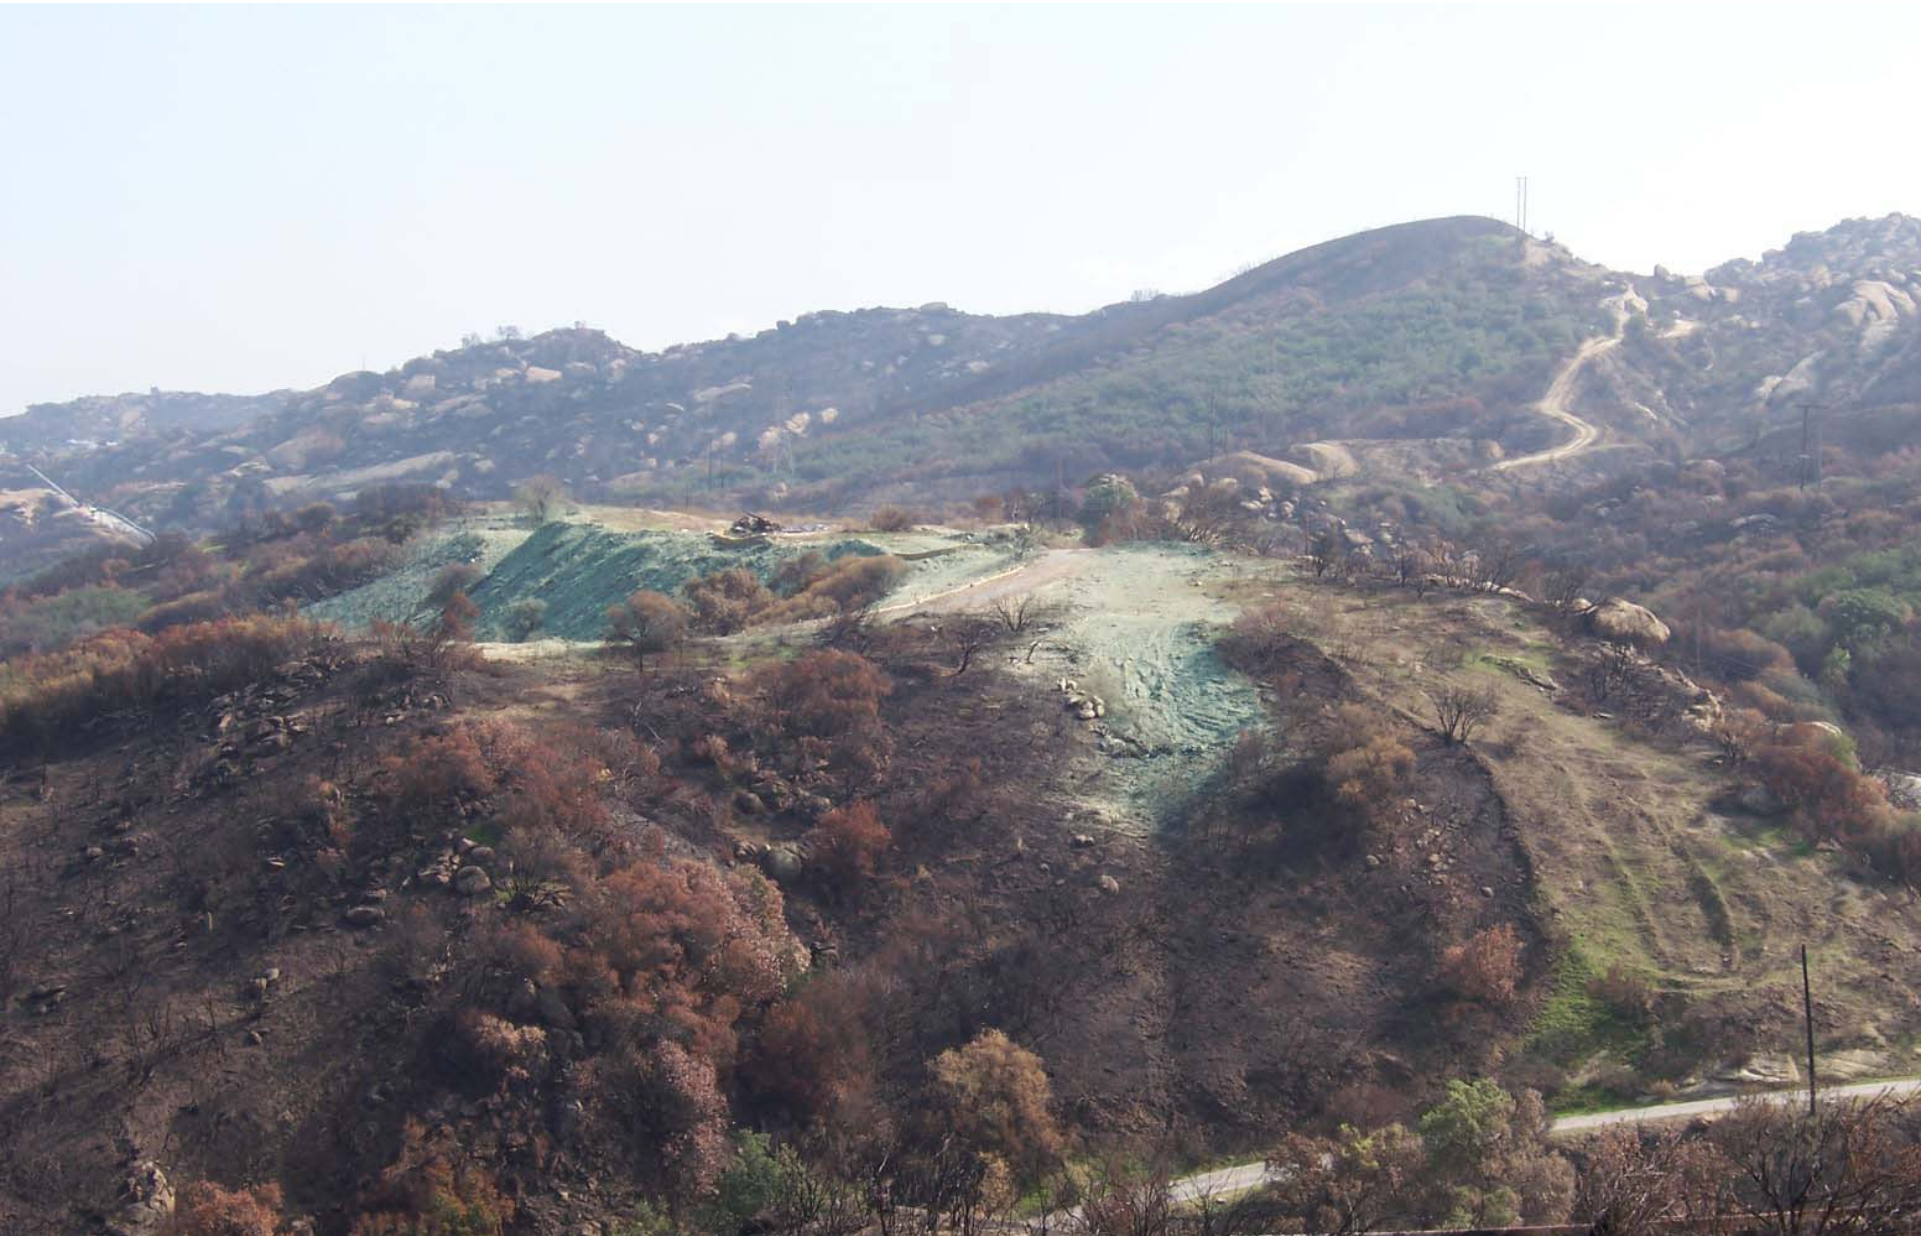
Group 2 – Area 2 Landfill

- Unlined landfill operated 1955 – 1980
- Unused fill material and construction debris (asphalt, concrete, drums, scrap metal, timber, vegetation) were disposed of in the upper flat portion and the steep north-facing slope.
- Near total re-vegetation of the disturbed areas was observed in the 1988 and 1995 aerial photographs.

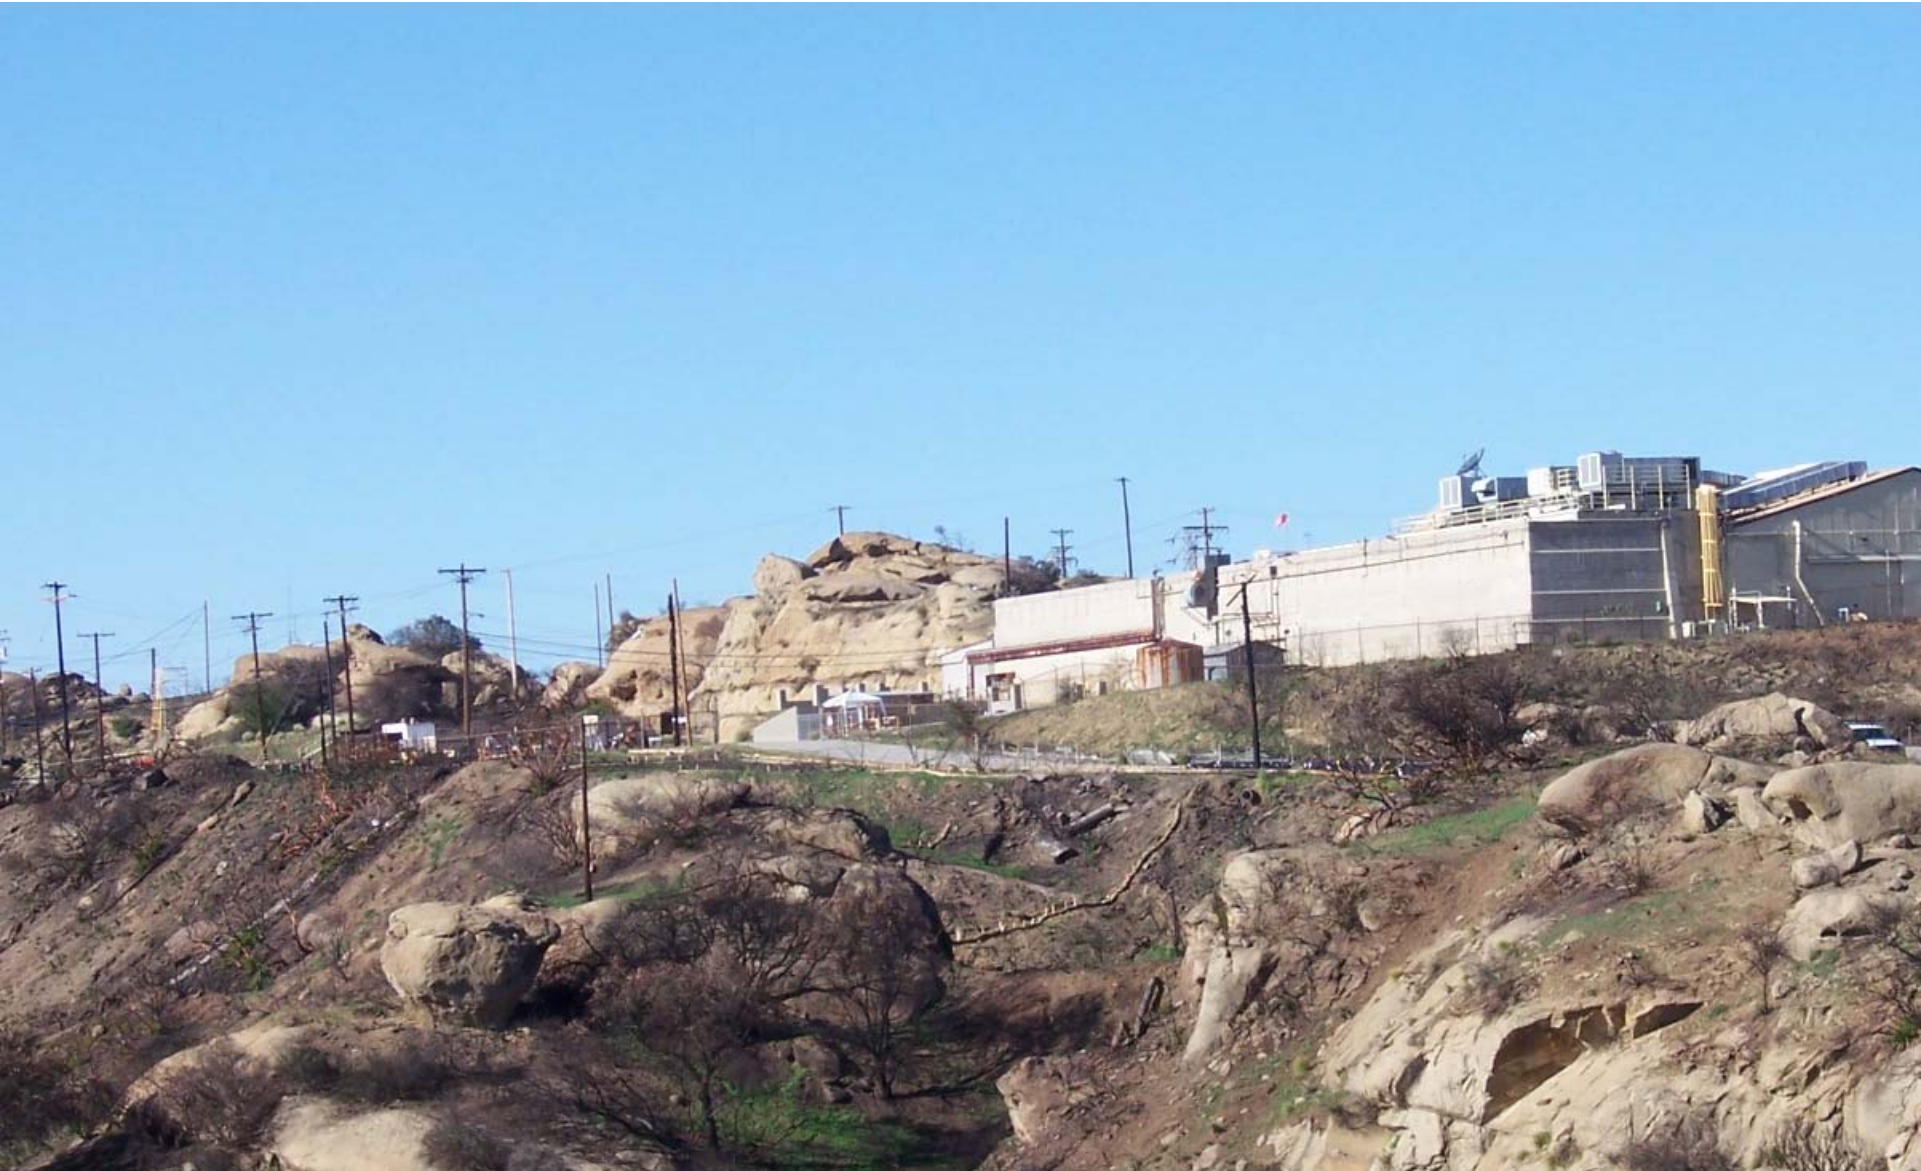
Group 2 – Expendable Launch Vehicle (ELV)

- Bldg. 202 was Laser and Electro-Optical System (LEOS) storage, a cafeteria, photo lab, and for manufacturing of harnesses for space shuttles.
- Bldg. 203 involved the use of a Lead Tinning Machine, Vapor Degreaser, Aqueous Cleaner, Sand Blaster, and machine tools.
- Bldg 206 was originally tested rocket engine components using LOX and petroleum-based fuels (RP-1 and JP-4), chemical storage, engine assembly and check, paint booth operations, machine shop, welding shop, steam cleaning operations, equipment storage, hazardous materials storage, and office space. Wastes were burned off in pond.

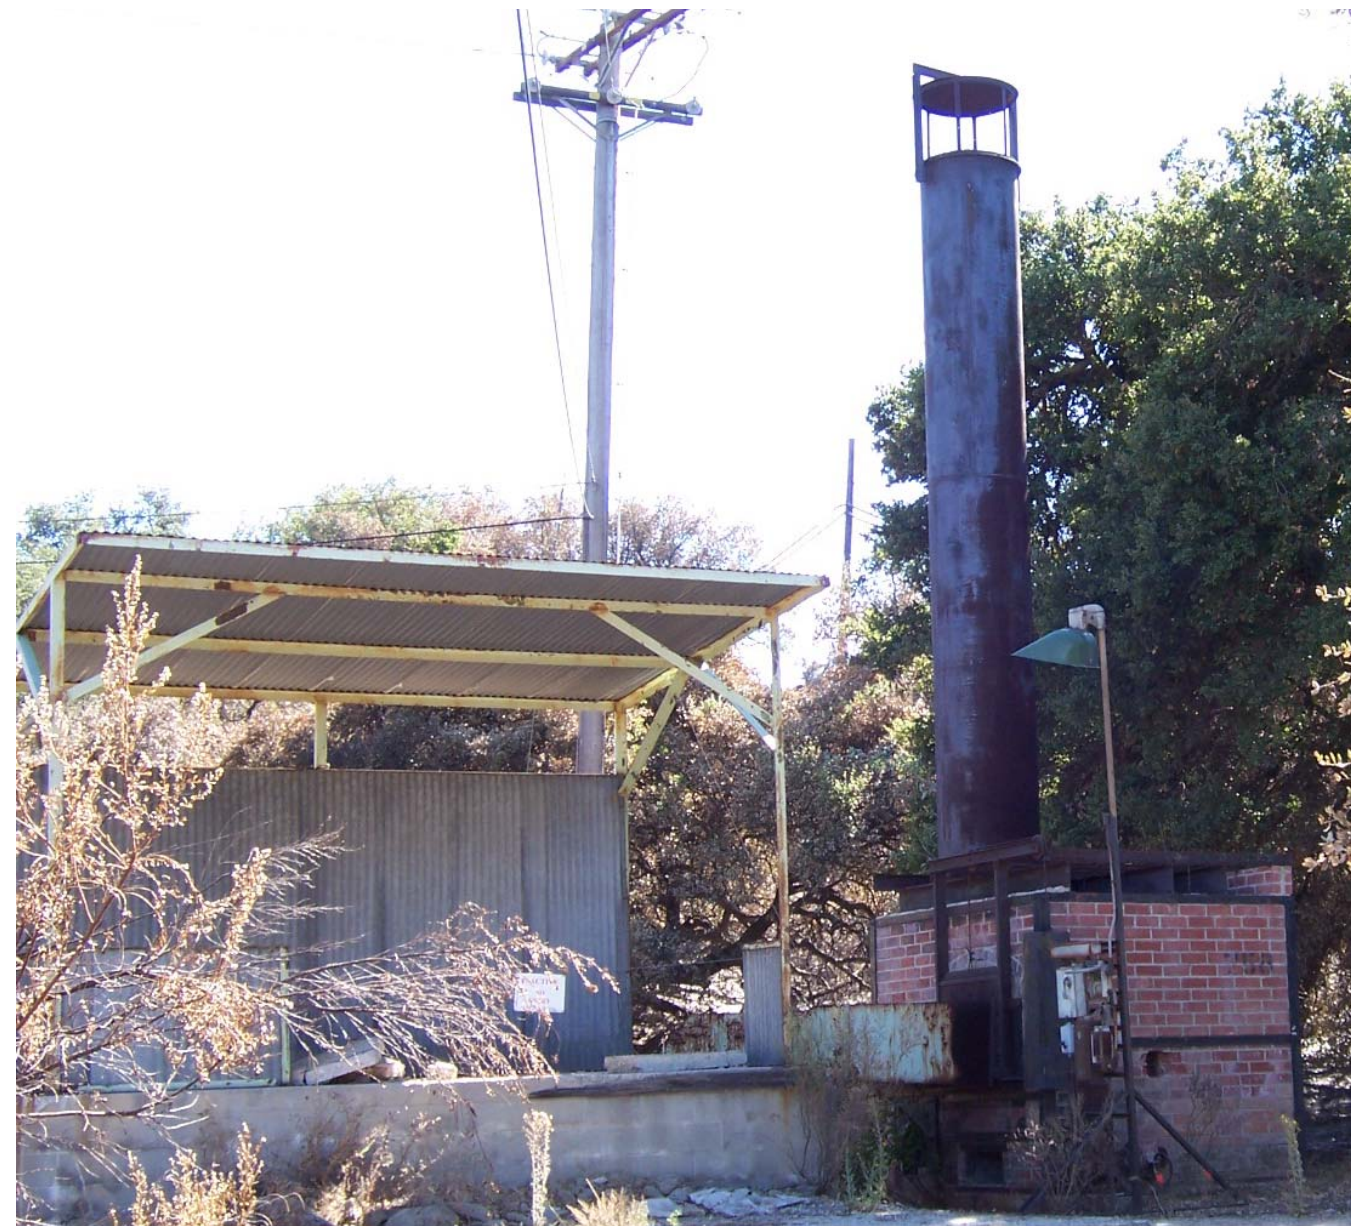
Group 2 – Former Incinerator & Sewage Treatment Plant

- The Incinerator was a brick structure approximately 10 feet by 8 feet with a 30-foot-high metal smokestack, surrounded by a 4-foot concrete apron.
- Operational from the mid-1950s through the 1970s. Waste from the Incinerator was deposited in an ash pile located in an unpaved area to the south of the Incinerator.
- Paper, photographs, and trash were burned at Building 2758.
- Soil investigation identified lead and silver exceeded the threshold limit concentration.
- Ash pile was removed and excavated in 1993.

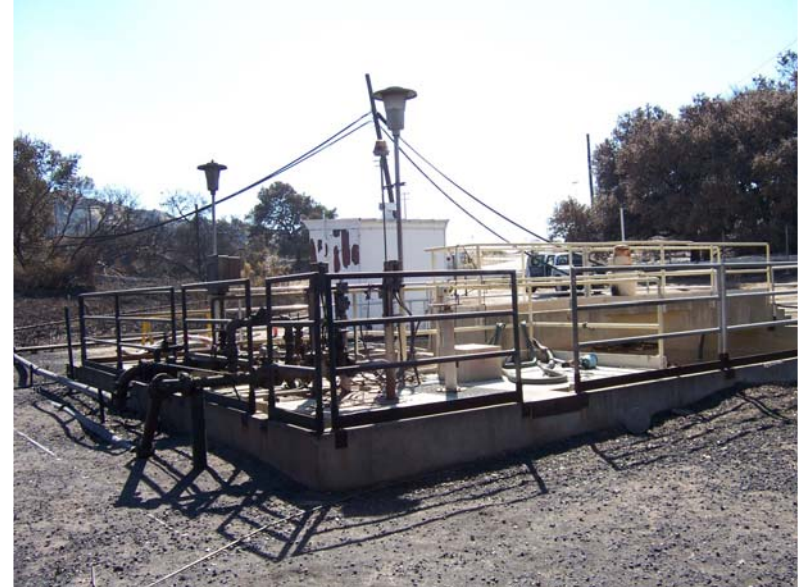
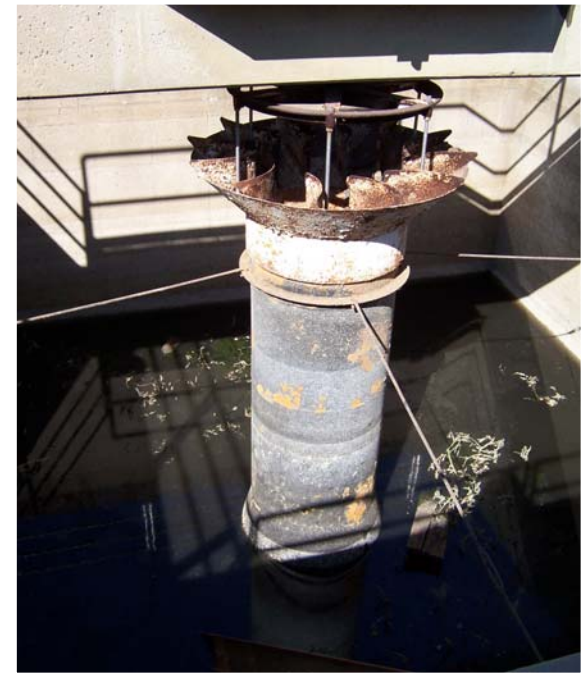
Sewage Treatment Plant - History

- Below grade, concrete-lined plant
- Operated from 1961 – 1987
- Received cooling tower water, possibly containing trace solvents / fuels, and sanitary sewage
- An inactive leach field lies to the east of the STP, and received waste from the ELV buildings (B211/202/203/206).
- The plant used a comminutor, source aeration unit, and clarifier where clarified effluent was removed from the top after solids settled to the bottom.
- Settled sludge was removed for disposal and treated water was pumped out and ultimately arrived in the Silvernale Reservoir.
