**REQUEST FOR ADDITIONAL SAMPLING/ANALYSIS
SANTA SUSANA FIELD LABORATORY – RFI GROUP 8
AREA OF CONCERN: BLDG 56 LANDFILL/EXCAVATION AREA
OUTFALL 7**

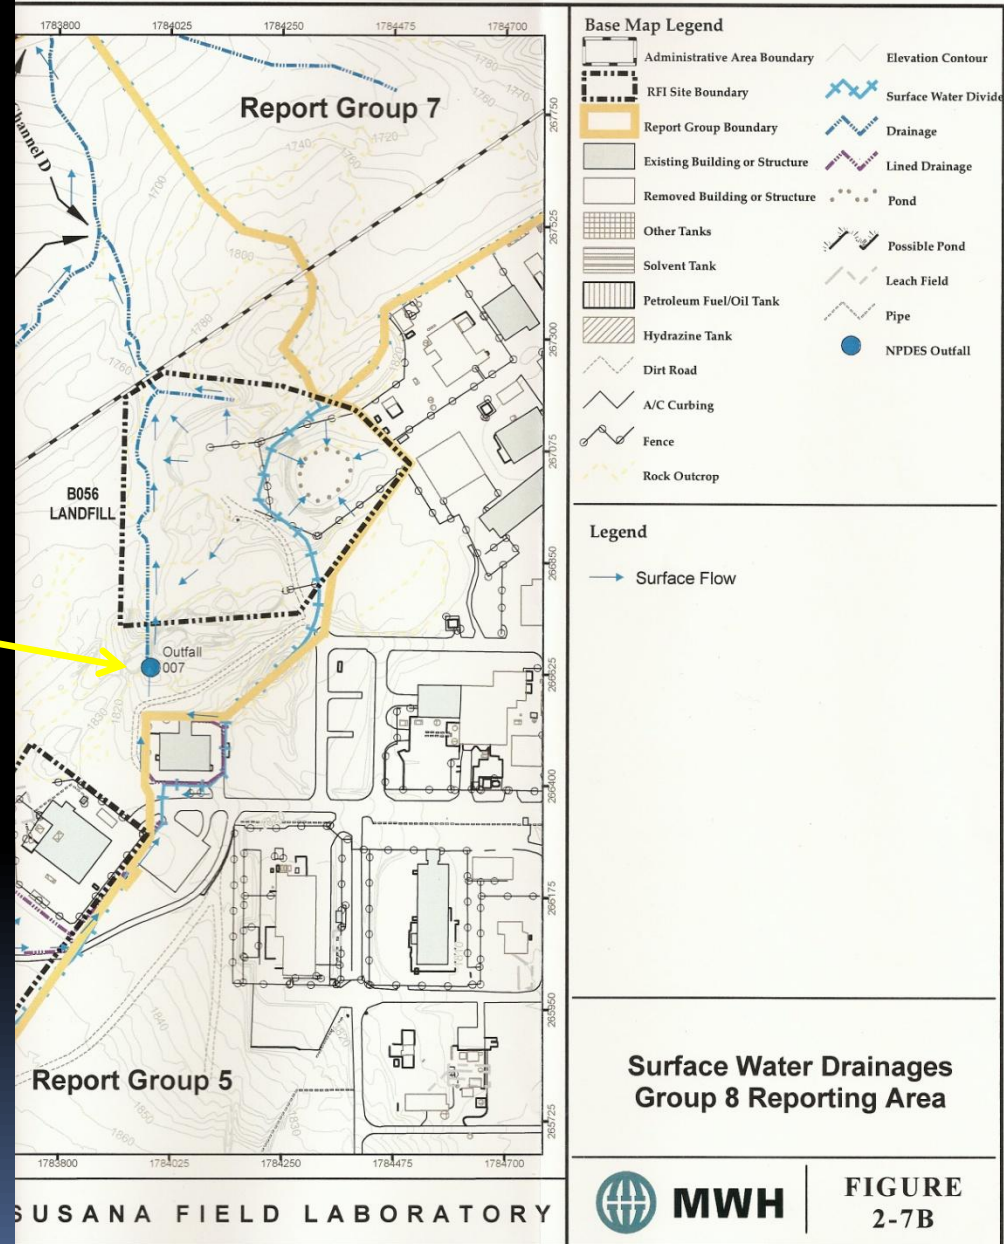
89 Drums of hazardous waste was stored “on top” of the landfill, DOE report states this area qualifies as a potential CERCLA site under DOE order 5400.4

The drums stored on top of the Bldg 56 Landfill area are described as having contained hazardous wastes including reaction products and TCE and other VOCs.

Oil and Grease up to 1100 mg/kg and groundwater impacts in RD7 at 130ppb TCE

- We believe that a sampling program is appropriate for this area based on the historical uses of the landfill itself, as well as long-term storage of 89 drums of hazardous wastes on top of the landfill (removed in 1980/1981). SAIC 91
- Pursuant to Section 13267 of the California Water Code it is appropriate to employ a monitoring program for these locations to determine if further action is needed.
- Thank you in advance for your consideration.
