May 14<sup>th</sup>, 2009

RE: RCRA Group 5 SSFL  
Comments for Santa Susana  
Field Laboratory Areas III and  
IV as defined within the RCRA  
group guidelines

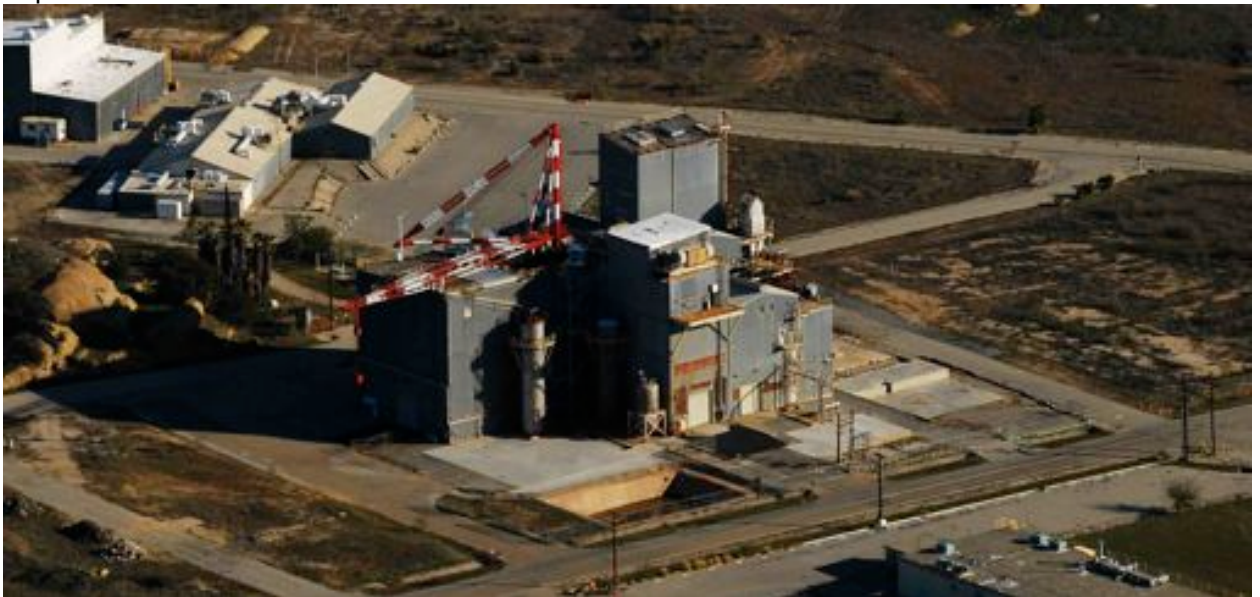
As we can see, this facility was used to clean things, which means washing off, and rinsing. Here we see a pond that is not even on the diagram in Group 5

The pond shown here, is not indicated in the SAP maps included in the Group 5 Report.

The pond area is not clearly marked in any of the maps and this was a burn/runoff pond that was clearly constructed for that specific purpose. Sampling needs to occur for all COCs in the pond area and the effluent drainage leading away.

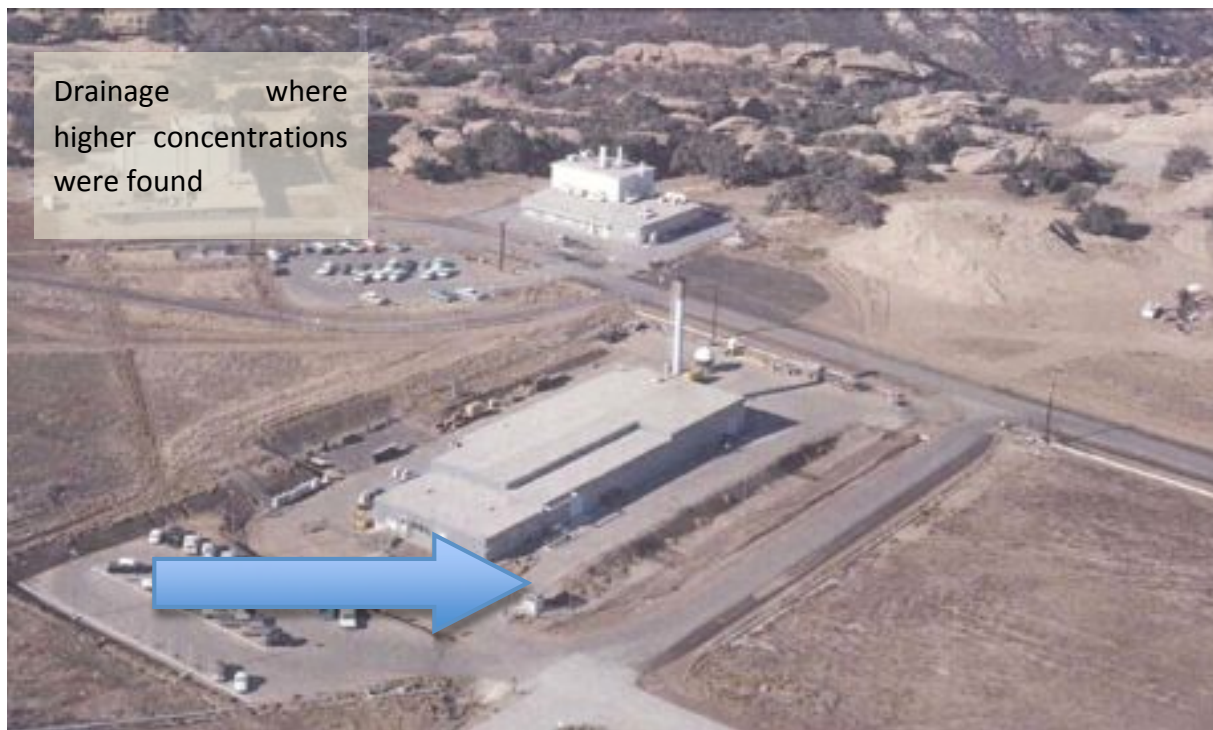
Figure S.1-1 RIHL RFI Site

Location of the UT07 Radwaste underground storage tank is not identified. When unknown operational use dates, and location is also not known, we ask that much more thorough investigation of this tank be done. We request that ultimate disposal information also be provided.

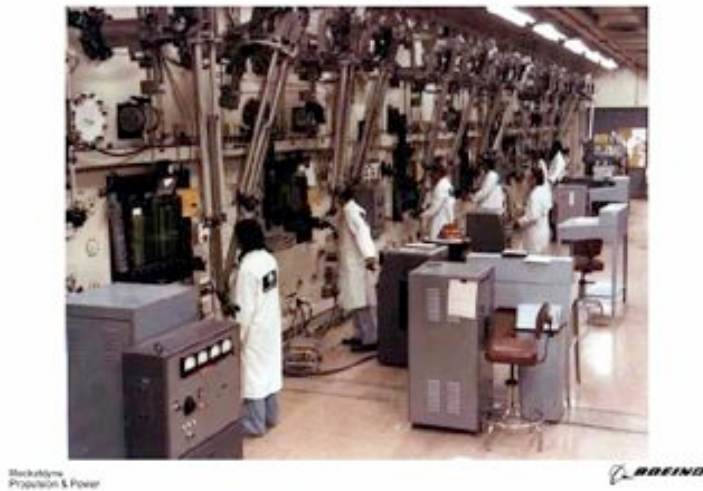
*Hot Laboratory (1978)*

Behind these giant vaults were offices where workers sat in an office environment with their backs to the vaults.

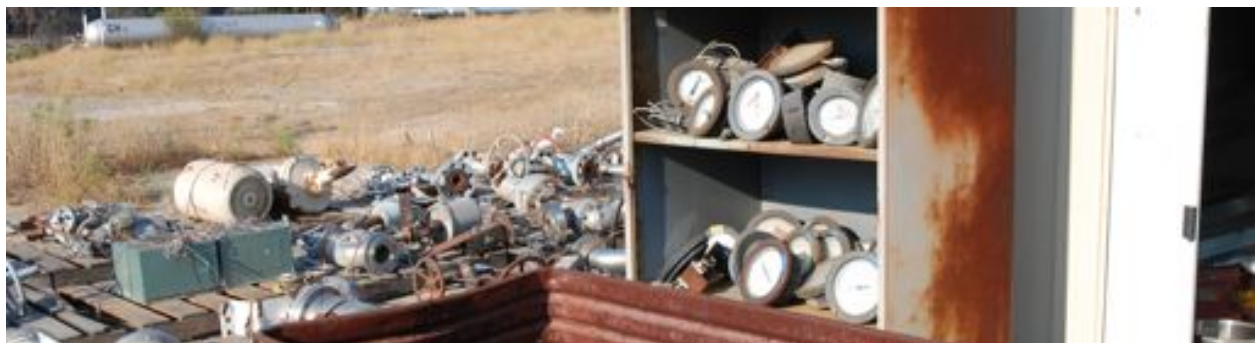
This area included a series of BMPs that consisted of straw waddling to encompass each of these areas of waste and equipment/asset storage. This activity demonstrates the understanding that contaminants may have entered the environment from these containers that are degraded in condition and may have leaked. Some of the equipment was initially tarped, and later the tarping was removed.

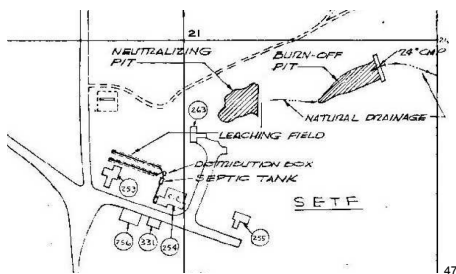
STL-IV Ponds (1960)

These specific early ponds are not clearly identified in the later building feature documentation logs. We are pleased to see these added layers in the reference maps to be used when considering sampling locations in the SAP.

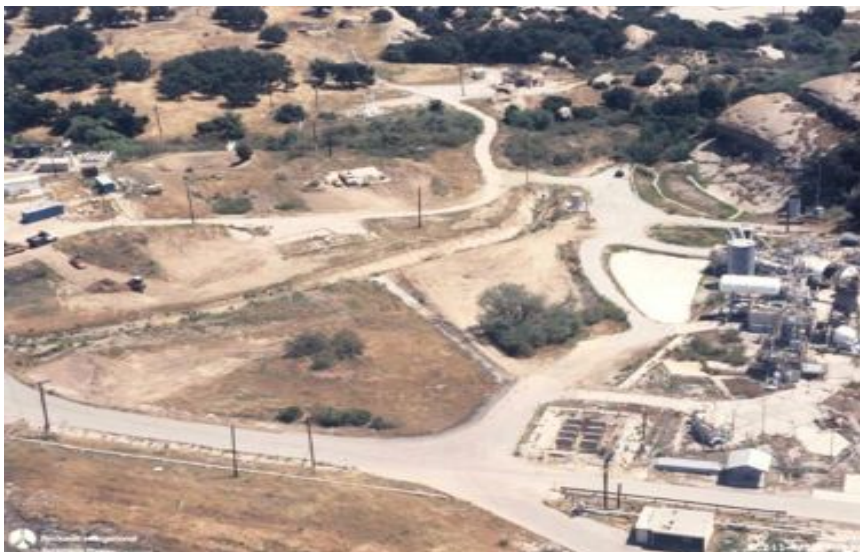
Another early photograph, where STL IV is already there, as is the disturbed soils on the lower right. This is early, when the Hot-Lab and building 55 were there, but prior to the SPTF. The shark is very apparent in this photograph and our photos show disturbed soil on the right side or “mouth” of the shark, which is also down-gradient from the areas sampled. We have questions about backfilling materials possibly deposited here, and therefore believe that sampling is justified since they did find some detects.

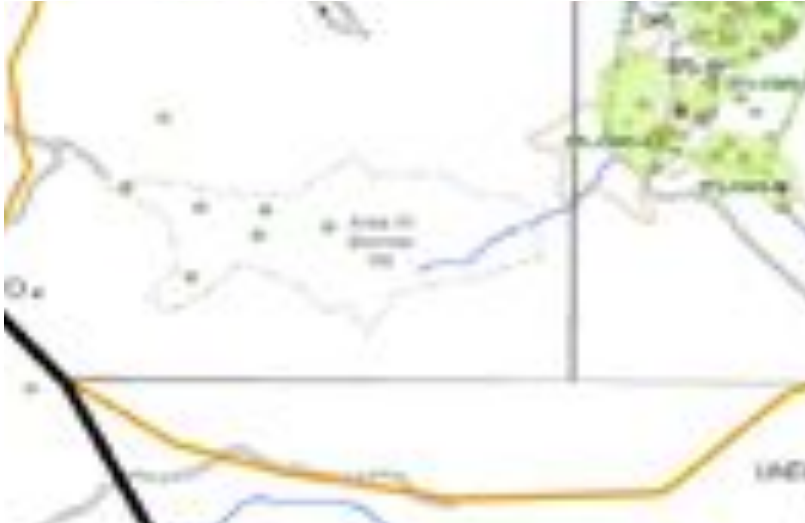
Effluent drainage from Area IV leading to the R2 Ponds, but also from drainage along the road leading to STL IV. This is a constructed drainage system that appears to be ignored by the effluent drainage documentation presented herein.

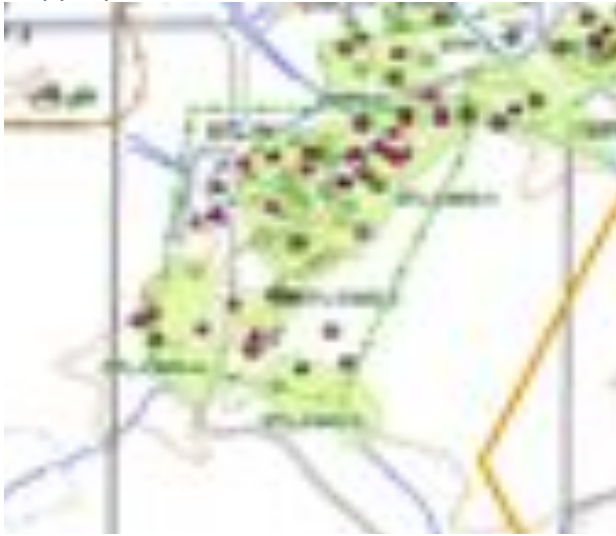
Inappropriate CMS areas delineated, even based on current sampling, which is inadequate:

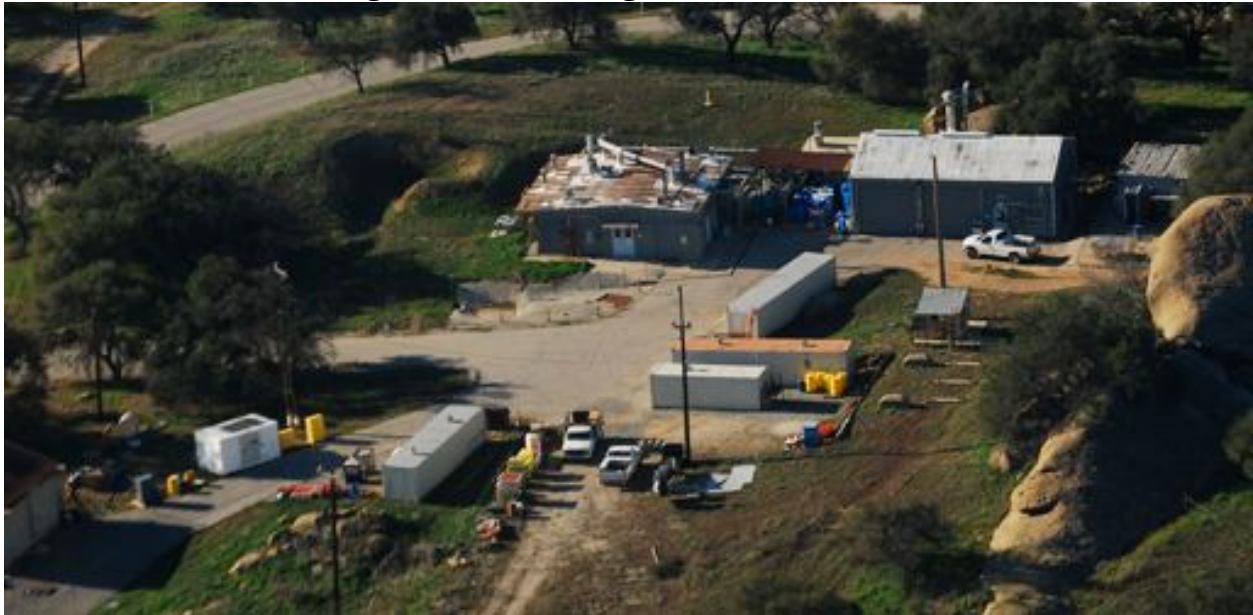
Please note the drum storage between buildings:

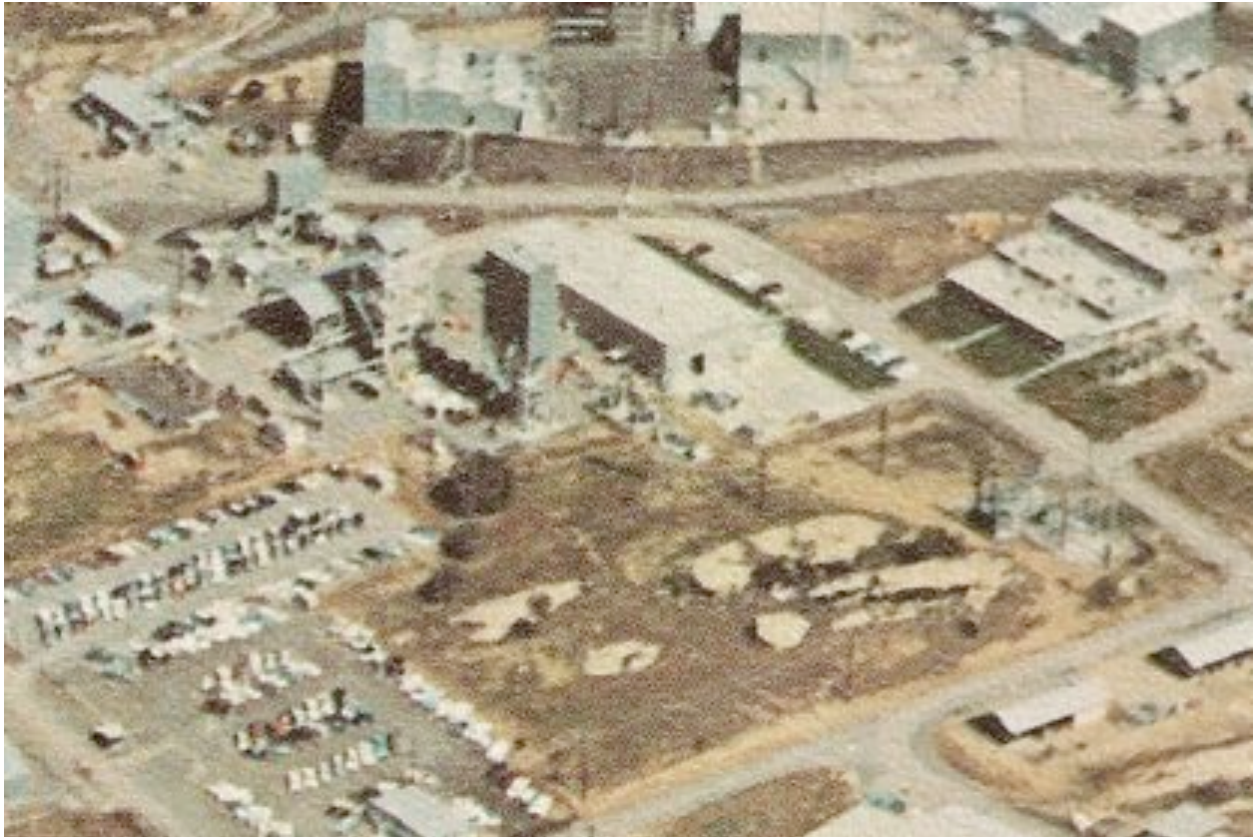
Building 006 was called the Sodium Lab and did have steam rising from it on our first tour day with Norm and his team in late 2007. This area in our photographs shows extreme staining of the concrete loading area and driveway. Here is a portion of a historical photograph with operational activities shown. This was a hazardous waste storage area and it appears as if very little sampling has taken place here, despite the very obvious evidence of corrosion and rust staining that are indicative of drum storage that was not adequately contained over the years.

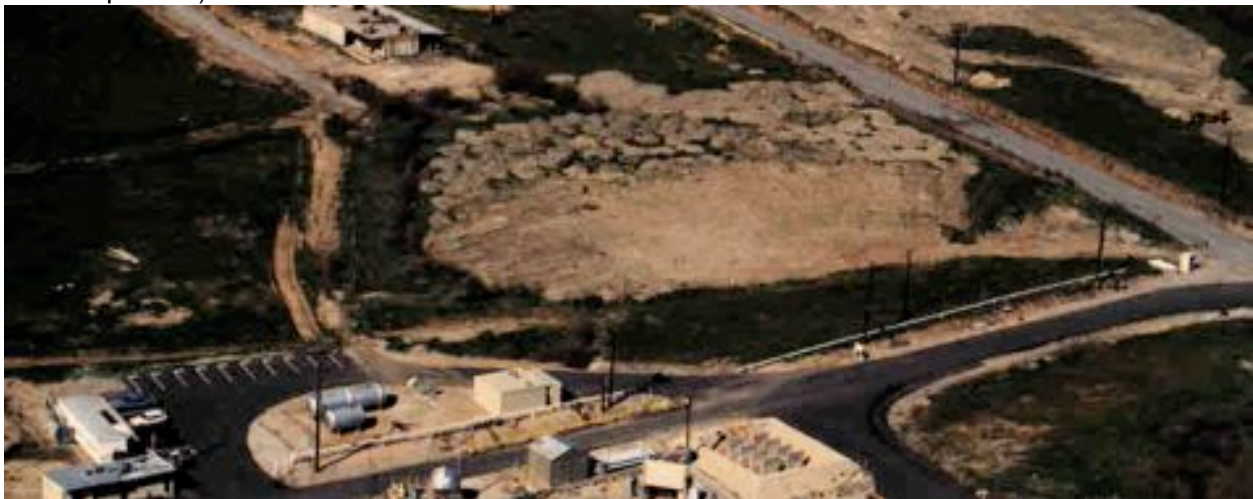
In this example, only some grab samples are recommended despite the size of these debris piles, the number of them, the fact that they were dumped many years ago (shown in historic photos).

In addition to the obvious massive dumping that took place in the area adjacent to STL IV, please note the road to the facility that is no longer there, but is adjacent to the dumping area.
