Santa Susana Field Laboratory

The Use of Trichloroethylene at NASA's SSFL Sites

This provides information on the cleanup of NASA properties at the Santa Susana Field Laboratory (SSFL).

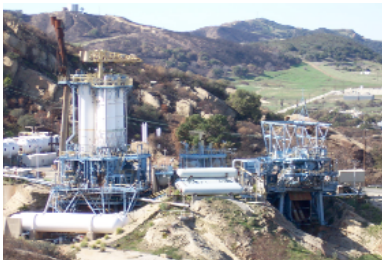
The Bravo Test Stands (including those pictured above) were among four areas NASA used for testing rocket engines.

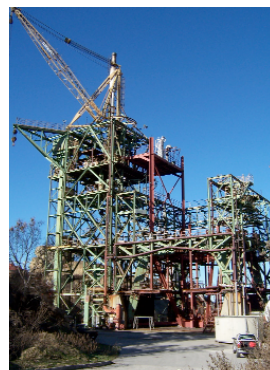
Coca Test Stand #4 was used during Space Shuttle Main Engine testing.

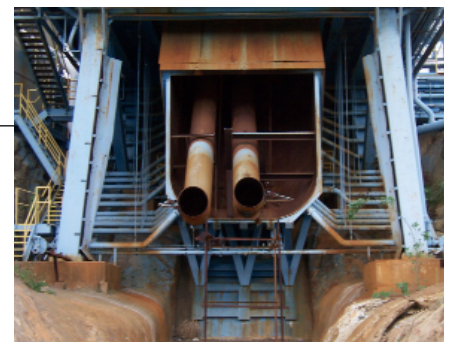
After 1961, a TCE Recovery System was put in place. This diagram shows the system at the bottom of a test stand.

From 1954 through 1993, there were more than 21,500 kerosene-fueled rocket engine test firings at SSFL that required TCE flushing, most of them in Area II. The majority of tests (95%) took place between 1955 and 1966. During the entire testing period for kerosene-fueled engines, some 500,000 gallons of TCE were released into the ground with the vast majority (97%) occurring before 1961. Prior to that year, the TCE used to clean engines ran down into a concrete spillway, which led to unlined ponds and some of the TCE spilled into the soil, eventually making its way into groundwater. Several ponds were subsequently excavated and backfilled. In 1961, the USAF instituted a TCE recovery system, consisting of “catch pans” located at each test position, which were connected by hose and pipeline to a collection storage tank. This TCE was later sold for recycling.
